NUMBER: 08-024-21

GROUP: 08 - Electrical

UAG UCG and UDG Radio Enhancements

2018	(BU)	Jeep Renegade
2019	(BV)	Jeep Renegade

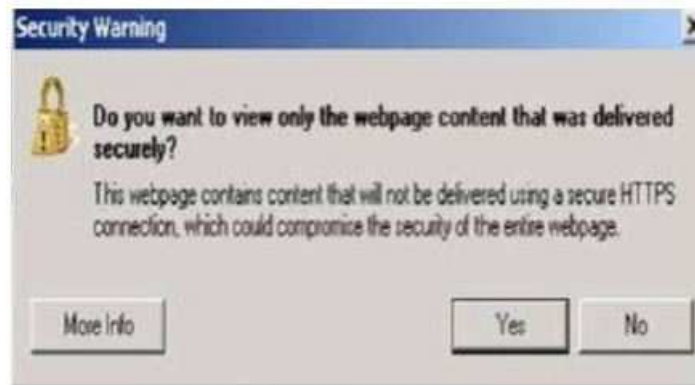
Fig. 1
Pop-up Security Message

3. If a security message appears “Do you want to view only the web page content that was delivered securely?” (Fig. 1) Press No to continue.

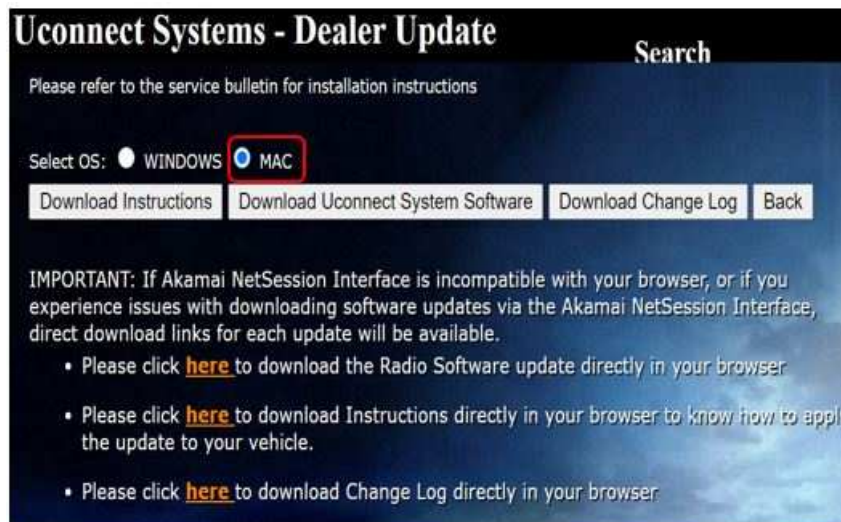
Fig. 2
MAC Download

4. Download the software update file to your local PC’s desktop. Make sure to select the “MAC” radial button for all downloads (Fig. 2) .

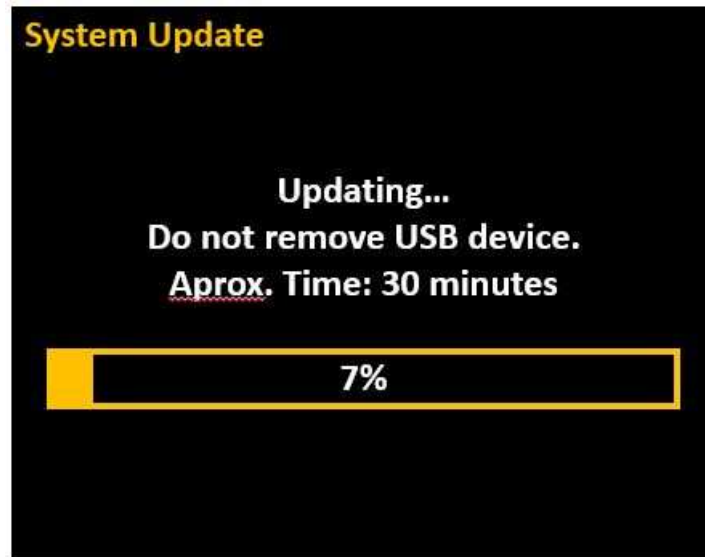
Fig. 4
Percentage Completed Screen

NOTE: There will be a variety of screens displayed throughout the update process. A black screen will appear multiple times in the process for a few minutes ([Fig. 4](#)).

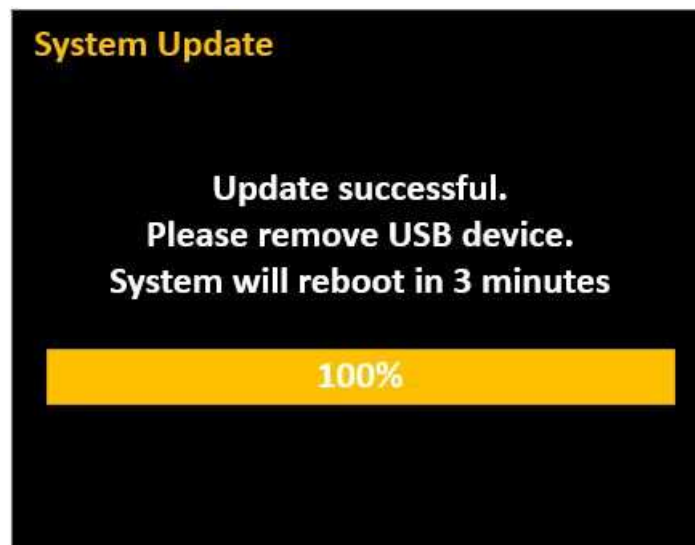
Fig. 5
Update Successful Screen

12. After the update is done the screen will display "Update successful" see ([Fig. 5](#)).
