# Technical Service Bulletin

| <b>Technical Service Bulletin:</b> TSB170119 | <b>Released Date:</b> 01-Feb-2021 |

## Charging System Alternator Bracket Malfunction

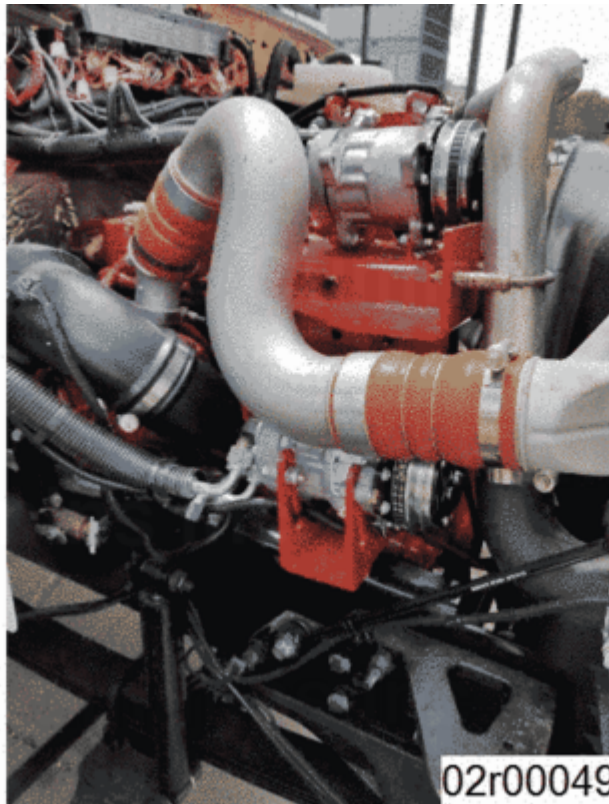
- Use of non-approved Dual Freon™ compressor system installed by aftermarket suppliers like Mobile Climate Control (MCC) and Bus Air.
- Aftermarket suppliers utilize a non-approved bracket painted red or black. See Figure 1 below.

Figure 1, Non-Approved Bus Air Charging System Alternator Bracket.

- Installation of any non-approved charging system alternator bracket will **not** be covered under Cummins® warranty.
- Repair locations are to contact their aftermarket supplier representative for repair guidance.

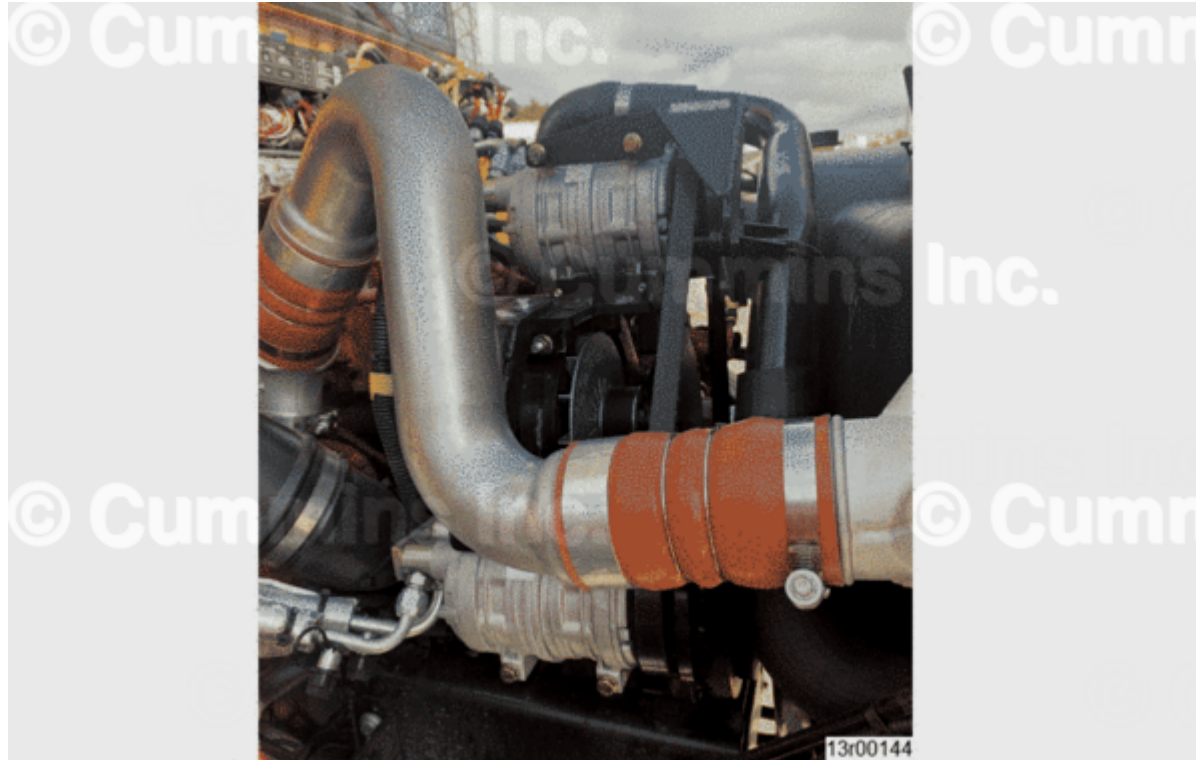
- Installation of a non-approved system alternator bracket. See Figure 1 and 2.
- Coolant leak at coolant thermostat housing. See Figure 3 and 5 below.
- Cylinder head cracking. See Figure 3 below.

Figure 2, Non-Approved Mobile Climate Control (MCC) Charging System Alternator Bracket.

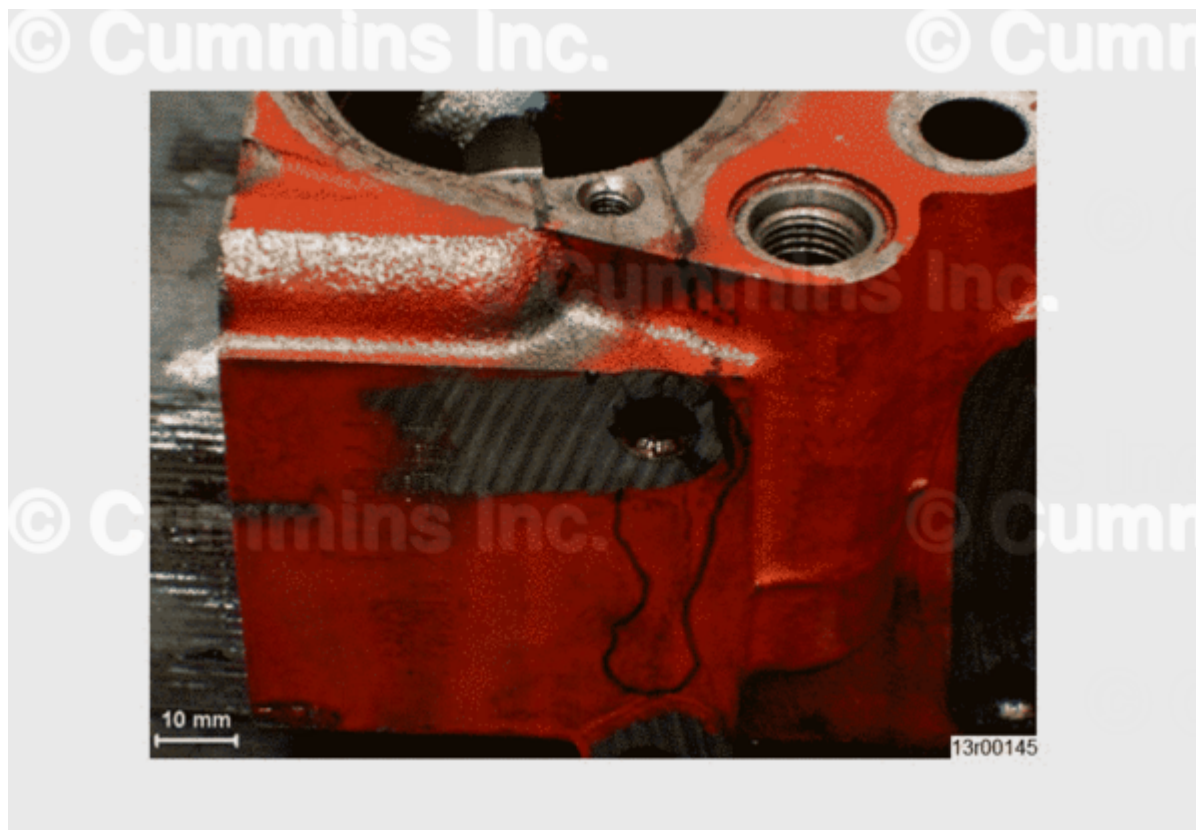
- Charging system alternator / refrigerant brackets can cause cracking to initiate near cylinder head coolant thermostat housing.

Figure 3, Coolant Leak at Coolant Thermostat Housing.

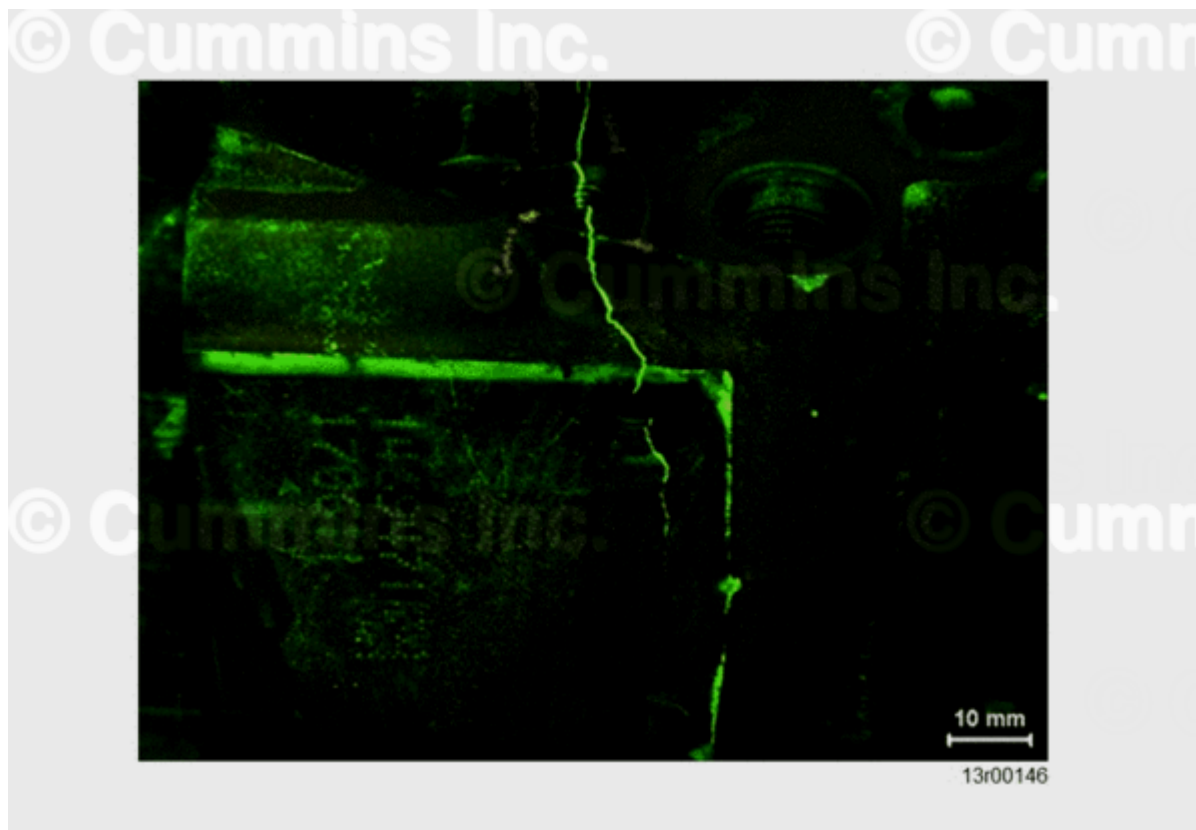
Figure 4, Magnetic Particle Inspection of Figure 3.

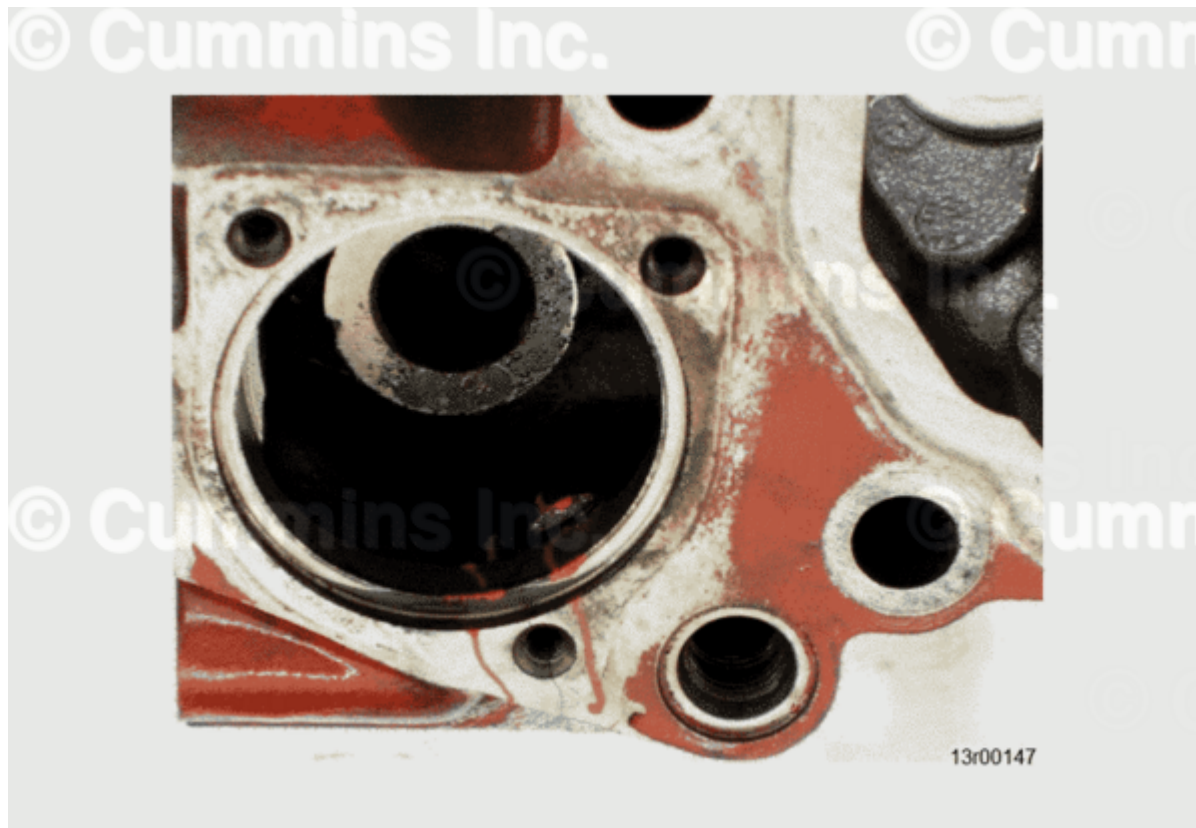
Figure 5, Coolant Leak at Coolant Thermostat Housing.

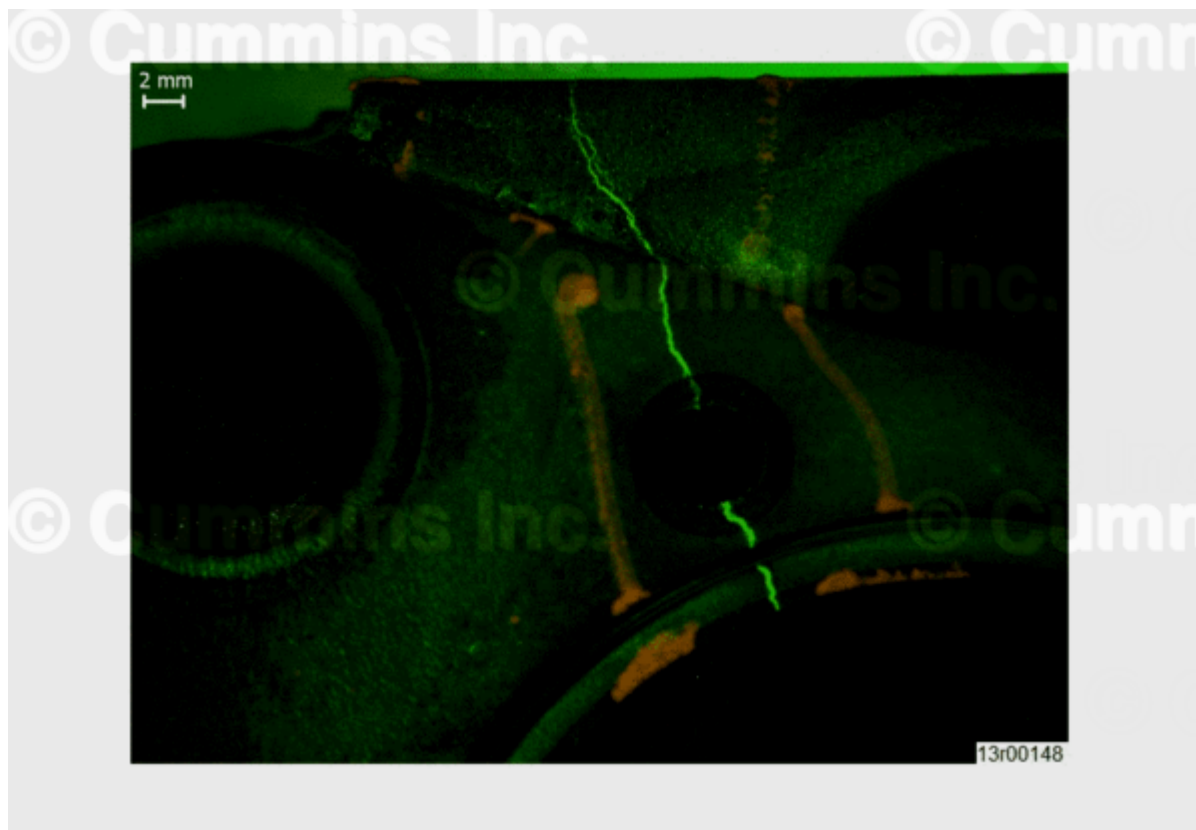
Figure 6, Magnetic Particle Inspection of Figure 5.

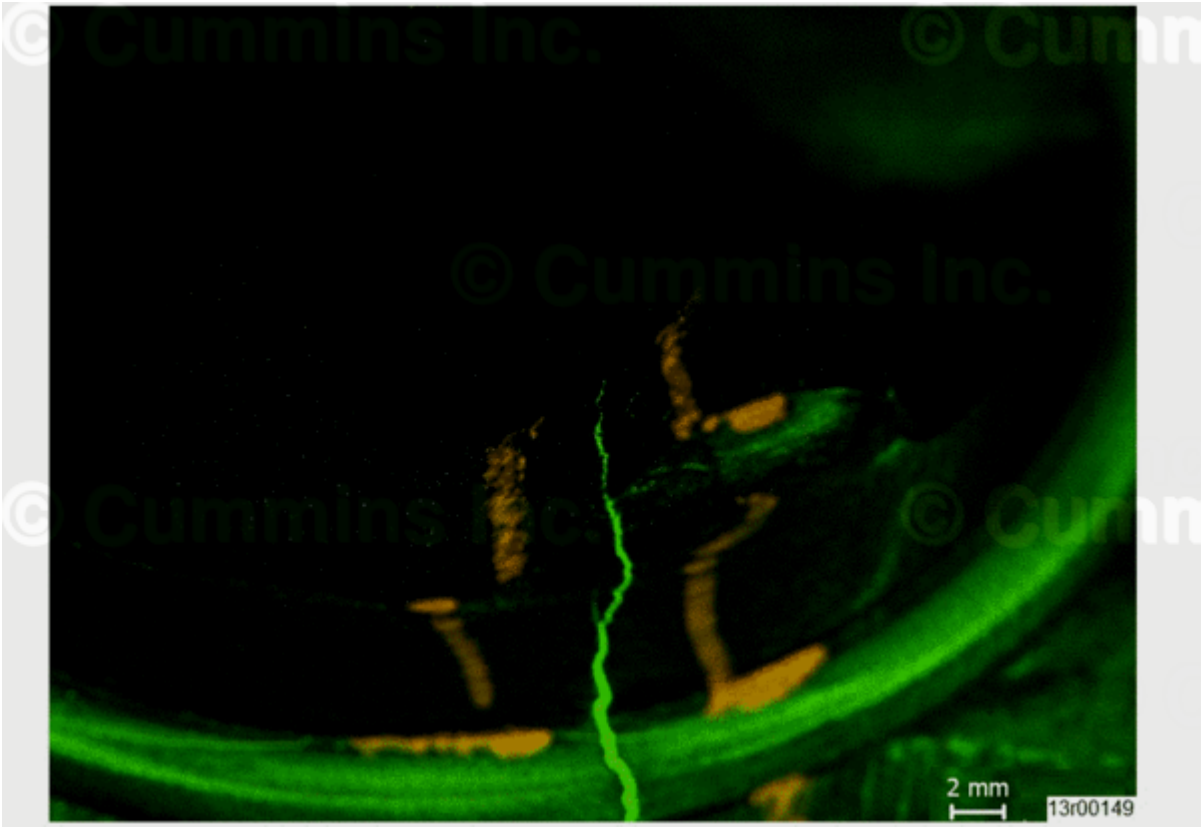
Figure 7, Magnetic Particle Inspection of Figure 5.
