Technical Service Bulletin

Technical Service Bulletin: TSB180095	Released Date: 25-Feb-2021
Repeat Occurrences or Troubleshooting Exhausted: Fault Codes 1682, 3574, and 3596.

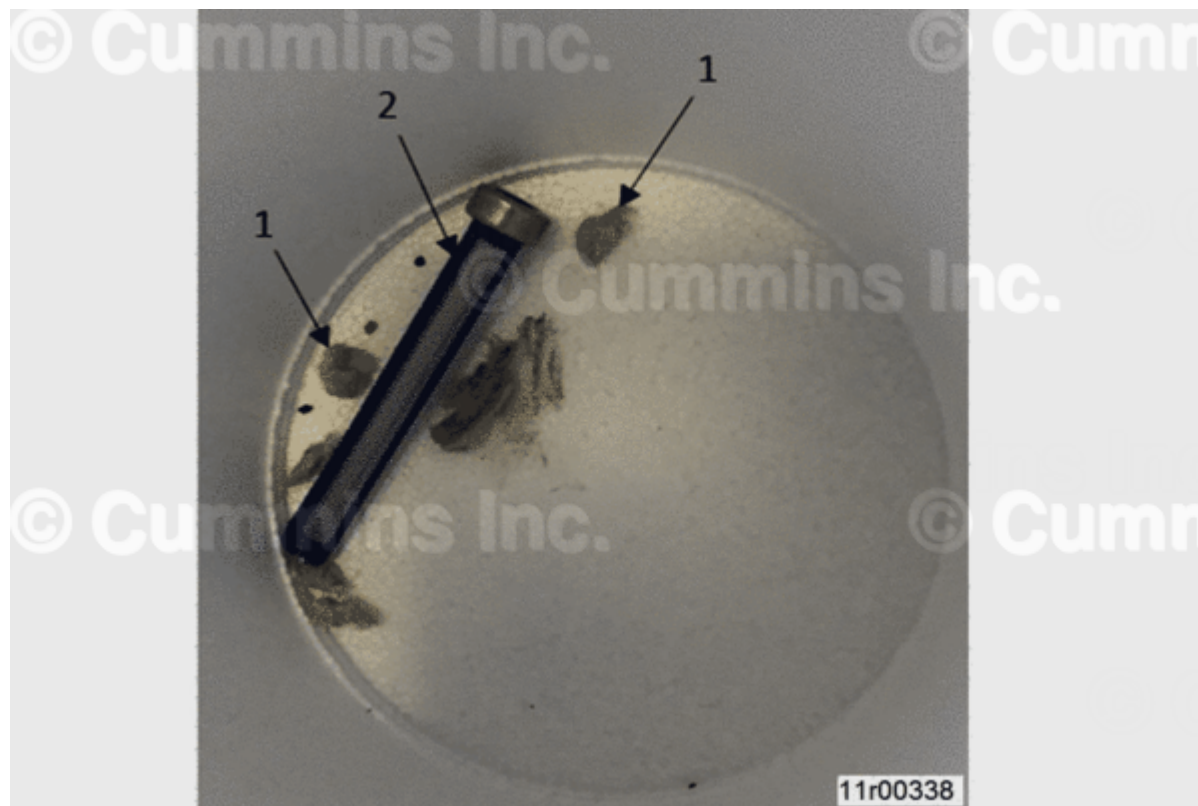
1. Debris builds up in intake fitting screen of aftertreatment DEF dosing unit and restricts flow into pump. Debris can be paper, fibers, or smaller particles of sand, rock, or dirt that build up over time.

Figure 1, Example of Debris Found in Intake of DEF System Causing Flow Blockage.

1. Paper debris.
2. Aftertreatment DEF dosing unit intake fitting screen.

- Flush intake line with clean water.
- Remove and replace aftertreatment DEF dosing unit intake fitting. Before removing intake fitting, verify area around fitting on aftertreatment dosing unit is clean so dirt is **not** knocked into intake port.

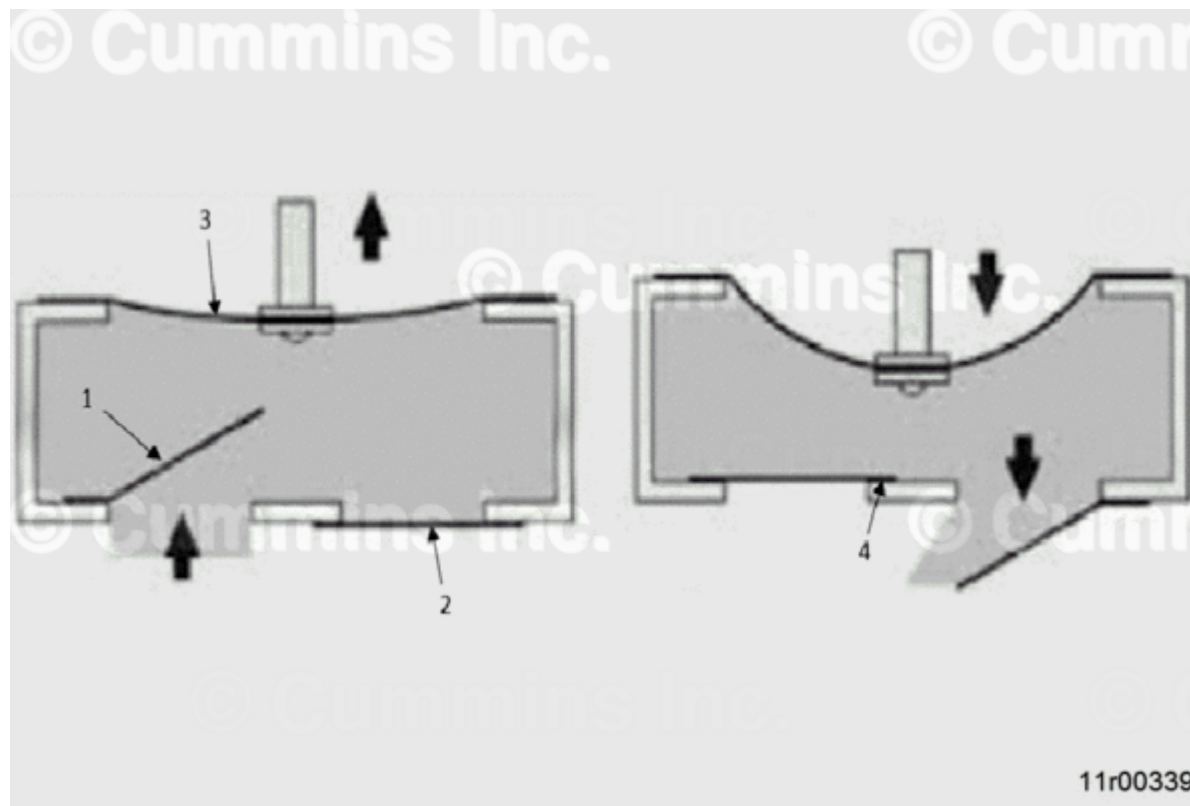
2. Debris collects on the pump intake valve in aftertreatment DEF dosing unit and prevents the intake valve from sealing properly. This form of debris will be small because debris has to pass through the 103 micron aftertreatment DEF dosing unit intake screen to get to the intake valve. Particles larger than 40 microns can cause pump performance issues (a human hair is approximately 50-70 microns wide).

Figure 2, Typical Operation of Diaphragm Style Pump in Aftertreatment DEF Dosing Unit.

1. Intake valve (membrane style).
2. Outlet valve (membrane style).
3. Pump diaphragm.
4. Location where debris builds up causing intake valve **not** to seal.

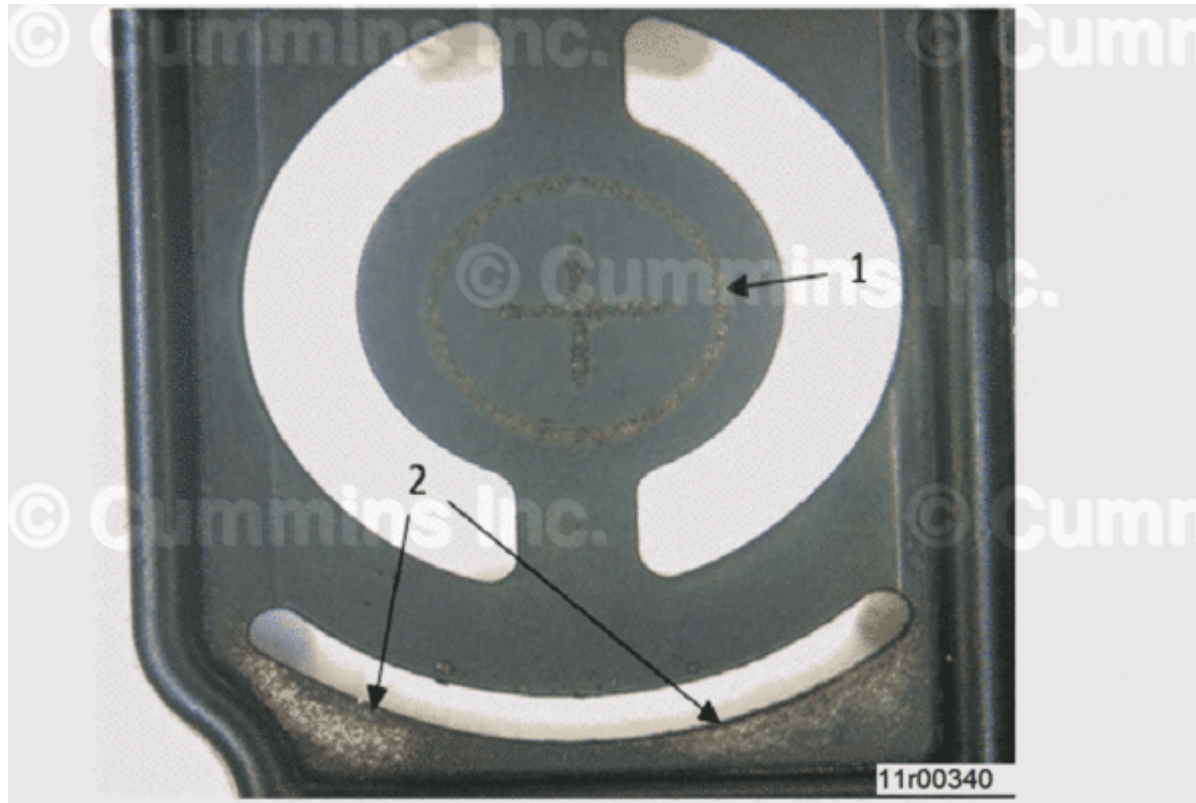
Figure 3, Debris Build Up on Aftertreatment DEF Dosing Unit Pump Intake Valve Plate. Intake Membrane (Valve) Seals Over this Plate On Pump Pressure Stroke.

1. Debris causing pump performance issue. This is what is flushed out when performing dosing unit non-air flush.
2. Loose debris that settled on the edge of the valve plate.

- Remove and discard aftertreatment DEF dosing unit filter. See corresponding Service Manual. Reference Procedure 011-060 in Section 11.
- Perform aftertreatment DEF dosing unit non-air flush three times. See corresponding Service Manual. Reference Procedure 011-058 in Section 11.
