Technical Journal

Noise when turning steering wheel

REF NO: TJ 35842.1.0	ISSUING DEPARTMENT: Technical Service	CAR MARKET: United States and Canada	
PARTNER: 3 US 7510 Volvo Car USA		ISSUE DATE: 2021-01-28	STATUS DATE: 2021-01-28
FUNC GROUP: 6412	FUNC DESC: Steering column; shaft	Page 1 of 3

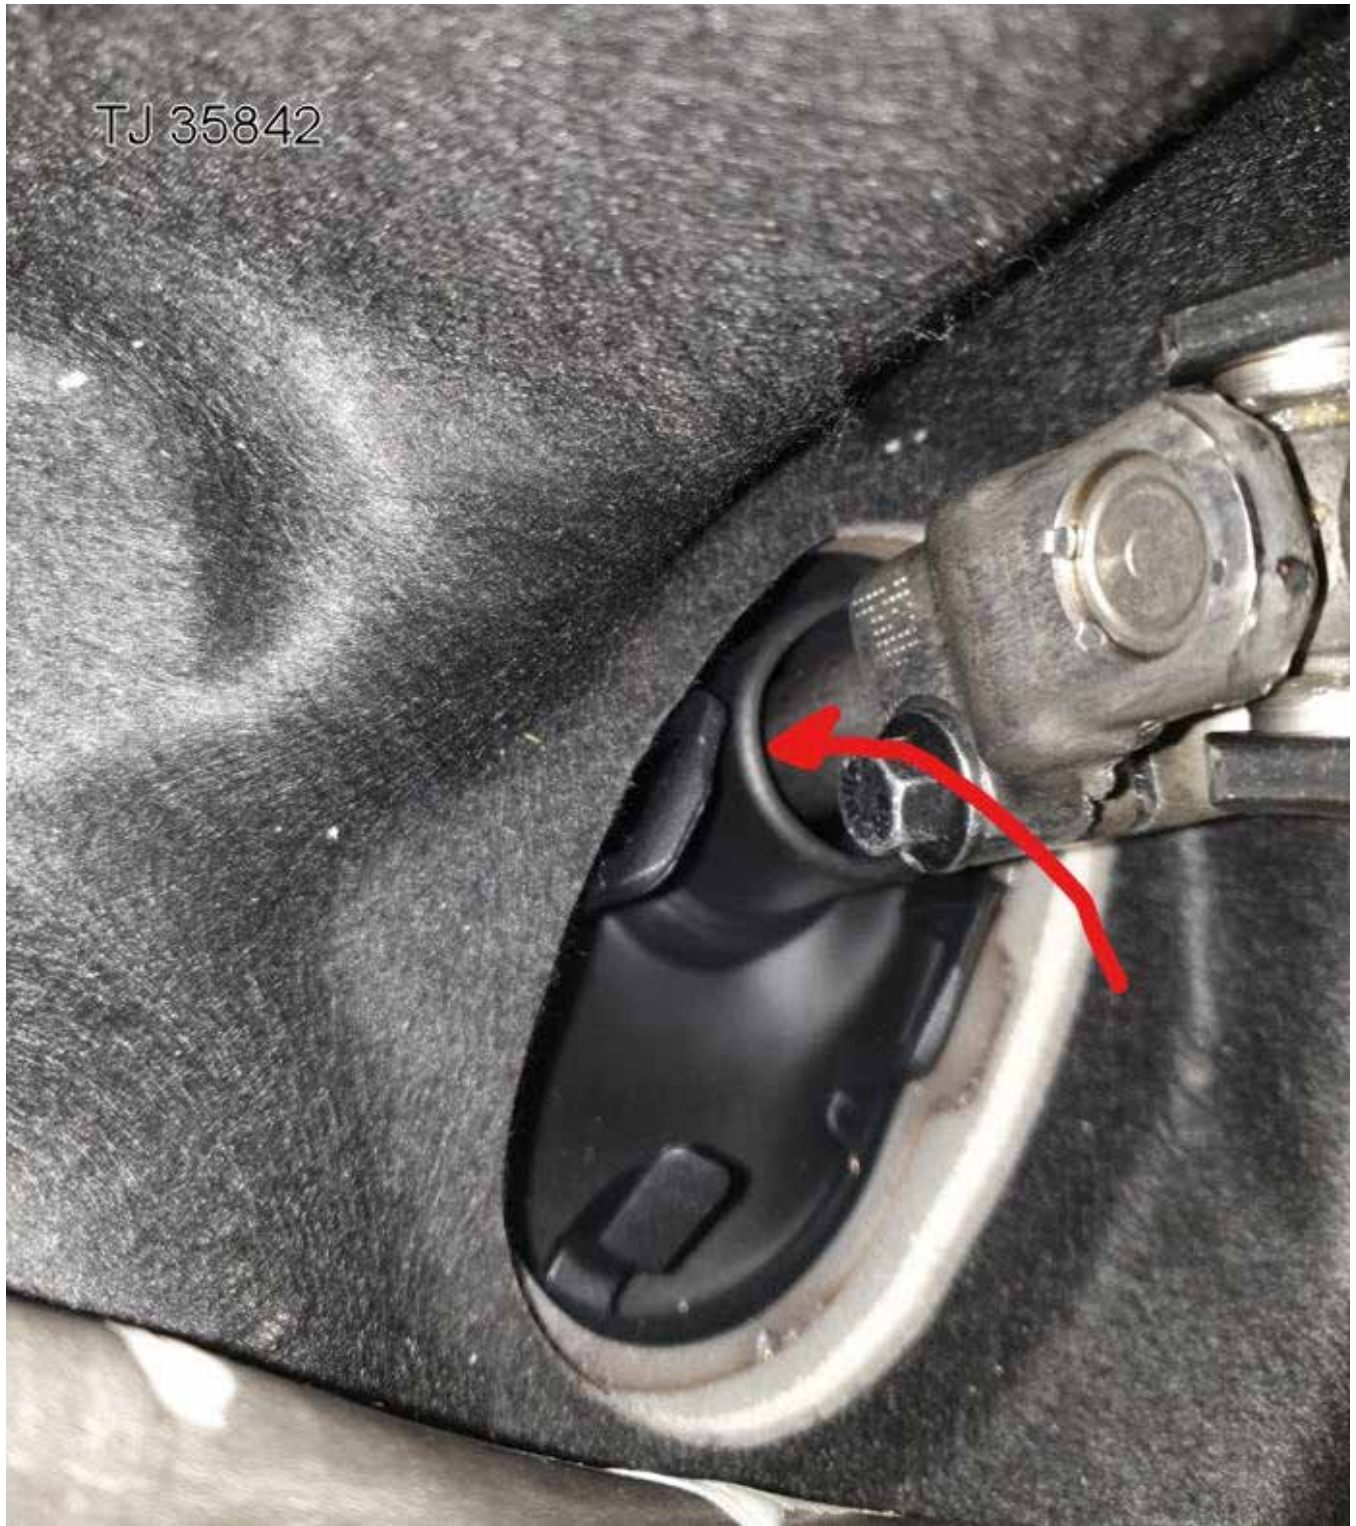
Check if the rubber grommet installed in the firewall for the steering column is causing the noise when rotating the steering wheel.

If confirmed, first check that the rubber grommet is installed properly, if needed try to adjust position of the grommet.

If position is good, but noise still occurs, then apply some PFPE Anti-squeak spray in the rubber grommet, P/N 30749880 (0.1 pce).
