Technical Journal

D-TPMS, Service required and DTC's

REF NO: TJ 31398.5.0	ISSUING DEPARTMENT: Technical Service	CAR MARKET: United States and Canada		
3 US 7	PARTNER: '510 Volvo Car USA	ISSUE DATE: 2021-02-03	STATUS DATE: 2021-02-17	
FUNC GROUP: 7761	FUNC DESC: Pressure control	Page 1 of 4

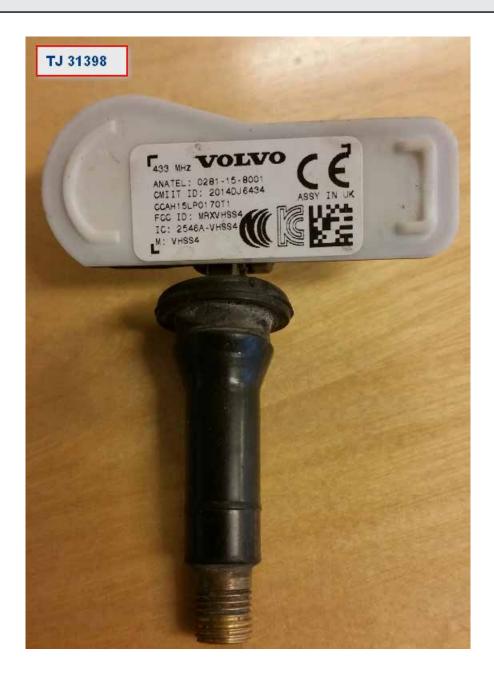
- 4. Check and, if necessary, turn off any non-Volvo accessory using 433 MHz that has been installed in the vehicle.
- 5. Remove tire from rim and inspect that the correct TPMS sensor is being used, the Volvo logo must be printed on the decal on TPMS sensor (see photo).
