Whine or Grind Noise From the Transmission

Service Category Drivetrain

Section Automatic Transmission/Transaxle

Some 2021 model year ES 350 vehicles equipped with a UA80E transmission may exhibit a whine or grind noise from the transmission. This condition may be caused by an issue with the front carrier assembly pinion shafts. Follow the Repair Procedure in this bulletin to address this condition.

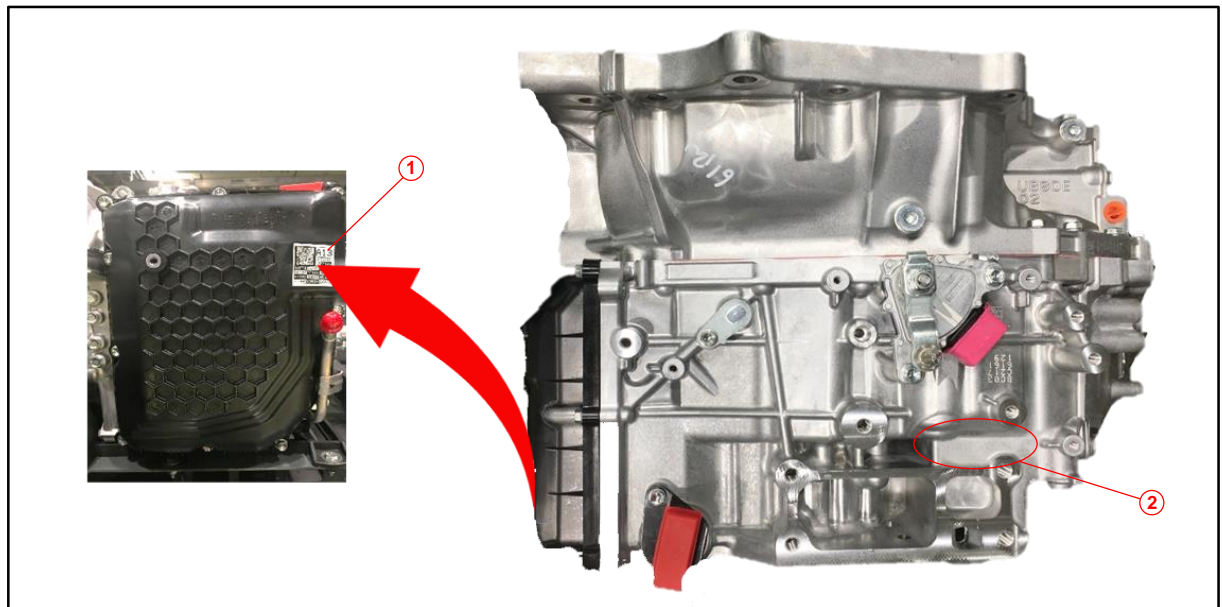
Figure 1. Serial Number Sticker and Engraved Serial Number Location

1. Locate the transaxle serial number, found on the sticker located on the transaxle assembly side cover or on the engraved location as shown. A serial number decoder is also provided below.
