SIB 51 03 21 TICKING NOISE FROM A-PILLAR AREA

2021-02-10

E-Series	Model Description	Production Date
G20	3 Series Sedan	Up to September 30, 2020

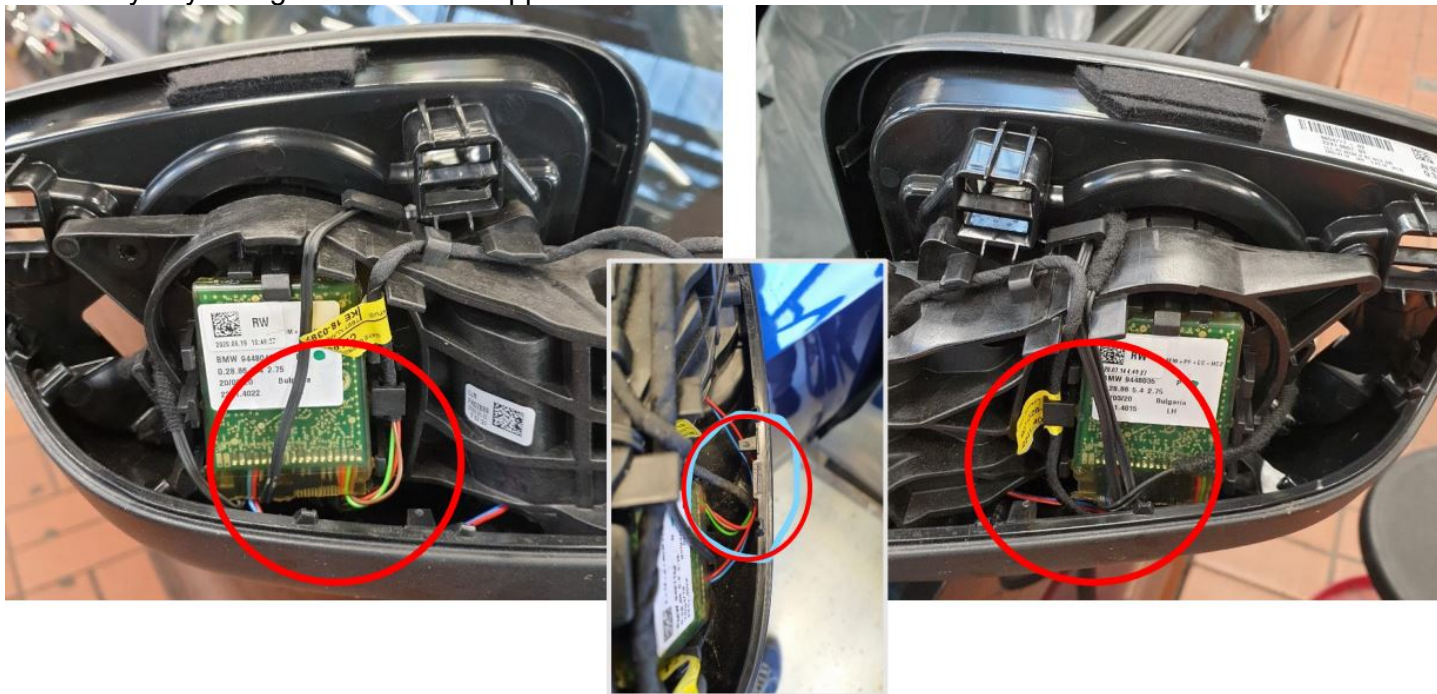
A ticking noise is present in the A-Pillar and side mirror area when driving at speeds of approximately 40 MPH. This can occur on either side of the vehicle.

Interference between the mirror wiring harness and the side view mirror cap.

1. Remove the mirror cap of the affected side following repair instructions REP 51 16 041 "Removing and installing/replacing protective cap on left or right outside rearview mirror".
2. Identify any wiring which is not wrapped in felt insulation as shown below:

3. Wrap any unwrapped wiring found in step 2 using an appropriate and available felt tape, such as P/N 61 13 6 920 760.
4. Reinstall the mirror cap and retest the vehicle.
