2021-02-17

E-Series	Model Description	Production Date
F48	X1 Sports Activity Vehicle	Up to December 7, 2020
G01	X3 Sports Activity Vehicle	Up to December 7, 2020
G02	X4 Sports Activity Coupe	Up to December 7, 2020

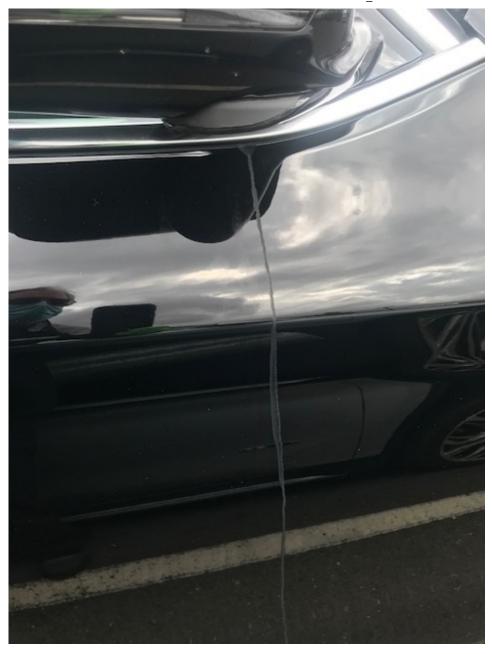
Streaks are found running mostly vertically down along the door outer skin from the lower window trim. This can affect any of the 4 side doors.

Note: The door streaks outlined in this bulletin are NOT the result of normal water droplets. The streaks will appear as a consistent streak down the door and may feel waxy and will be challenging to clean.

Insufficient protective coating of the aluminum door trim causes oxidation to form and trail down the door skin.

Replace the affected door trim and clean the paint using an alcohol-based cleaner which is safe for vehicle paint. Paint correction may be required if the streaks cannot be removed from the vehicle clearcoat.

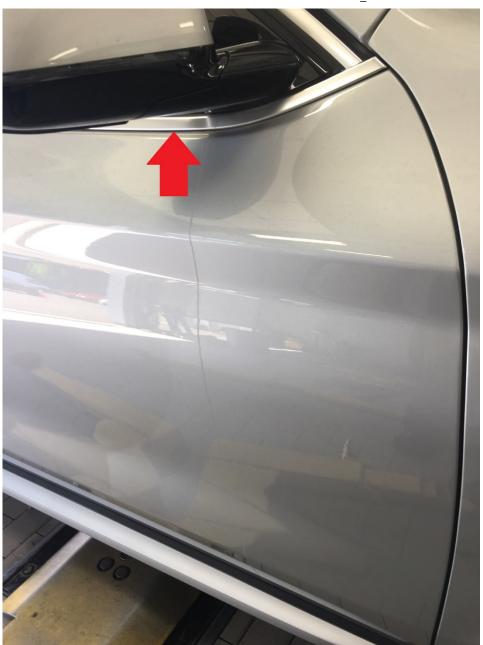
1. Replace the shaft cover (window molding) on the affected door following ISTA repair instructions for the applicable model and trim being replaced. A photo is shown below demonstrating which trim is to be replaced. A driver's door shaft cover is being shown as an example, but any of the 4 doors can be affected.

2. Clean the streaks on the door paint using an alcohol-based cleaner which is safe for vehicle paint, such as R2 cleaner P/N 83 19 0 417 324. If the streaks cannot be cleaned from the vehicle paint, the vehicle may require paint correction.
