SIB 51 12 18

TRIM STRIP IS LOOSE OR DETACHED FROM ROOF

2021-02-05

E-Series	Model Description	Production Date
F90	M5 Sedan	October 2017-April 2018

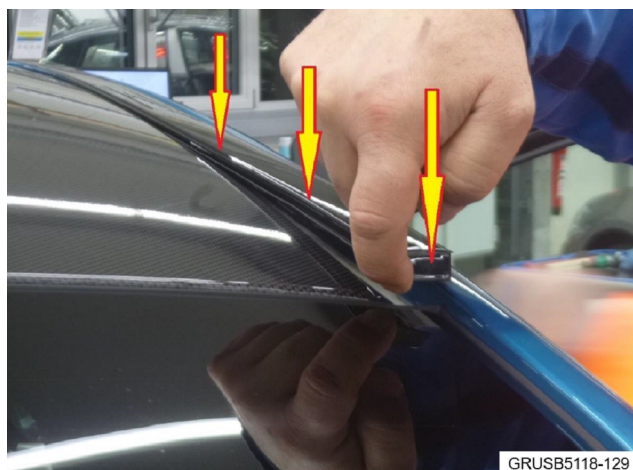
The roof trim strip may be loose or detached.

The roof trim strip adhesive was not sufficient.

1. Inspect both the right and left side roof trim for loose clip connections. If loose trim strips are found on either side, proceed to step 2.
