SIB 54 08 19

2021-02-03

SUNROOF REVERSES WHEN CLOSING

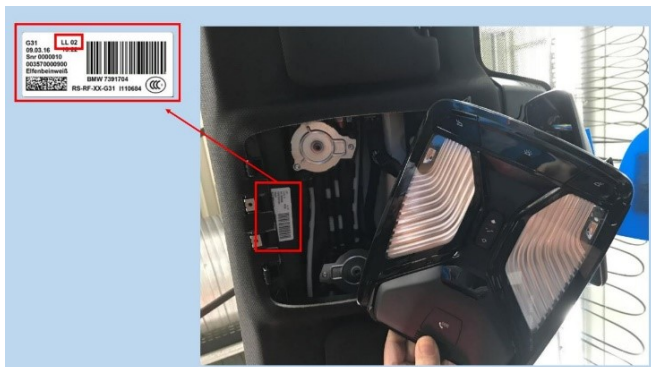
4. With the FZD Removed, inspect the “LL” number as shown to the left.

Is the LL number less than 25 or exactly 45?

Yes: Continue to step 5.

No: Continue to step 6.

5. Replace the wind deflector following repair instructions **REP 54 13 090** “Removing and installing/replacing wind deflector”.
