SIB 63 03 21

2021-02-24

**CONDENSATION IN TAILLIGHT****MODEL**

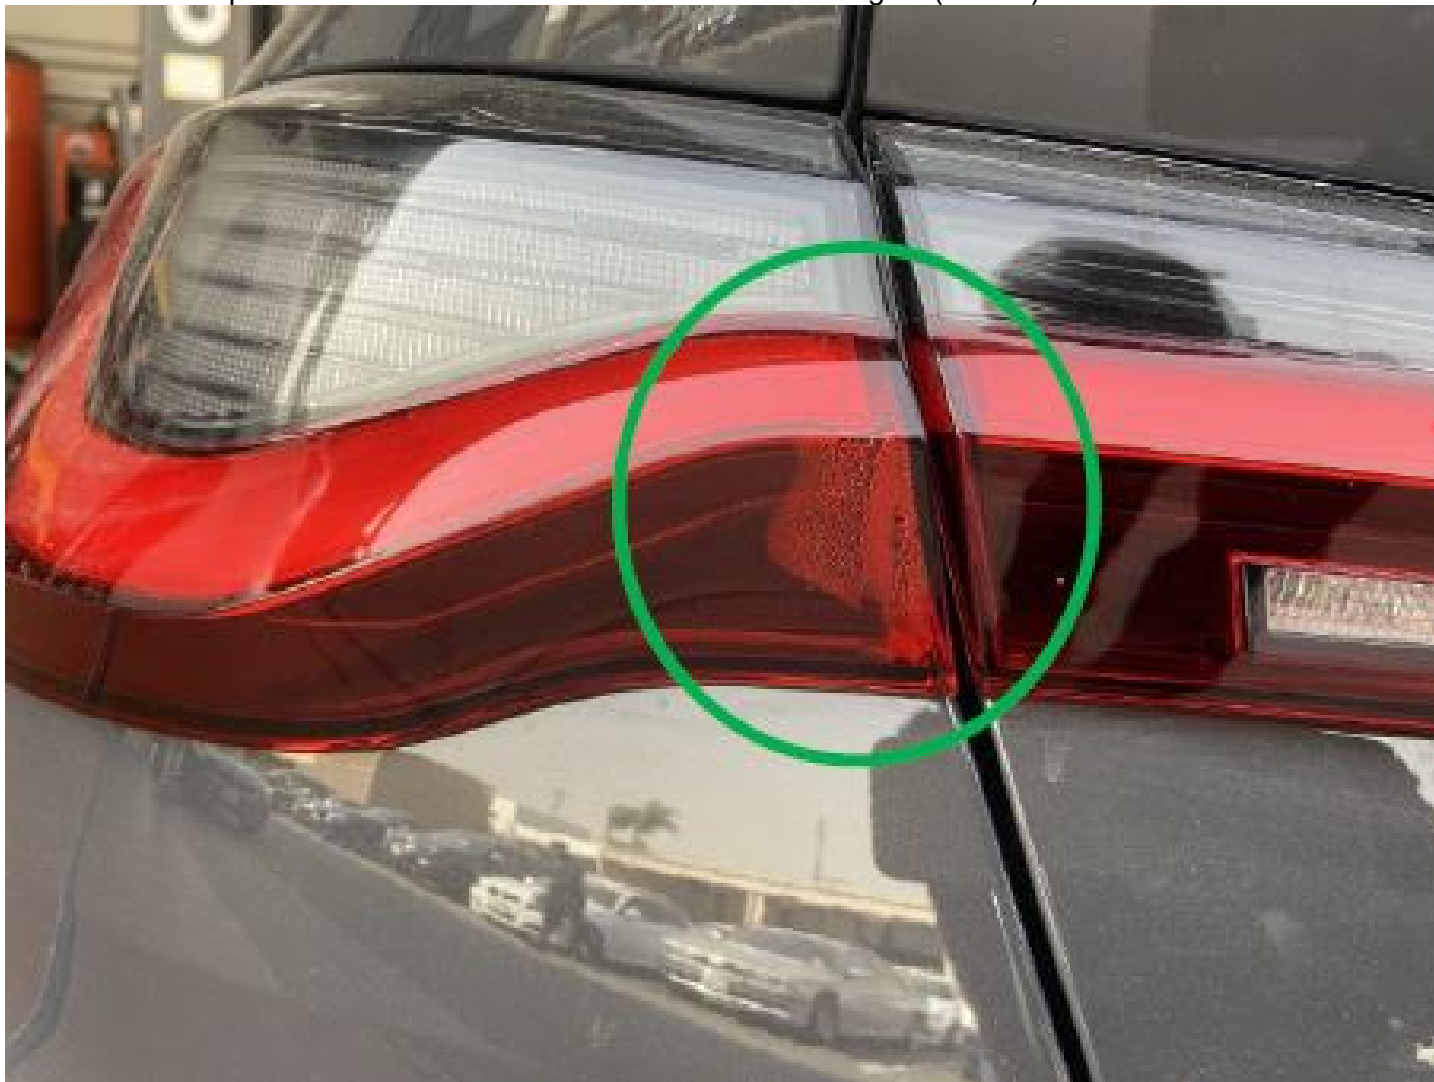
Condensation is present on the inner surfaces in one or both taillights (circled).

Modern BMW vehicles utilize waterproof membrane technology which allows for naturally occurring condensation and air to escape, without allowing excess water or dirt entry. Vehicles which utilize this membrane technology will dry normal condensation at a slower rate than open concept taillights used on previous models. This is a normal condition and requires no correction.

The condensation shown will typically form along the geometrical edges or corners of the taillight lenses. This is a normal characteristic of modern taillights and requires no correction, as this is not a defect.
