SIB 64 02 21

2021-02-24

CHECK CONTROL MESSAGE "COOLANT LEVEL. TOO LITTLE COOLANT"

E-Series	Model Description	Production Date	Affected Option Code
G07	X7 Sports Activity Vehicle	September 1 thru November 30 2020	4NN - automatic air conditioning with 5-zone control

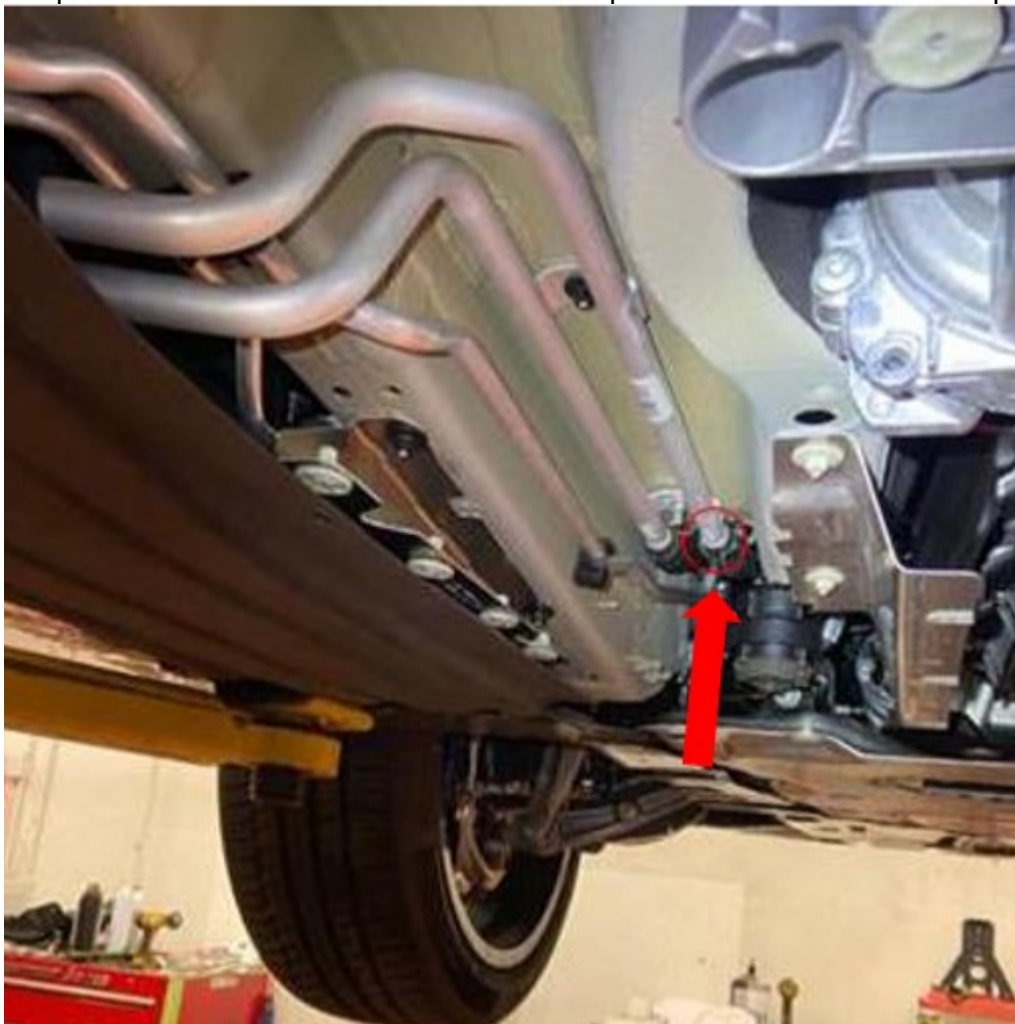
A leak may occur in the coolant pipes that run underneath the vehicle floor.

The possible leak is located at the connection point between the aluminum pipe and the downstream hose.

The tension on the spring-band clamp may not be uniformly applied. Remove the spring-band clamp and replace it with a worm-type hose clamp.

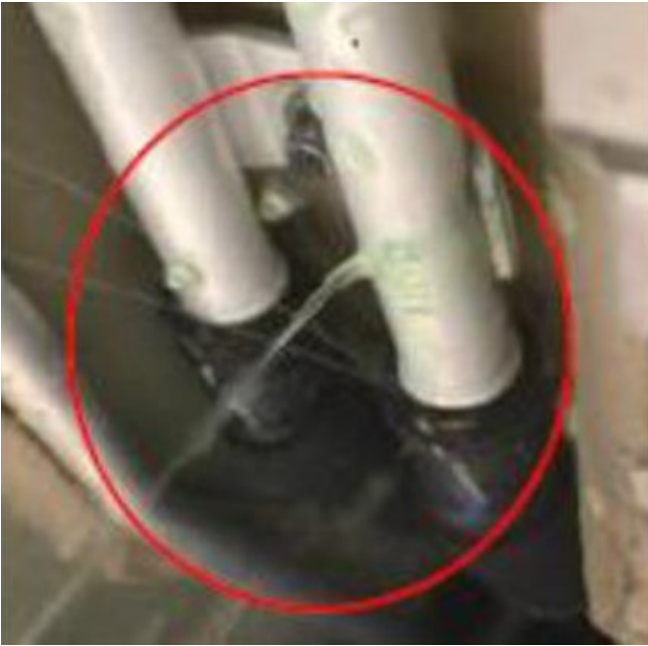
The aluminum pipe and the hose are connected to each other by a spring-band clamp.
