SIB 65 01 21

2021-02-23

## SPORADIC FAILURE OR CRACKING NOISE IN BASS SPEAKERS

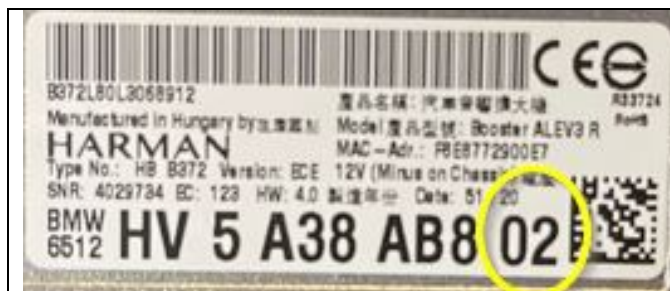
The revision index (circled) is located to the right of the part number.

**The revision index must be 02 or higher.**

**Note: Check the revision index before installing.**
