| Dealer Principal | General Manager | Sales Manager | Service Manager | Parts Manager | Marketing | Finance |
|---|---|---|---|---|---|---|
| Bulletin #: A 02 2021 03 | | Name: | | | Supersedes: n/a | |

## Aftersales Bulletin

### RR31 – Engine Earth Connections Check

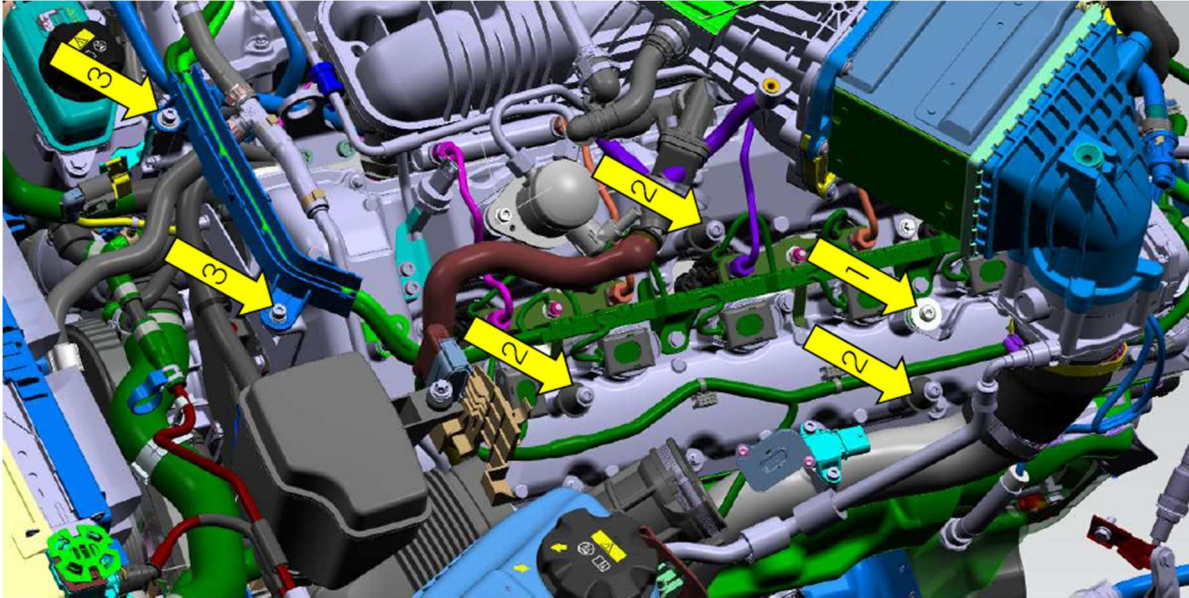
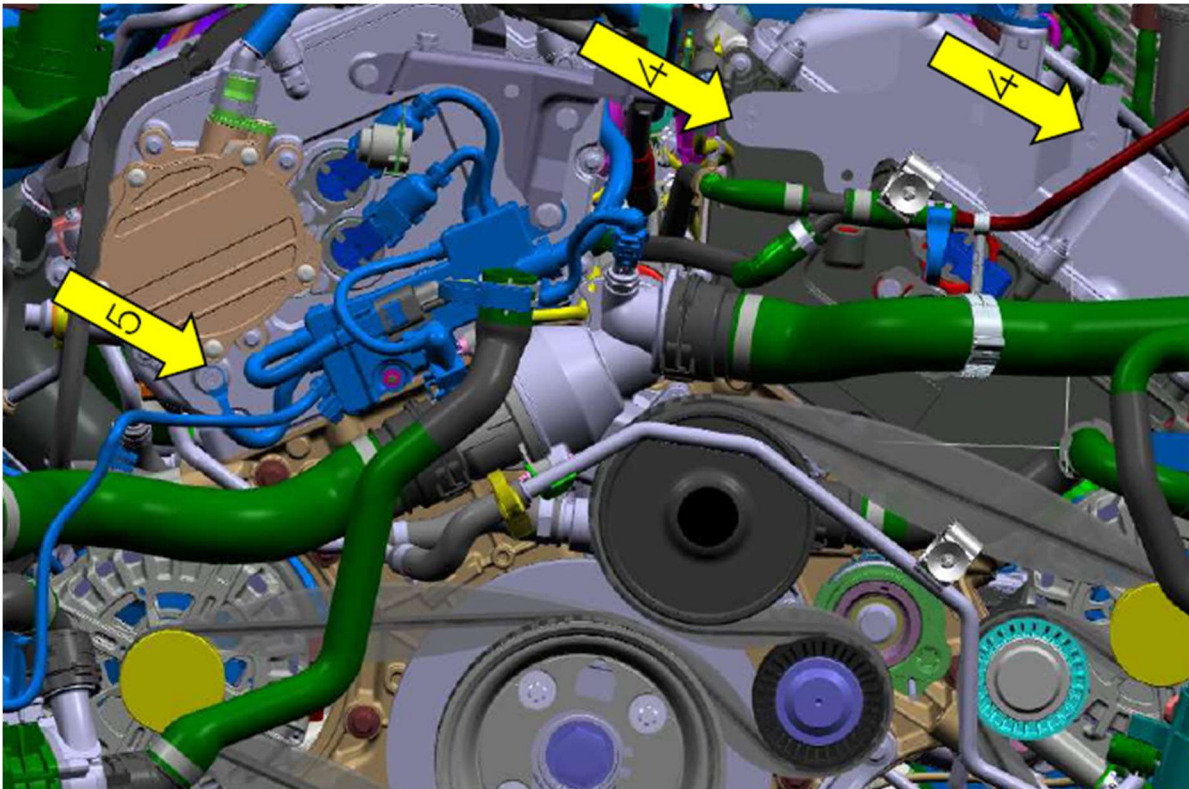
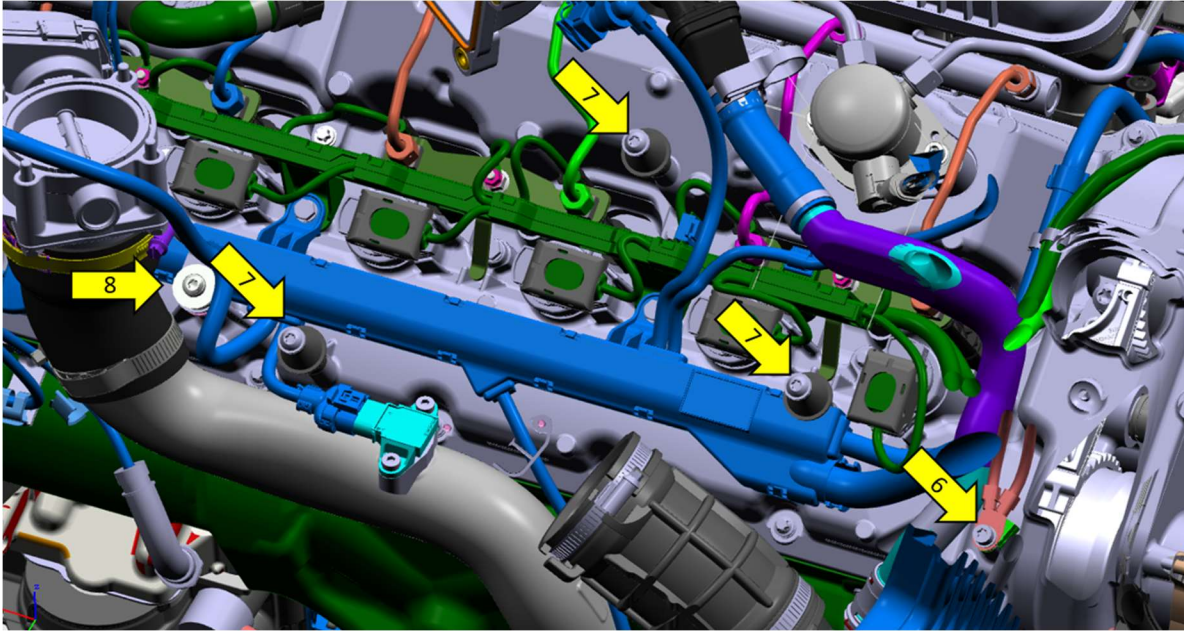
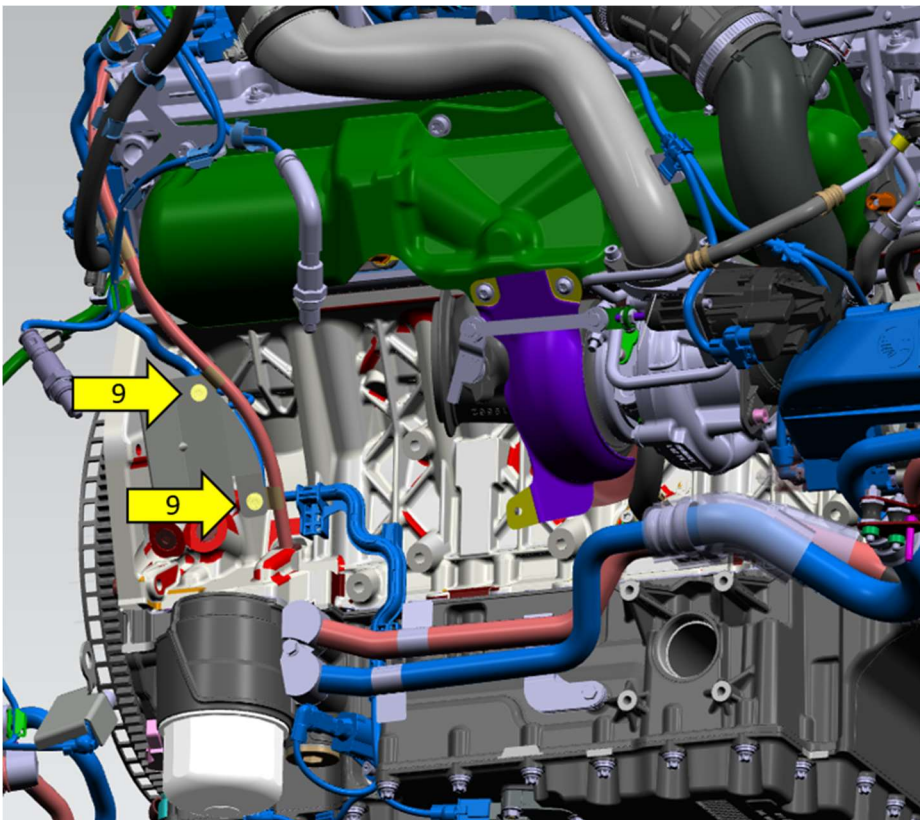
A very small number of Rolls-Royce Cullinan (RR31) vehicles have been identified as having a potential issue concerning the engine earth connections. It could be possible that during the engine assembly, one of 16 earth connectors was not torqued to the required specification resulting in an inconsistent electric connection. If one of these connectors is not tightened correctly the following problems may occur: 1) MIL light would be activated, 2) failure to start the engine, 3) long term – oil pressure sensor damage.

In the images below you can see the torque connections labelled with arrows.

There are 16 torque screw connections on the engine that will need to be checked. All of these connections need to be undone and re-torqued to 10Nm.
