Technical Service Bulletin

51 Water intrusion into the front footwells

51 21 20 2062553/1 March 15, 2021.

Model(s)	Year	VIN Range	Vehicle-Specific Equipment
Q3	2019	000001 - 071750	Not Applicable

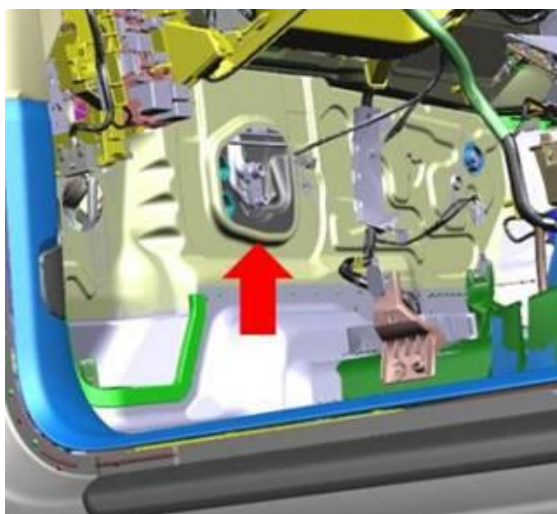
- Water is found to have entered through the pass-through in the bulkhead for the HVAC unit.

The sealing between the adjacent metal panels that comprise the bulkhead was found to be insufficient. As a result, water can enter between these panels, migrate down to the pass-through for the HVAC unit and enter the cabin settling in the front footwell area.

Figure 1. Water entry point (pass-through shown with seal removed).

1. If evidence of water in the footwell area is confirmed leave the front carpet pulled away from the bulkhead, then gain visual access to the HVAC pass-through inside the cabin and run water on the bulkhead sheet metal outside the vehicle in an attempt to duplicate the water leak in this area (Figure 1). If the water leak cannot be duplicated under these conditions be aware that this may not be the root cause of the leak and/or there may be an additional area of water intrusion not covered in this TSB. Diagnose accordingly.

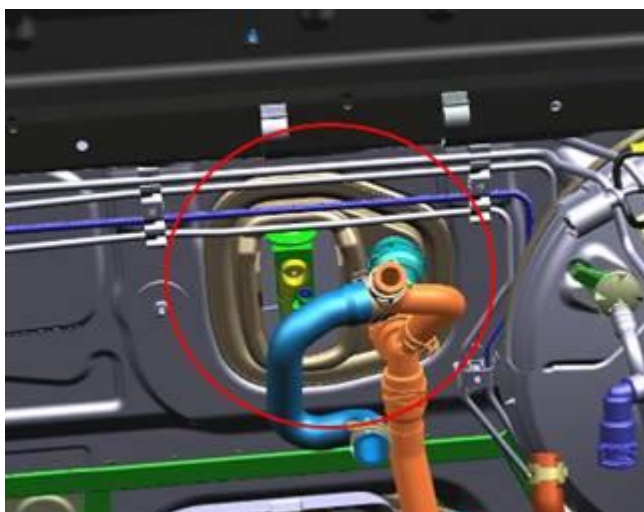
Figure 2. HVAC unit bulkhead pass-through.

2. If, when moving the carpet away from the bulkhead for inspection, you find the carpeting to be wet leave the carpet elevated to dry. Depending on the severity of the water intrusion inspect any electrical connections that are exposed to the water and repair as necessary.
3. Figure 2 shows the HVAC unit bulkhead pass-through from the engine compartment with the seal installed.

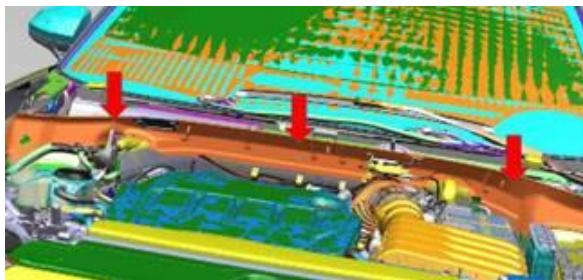
Figure 3. Plenum chamber bulkhead.

4. Remove the plenum chamber cover. Remove the plenum chamber bulkhead (Figure 3).

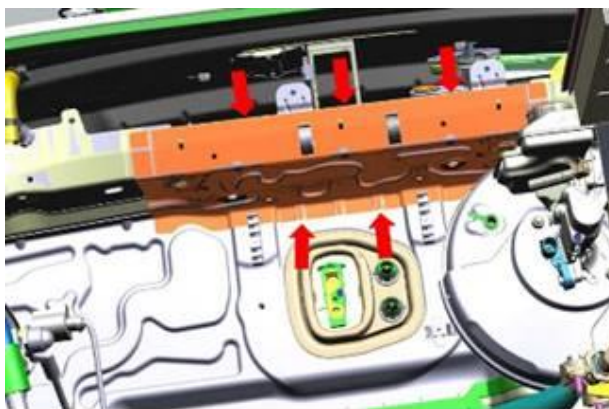
5. Figure 4 shows the water entry point at the top of the plenum chamber bulkhead and the water exit at the bottom.

Figure 4. Water entry and exit areas of the plenum chamber bulkhead.

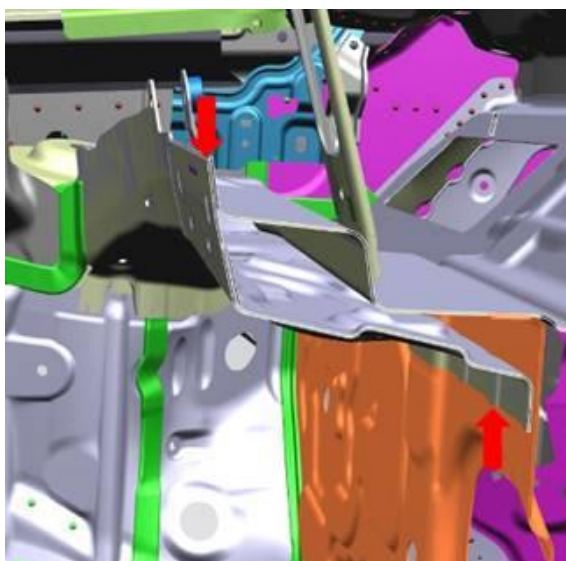
6. Figure 5 shows a side view of the water entry and exit points of the plenum chamber bulkhead.

Figure 5. Side view of the water entry and exit areas of the plenum chamber bulkhead.

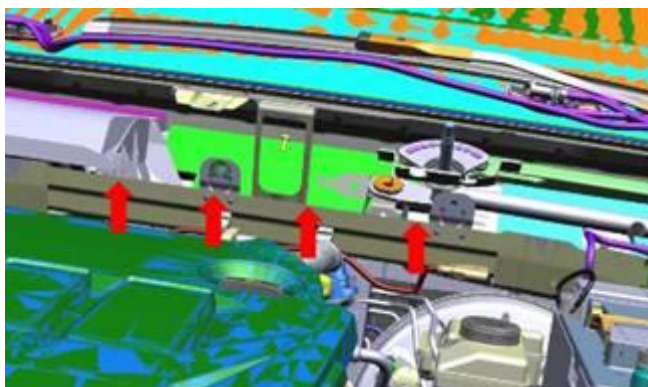
Figure 6. Body sealant application area of the plenum chamber bulkhead.

7. The red arrows in Figure 6 show the area of the plenum chamber bulkhead where body sealant will need to be applied. Clean this area with D 009 401 04 All Purpose cleaner or isopropyl alcohol.

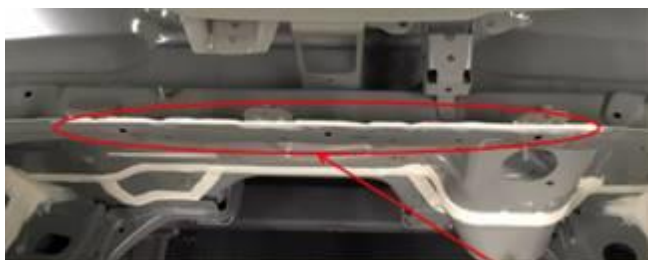
Figure 7. Sealant applied.

8. To the area shown in Figure 7 apply 1k adhesive sealant D 511 500 A2 or either of the following alternative products:

- 08689 3M™ Urethane Seam Sealer – White.

- 08694 3M™ Urethane Seam Sealer – Black.

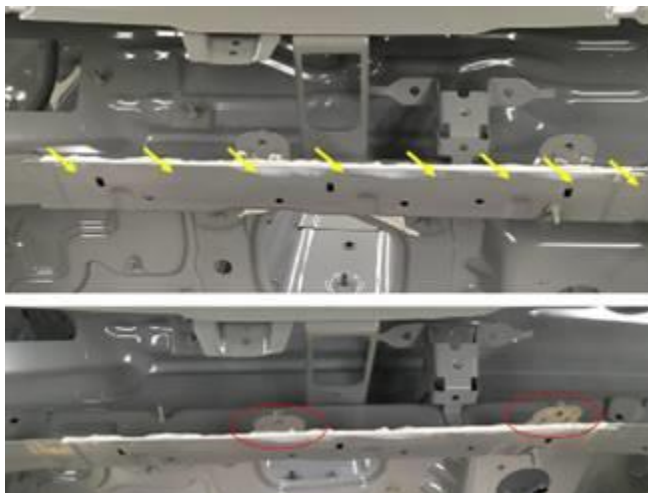
Figure 8. Sealant properly applied.

9. Ensure that there are no bubbles in the applied sealant. Work the sealant into the seam (yellow arrows) if necessary to achieve a water-tight seal (Figure 8, area circled red).
