Technical Service Bulletin

91 No diagnostics communication to the telematics control module

91 21 81 2056076/12 March 15, 2021. Supersedes Technical Service Bulletin Group 91 number 21-77 dated March 2, 2021 for reasons listed below.

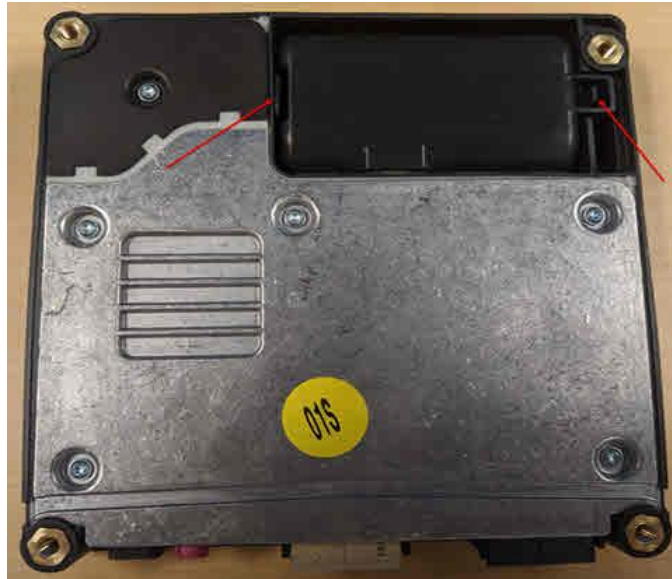
Figure 2. Backup battery compartment location.

1. Remove and unplug the telematics control module, J949 (address word 0075) according to the repair manual in Elsa.
2. Open the battery compartment of the telematics control module, J949 (address word 0075) and disconnect the backup battery (Figures 2 - 3).

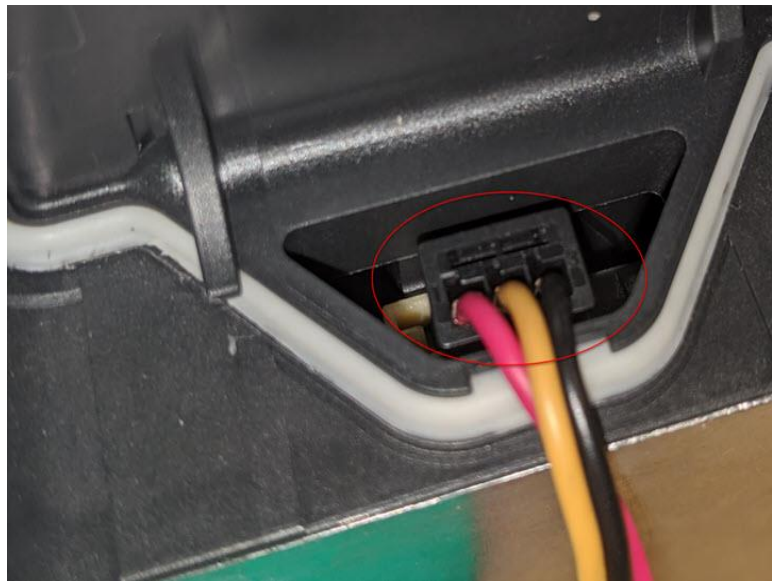
Figure 3. Backup battery connector (no release mechanism).
