GROUP ELE	MODEL 2015-2017MY Sedona (YP) w/PSD
	NUMBER 233	DATE March 2020
TECHNICAL SERVICE BULLETIN		
SUBJECT: POWER SLIDING DOOR (PSD) OPERATION INSPECTION AND REPAIR

POWER SLIDING DOOR (PSD) OPERATION INSPECTION AND REPAIR

Model	Production Date Range
Sedona (YP)	July 21, 2014 to April 4, 2017

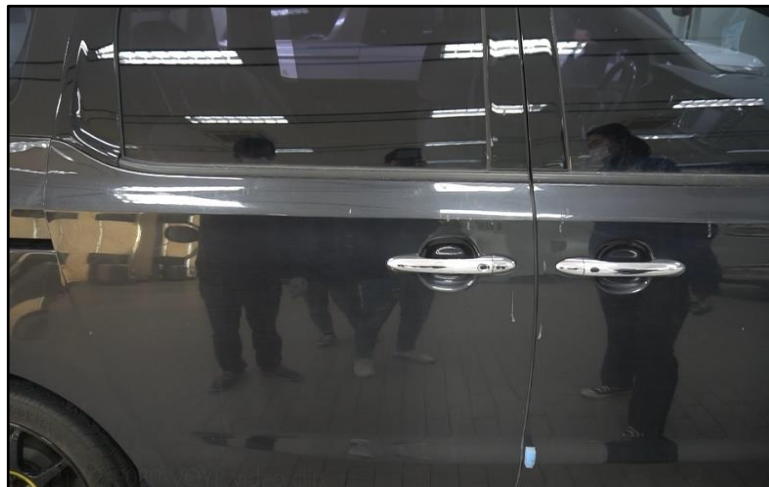
Note: The PSD features a '2-stage latching mechanism'. In stage one (1), the door may appear to be fully closed (1st latching), however, only in stage two (2), the PSD will actually be fully closed/secured (2nd latching).

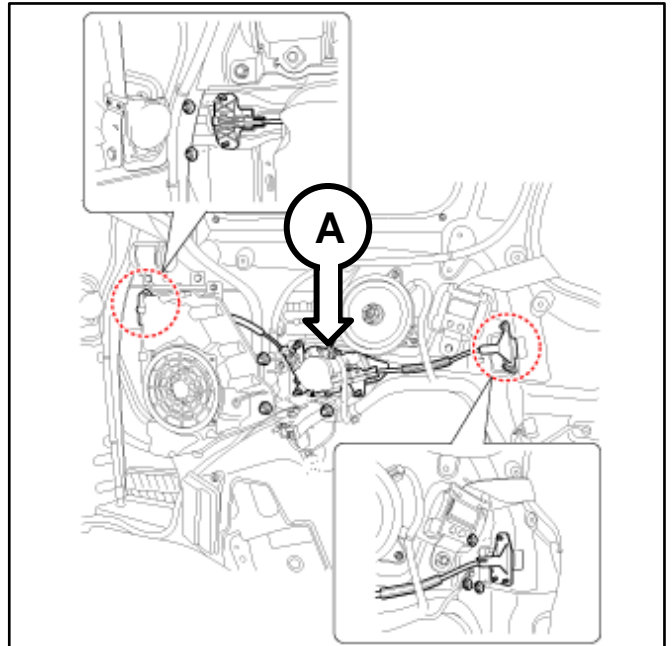
- 1a. The PSD (Left or Right Side) will not closed fully and/or is secured on the 2nd stage latching after closing in auto-mode.

Replace the Power Sliding Door (PSD) Drive Unit/Motor (A) by referring to the “Body Electrical System → Power Sliding Door System → Power Sliding Door Drive Unit → Repair procedures” chapter in the applicable Shop Manual on KGIS.

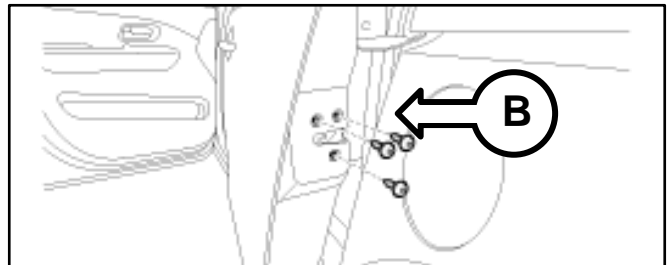
Note: Check if the PSD latch is fixed (Hold Open Lock) at the back when the door fully opens.

3. Replace the rear door latch assembly (B) by referring to the “Body (Interior Exterior) → Exterior → Rear Door → Rear Door Latch → Repair procedures” chapter in the applicable Shop Manual on KGIS.
