01-21-01TT - DTCs P0442, P0457

Release date: 03/19/2021

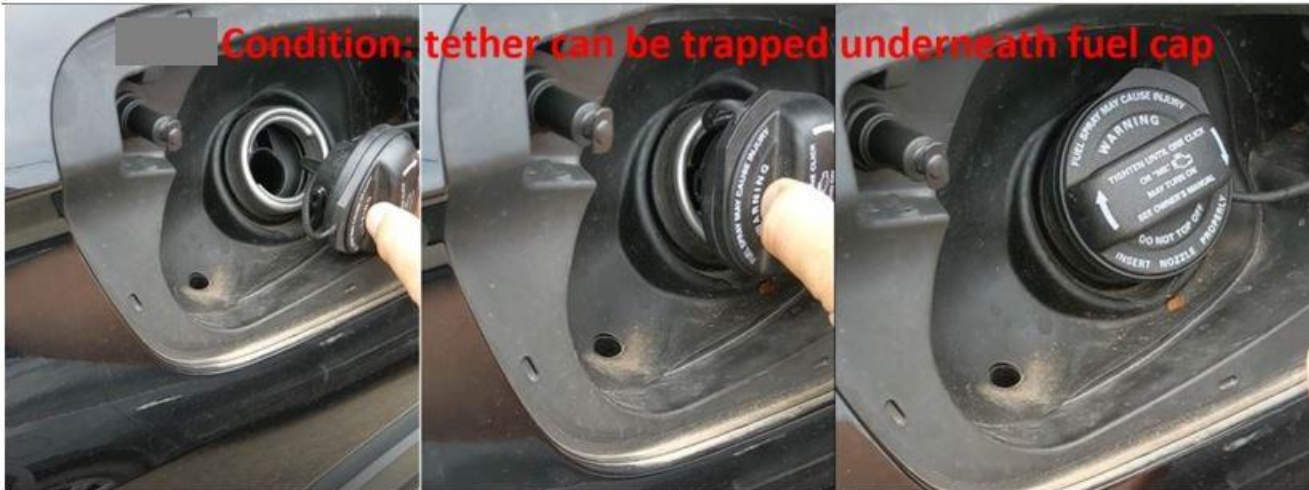
Figure 1

Vehicle may have the Malfunction Indicator Lamp (MIL) ON, with faults P0442 and/or P0457 stored. Cases have been found with the fuel cap tether trapped under fuel cap. If the MIL has illuminated, the light will remain for some time even if the customer has corrected the fuel cap concern. ODIS diagnosis includes a check of the fuel cap and condition; even if the fuel cap is correctly installed, visual evidence could indicate a previously incorrectly installed fuel cap that may have caused the EVAP faults.

When inspecting the fuel cap during ODIS diagnosis, the condition of the fuel cap seal and the fuel cap tether should be inspected for damages such as those shown in Figure 1.

If any of these issues are identified, this could mean that the cap has been incorrectly installed in the past. In this case, the customer should be instructed of the condition and correct fuel cap assembly. The fuel cap should only be replaced if the seal is damaged, or the fuel cap no longer seals at the filler neck.

Even if evidence of an incorrectly installed cap is found, ODIS diagnosis should still be completed to determine whether or not any other EVAP leaks are present in the system. If any leaks are identified, repairs should be performed as normal.
