Technical Service Bulletin

50 Creaking noises heard when body twists during braking or steering maneuvers

50 21 06 2062633/1 March 19, 2021.

Model(s)	Year	VIN Range	Vehicle-Specific Equipment
A4	2017 - 2022	All	Not Applicable
A4 allroad, A5, A5 Sportback, and A5 Cabriolet	2018 - 2022	All	Not Applicable

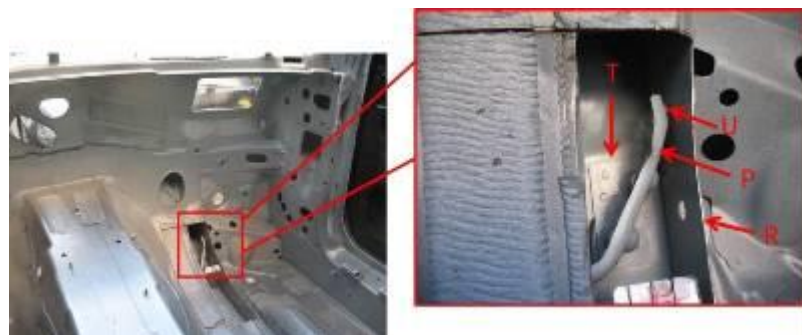
During a cornering or hard braking maneuver the longitudinal member reinforcement plate 'P' over the threaded console 'T' can make contact at point 'U' (Figure 1).

Figure 1. Cutaway view of the longitudinal member.

There has been an improvement in the construction of the longitudinal member assembly.

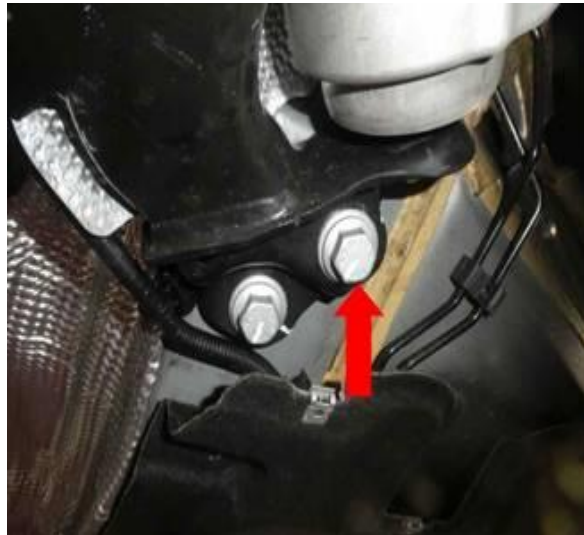
Figure 2. Front most bolt on subframe to be loosened.

As specified in the repair manual, it is necessary to replace all loosened subframe bolts at the conclusion of the entire repair.

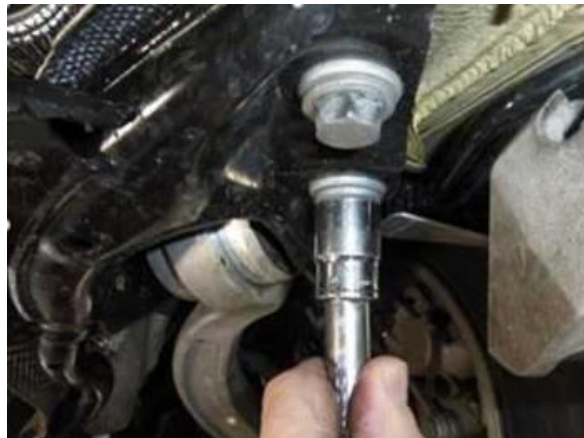
3. In many cases an audible 'cracking' noise can be heard in the course of loosening and tightening the subframe bolt (Figure 3).

Figure 3. Loosening the front most subframe bolt.

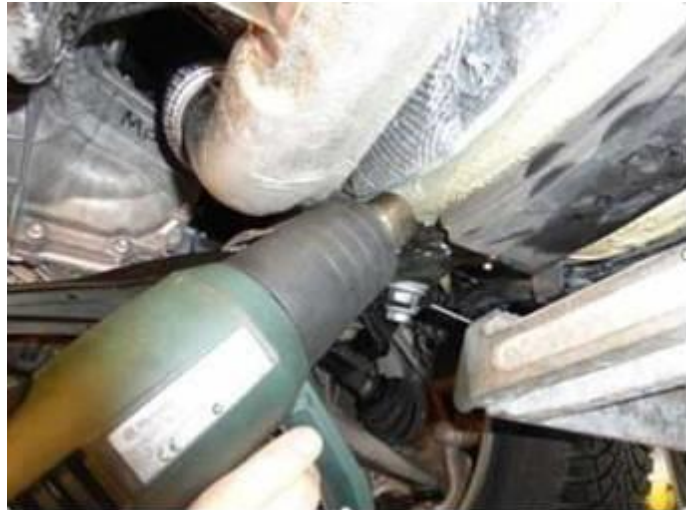
Figure 4. Warming the area of the body near the rear transverse link.

4. Test drive the vehicle.
 - If there is no change or elimination of the noise achieved during this diagnostic step, the repair in this TSB will not be effective and diagnosis must continue outside the scope of this repair procedure.
 - If the noise characteristics do, in fact, change or if the noise is eliminated proceed as follows.
5. Duplication of this noise is difficult when the vehicle is cold. If you suspect that the cold is preventing duplication of this symptom warm up the longitudinal member/body in the area of the rear transverse link bolted connection with a hot air blower set for an outlet temp of approximately 550°C (1022 °F) (Figure 4).

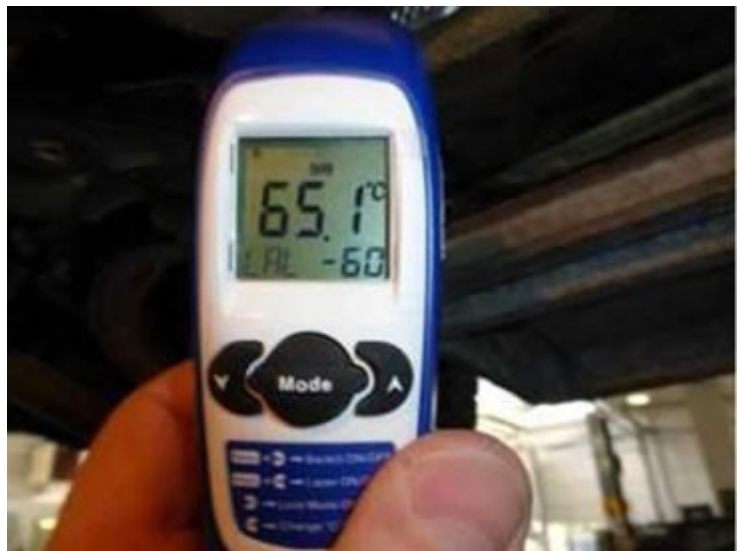
Figure 5. Surface temperature warmed to 65° C (149°F).

6. Warm the surface to approximately 65 °C (149°F) (Figure 5).

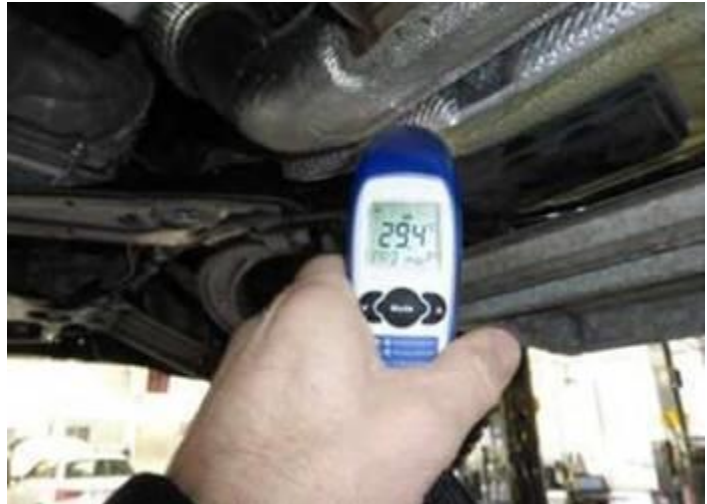
Figure 6. Surface temperature cooled to approximately 30° C (86°F).

7. Allow the surface temperature to cool to approximately 30 °C (86°F) then test drive the vehicle again (Figure 6).

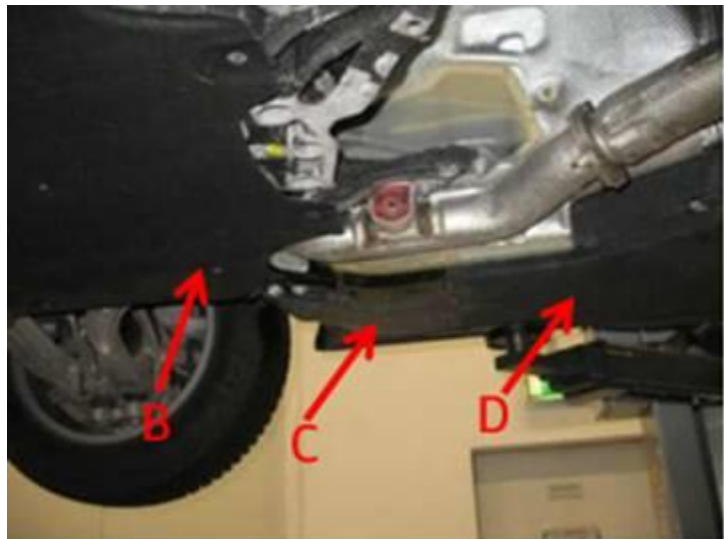
Figure 7. Underbody trim to be removed.

8. Merely lowering the vehicle from the hoist can immediately elicit the noise symptom after this warming process.
9. With the symptom confirmed, remove the front middle underbody trim 'B', front underbody trim 'C' and the underbody trim 'D' (Figure 7).

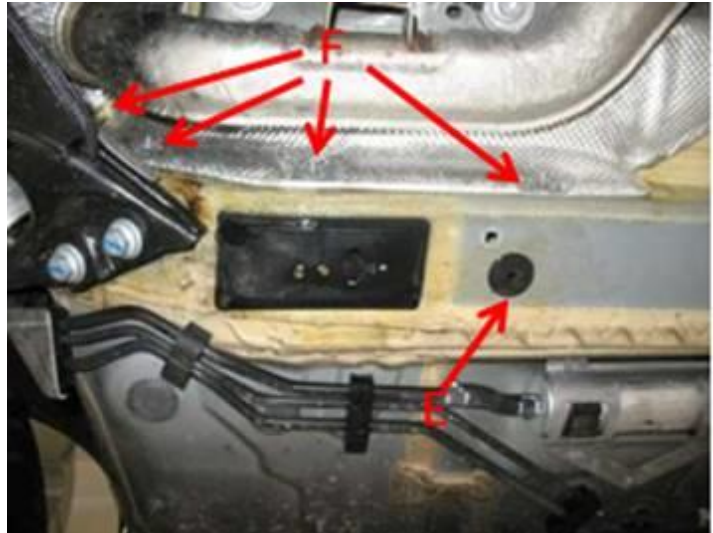
Figure 8. Gaining access to the longitudinal member.

10. In order to provide appropriate access to the affected area inside the longitudinal member begin by unscrewing the four sheet nut fasteners 'F' for the heat shield from their studs.

Bend the heat shield slightly away from the longitudinal member (Figure 8).

Remove grommet 'E'.

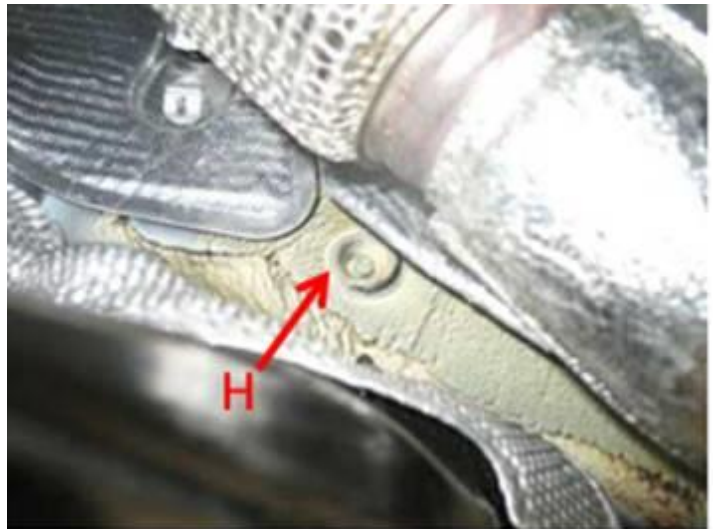
Figure 9. Remove grommet 'H'.

11. Remove grommet 'H' from the longitudinal member (Figure 9).

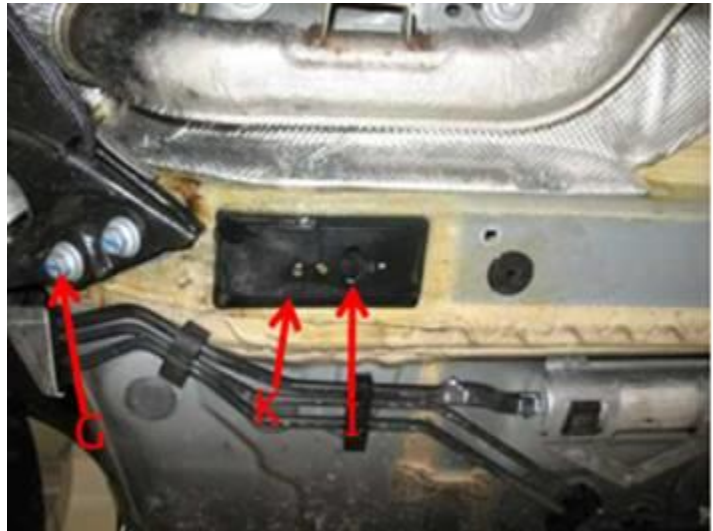
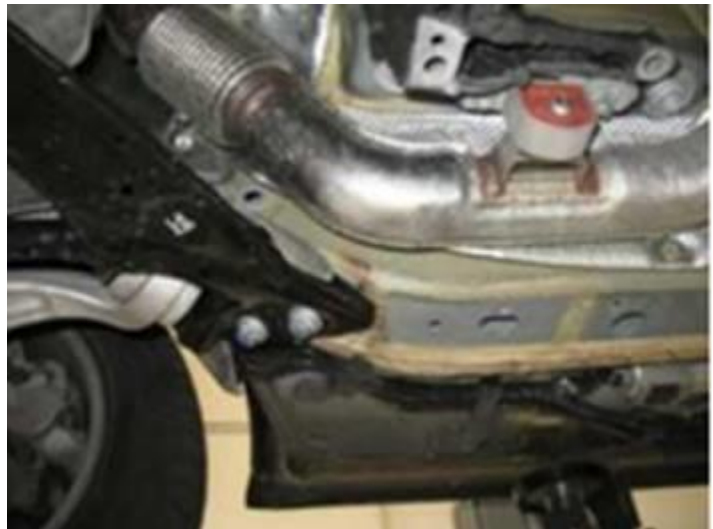
Figure 10. Remove impact protector.

Figure 11. Impact protector removed.

12. Because bolt 'G' was loosened in the diagnosis process it must be replaced. Replace bolt 'G' using the installation and tightening procedure in ElsaPro.

Remove the impact protector 'K'. Pry out clip 'I' from the impact protector and remove it from the longitudinal member (Figures 10 - 11).

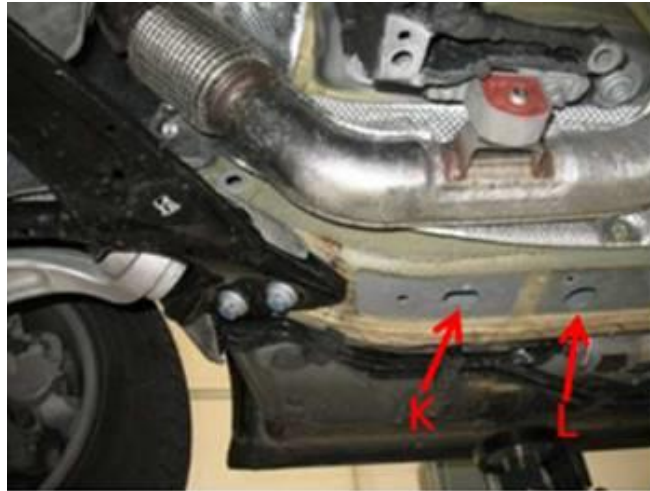
Figure 12. Access for improvised tool.

13. By shining a flash light through the opening 'K' from the now removed impact protector you can see the upper round hole 'M' (Figure 12) in the longitudinal member reinforcement plate 'N' (Figure 13) when viewed through hole 'L' (hole from grommet 'E' from Figure 8).

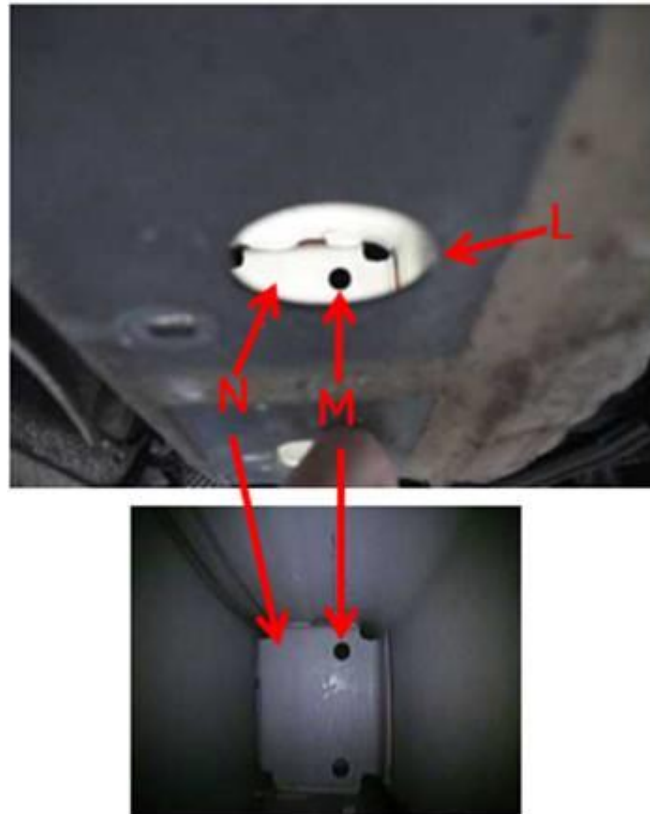
Figure 13. Access hole 'M' and access hole in longitudinal member reinforcement.

14. Figure 13 shows the view through hole 'L' when illuminated through hole 'K' (Figure 12). This is the path through which you will insert an improvised chisel.

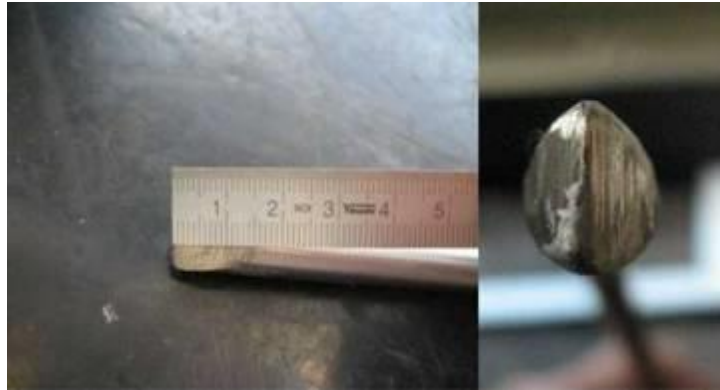
Figure 14. Ground tip of steel rod.

15. An improvised tool for this modification will be necessary. Begin fabricating this tool by obtaining a steel rod 10mm in diameter and 50cm long (Figure 14). Grind the tip of one end of the rod into a chisel shape. The length of the grind should be 15mm +/-3mm on each side as shown in Figure 14.

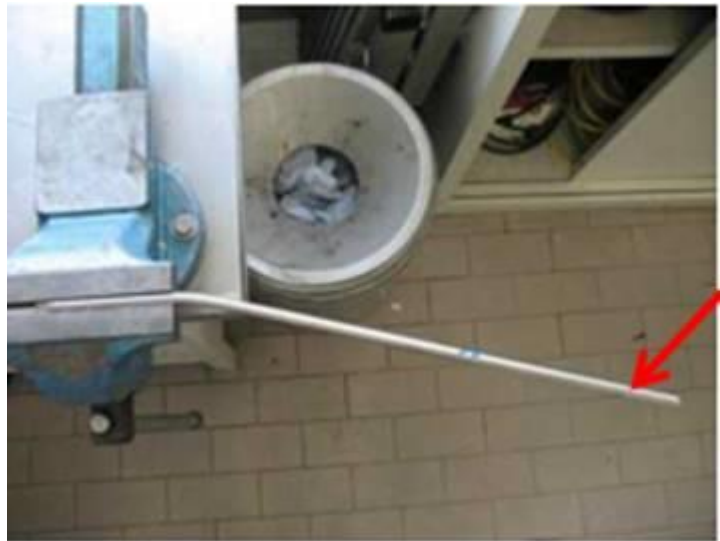
Figure 15. 50cm long x 10mm steel rod.

16. Mount one end of the rod into a vice 11cm deep with the chisel shape parallel to the ground (Figure 15).

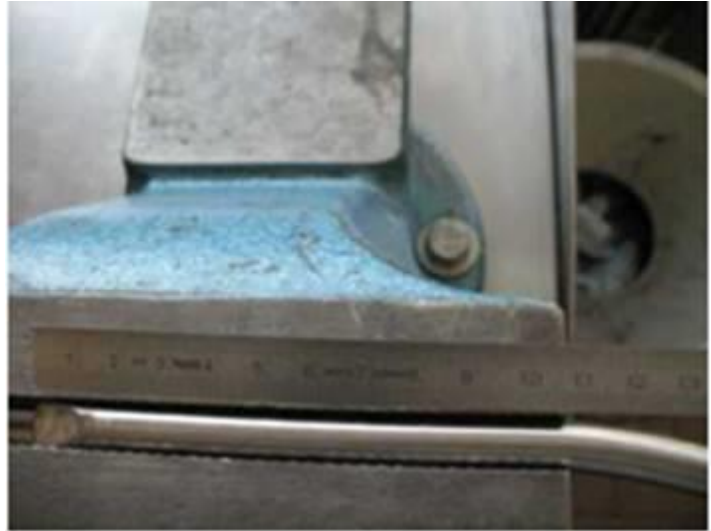
Figure 16. Rod inserted in a vice 11cm from the chisel end.

17. A bend will be created 11cm deep from the chisel end (Figure 16).

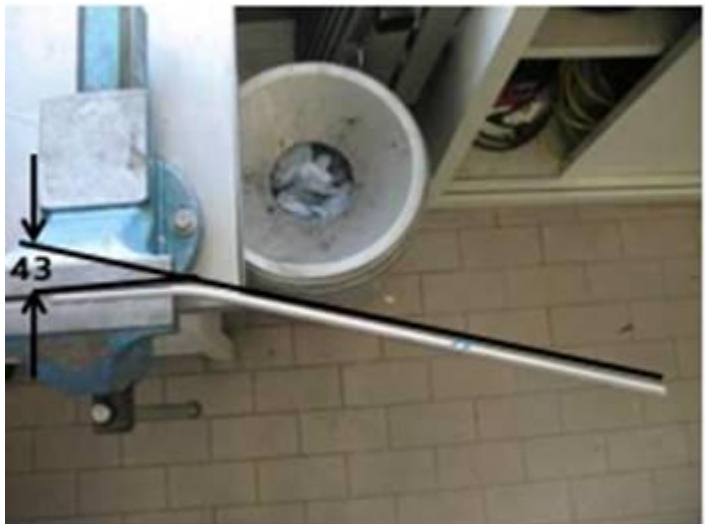
Figure 17. Bend created 43mm from the axis of the long end of the steel rod.

18. Bend the steel bar at the 11cm apex until a distance of 43 mm +/- 3 mm is created between the axis of the longer end of the rod and the axis of the shorter end of the rod at its tip (Figure 17).

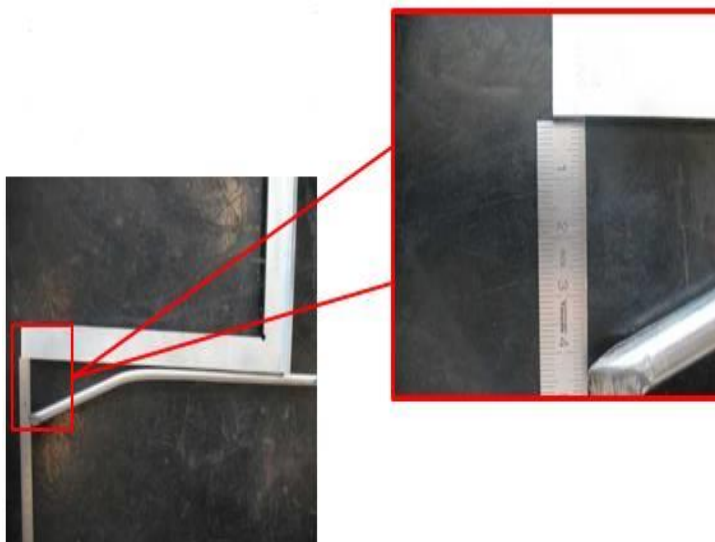
Figure 18. Verifying distance of 43mm in the bend.

19. Measure and verify this distance (Figure 18).

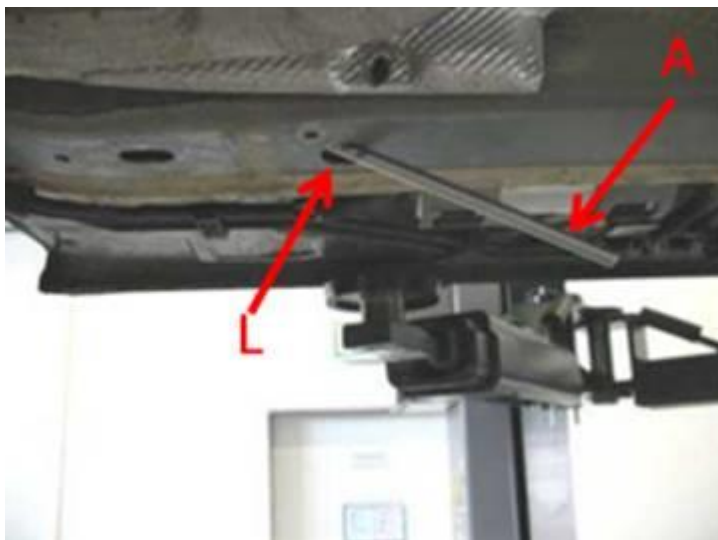
Figure 19. Insert the steel rod.

20. Insert the chisel end of the steel rod 'A' into the body opening 'L' in the longitudinal member (Figure 19).

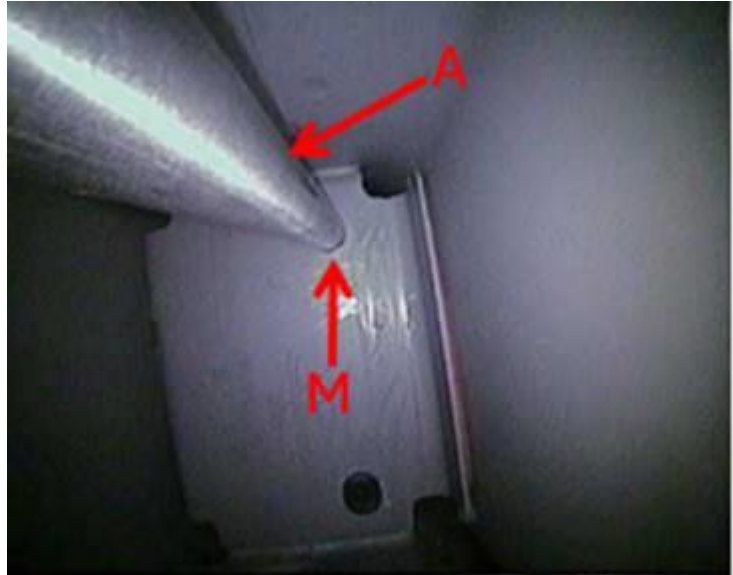
Figure 20. Feeding the steel rod through the reinforcement plate.

21. Now feed steel rod 'A' through hole 'M' (upper hole) in the reinforcement plate (Figure 20).

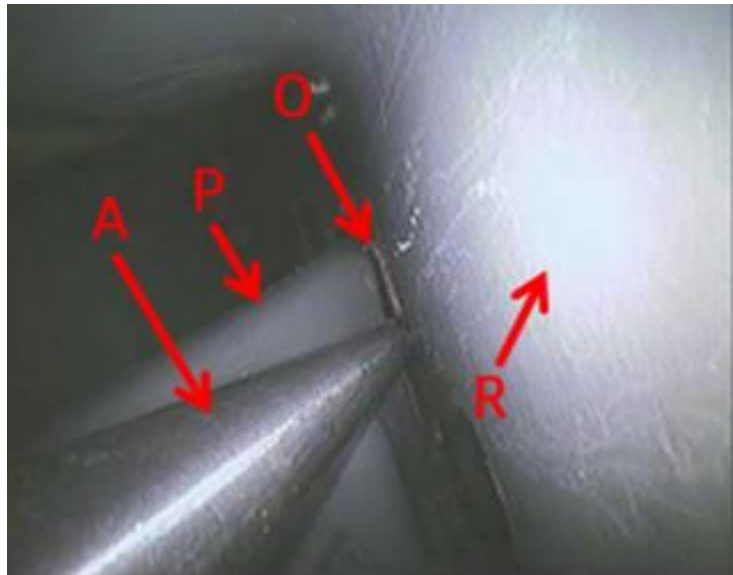
Figure 21. Engaging the chisel end of the steel rod inside the longitudinal member.

22. The chisel end of the steel rod is to be fed far enough to engage the front reinforcement plate 'P' at point 'O' such that it is lodged into the gap between reinforcement plate 'P' and the wall of the longitudinal member 'R' (Figure 21).

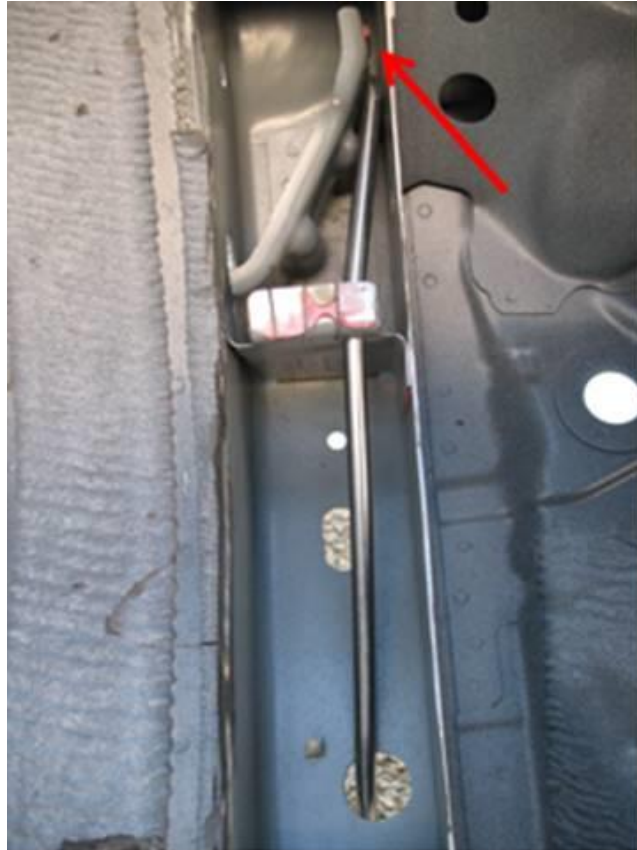
Figure 22. Cutaway view of the longitudinal member illustrating the steel rod positioning.

23. If the steel rod bend angle and chisel point orientation are created as described the tool will reach the appropriate point of contact when it is guided into the holes in the longitudinal member as described (Figure 22).

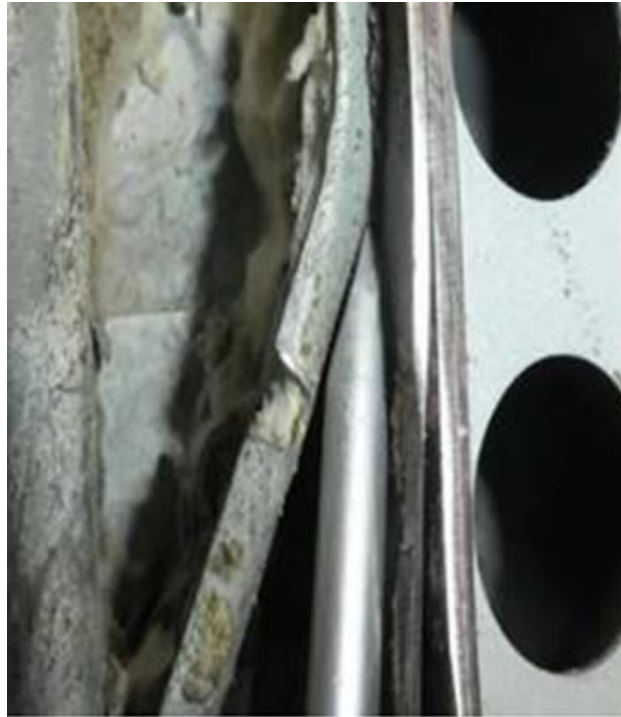
Figure 23. The chisel end of the steel rod properly engaged with the reinforcement plate.

24. The chisel end of the steel rod must be inserted as shown in Figure 23 with the wedge engaged consistent with the space formed by the longitudinal member support to the longitudinal member housing.

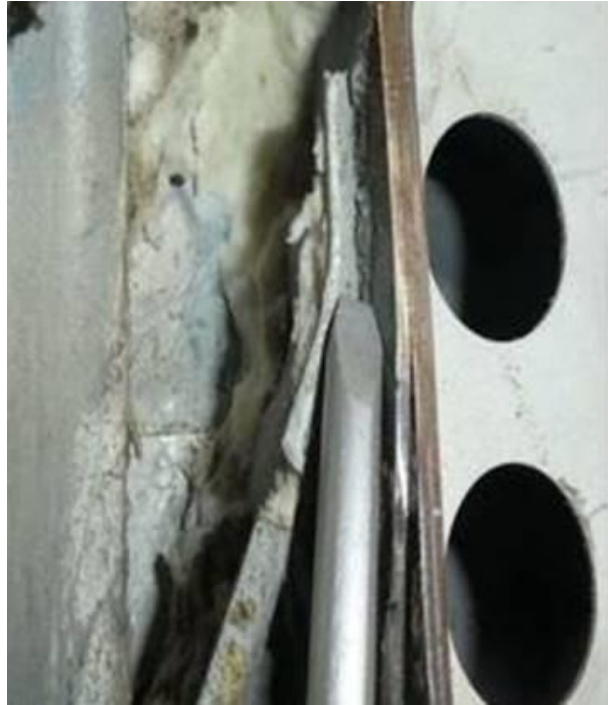
Figure 24. *Incorrect engagement of the chisel end.*

25. Figure 24 shows an incorrect engagement of the chisel end.

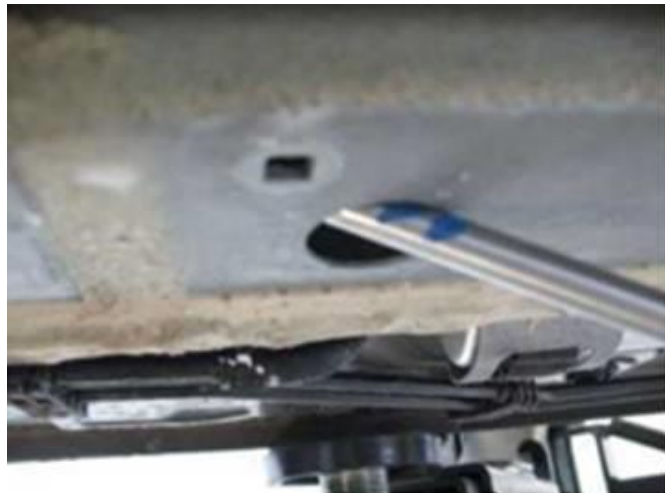
Figure 25. *Marking the steel rod.*

26. Using a marker mark the point at which the steel rod makes contact with the longitudinal member. Then make a mark 10mm – 15mm rearward of that contact point on the steel rod (Figure 25).

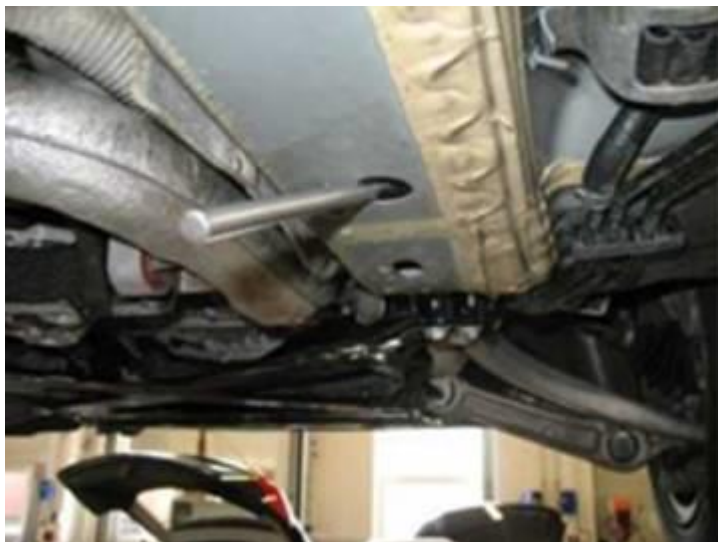
Figure 26. Steel rod driven forward at least 10mm.

27. Using a hammer drive the steel rod a distance of 10 mm. Then pull the bending tool out of the longitudinal member again (Figure 26).

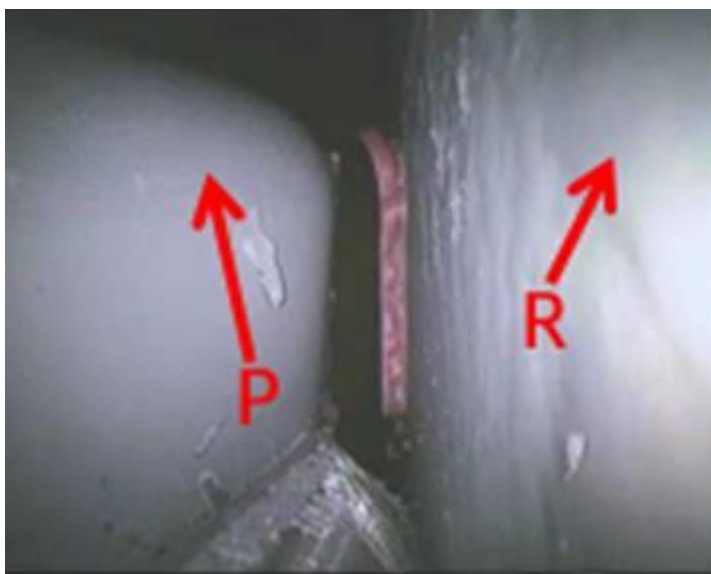
28. As a result, a distance of approximately 3 mm is created between reinforcement plate 'P' and the longitudinal member 'R'. Separating this point of contact eliminates the noise generation (Figure 27).

Figure 27. 3mm gap created between reinforcement plate and longitudinal member.

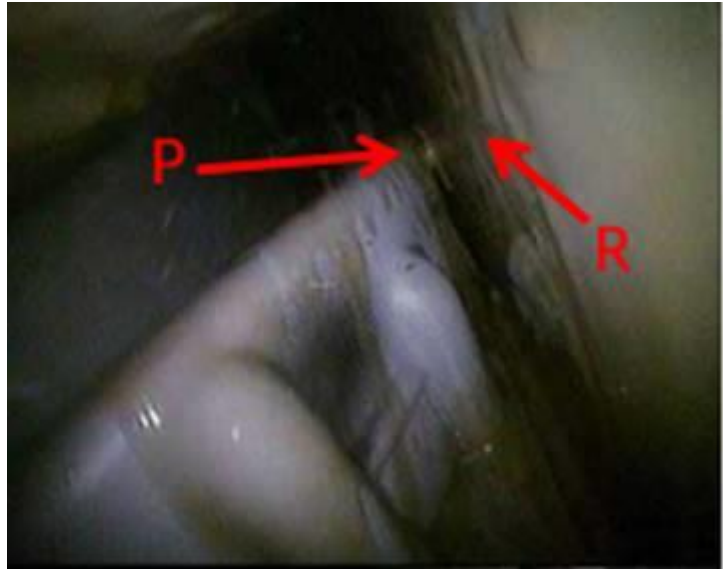
Figure 28. Cavity wax applied.

29. All points that were contacted and / or struck are likely have had their corrosion protective layer compromised. Because of this thoroughly coat all areas with cavity wax (Figure 28).

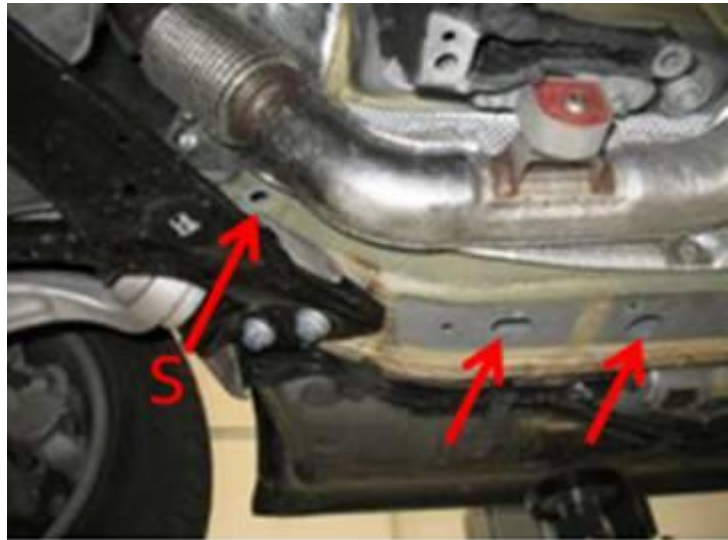
Figure 29. Access opening for cavity wax application.

30. Cavity wax can be applied through the openings shown in figure 28. The separation point in the longitudinal member can be accessed through hole 'S' (Figure 29).
