Business Class M2
Cascadia
108SD/114SD
> New Cascadia

**Freightliner
Service Bulletin**

General Information

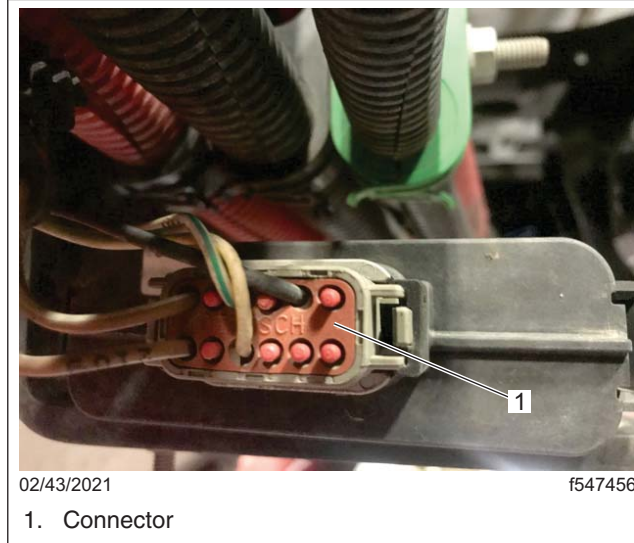
Fig. 2, TPMS Module Connector

IMPORTANT: [Fig. 2](#) is intended for visual orientation purposes only. The wire routing should NOT be such that the wire connections are stressed, as is seen here. Proper procedure for wiring with this module is outlined below in Step 7.

3. Disconnect the wiring harness connector from the TPMS module. See [Fig. 2](#).

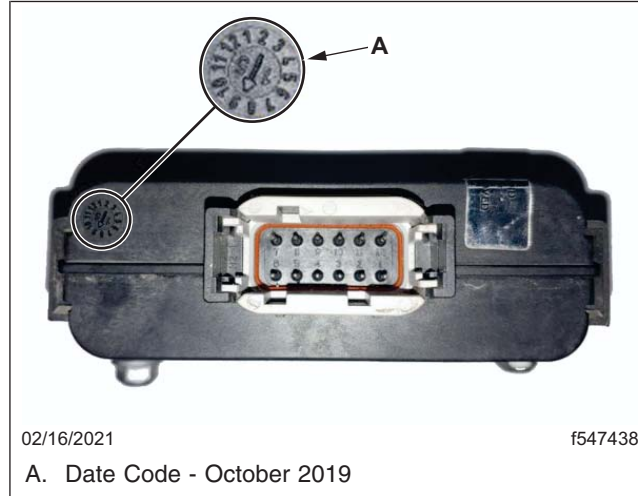
Fig. 4, TPMS Housing Date Code

New Cascadia vehicles built from September 9, 2019 through October 1, 2020, with the tire pressure monitoring system (TPMS) modules communicating on the J1939 500K baud rate (part numbers BW K138367 or BW K165667) and stamped with the TPMS housing date codes from February 2019 to June 2019, may experience water intrusion into the TPMS module.

5. Inspect the TPMS housing date code. If the date is between February 2019 and June 2019, replace the TPMS module. See [Fig. 4](#) for the location of the date code.
