SS 3070-FTL2021 P4 New Cascadia Side Guard Radar Harness Moisture Intrusion

This solution applies to all P4 vehicles with side radar.

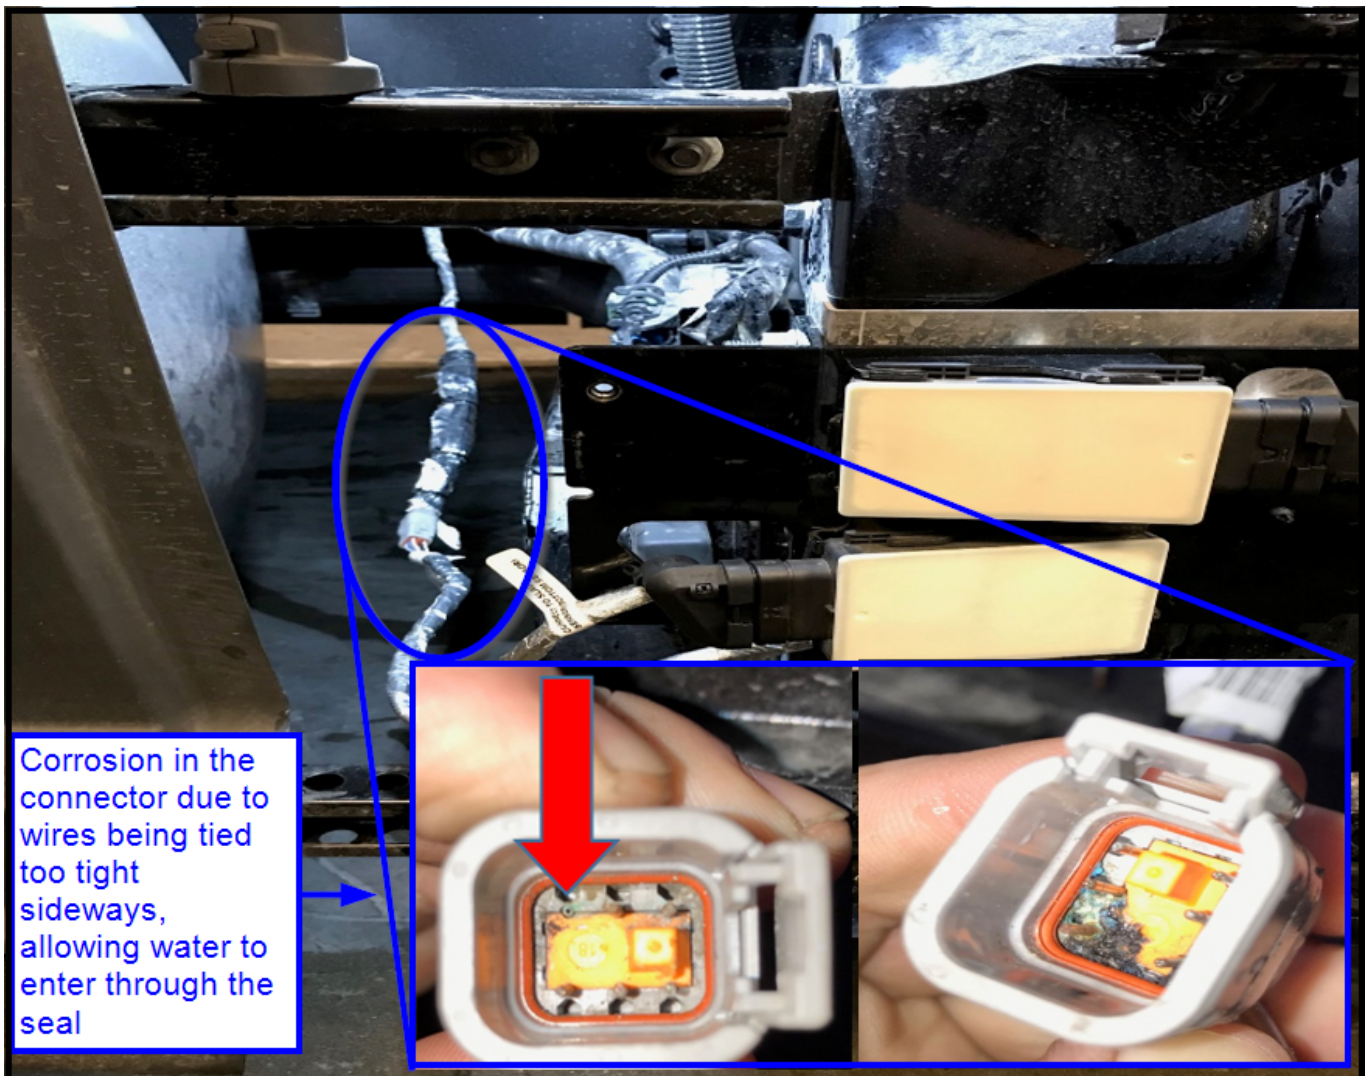
The 6-pin connector located at the side radar can show signs of water intrusion if wires are strained at the connector. Wires without strain relief can allow water to intrude past the seals, resulting in corrosion on the terminals and pins within the connector. (See Figure 1)

Figure 1 - Water in Connector

It is always recommended to mount connectors, ensuring that no strain is created on wires entry point. If terminals or pins are damaged within the connector, it is recommended to replace all damaged parts prior to reassembly.

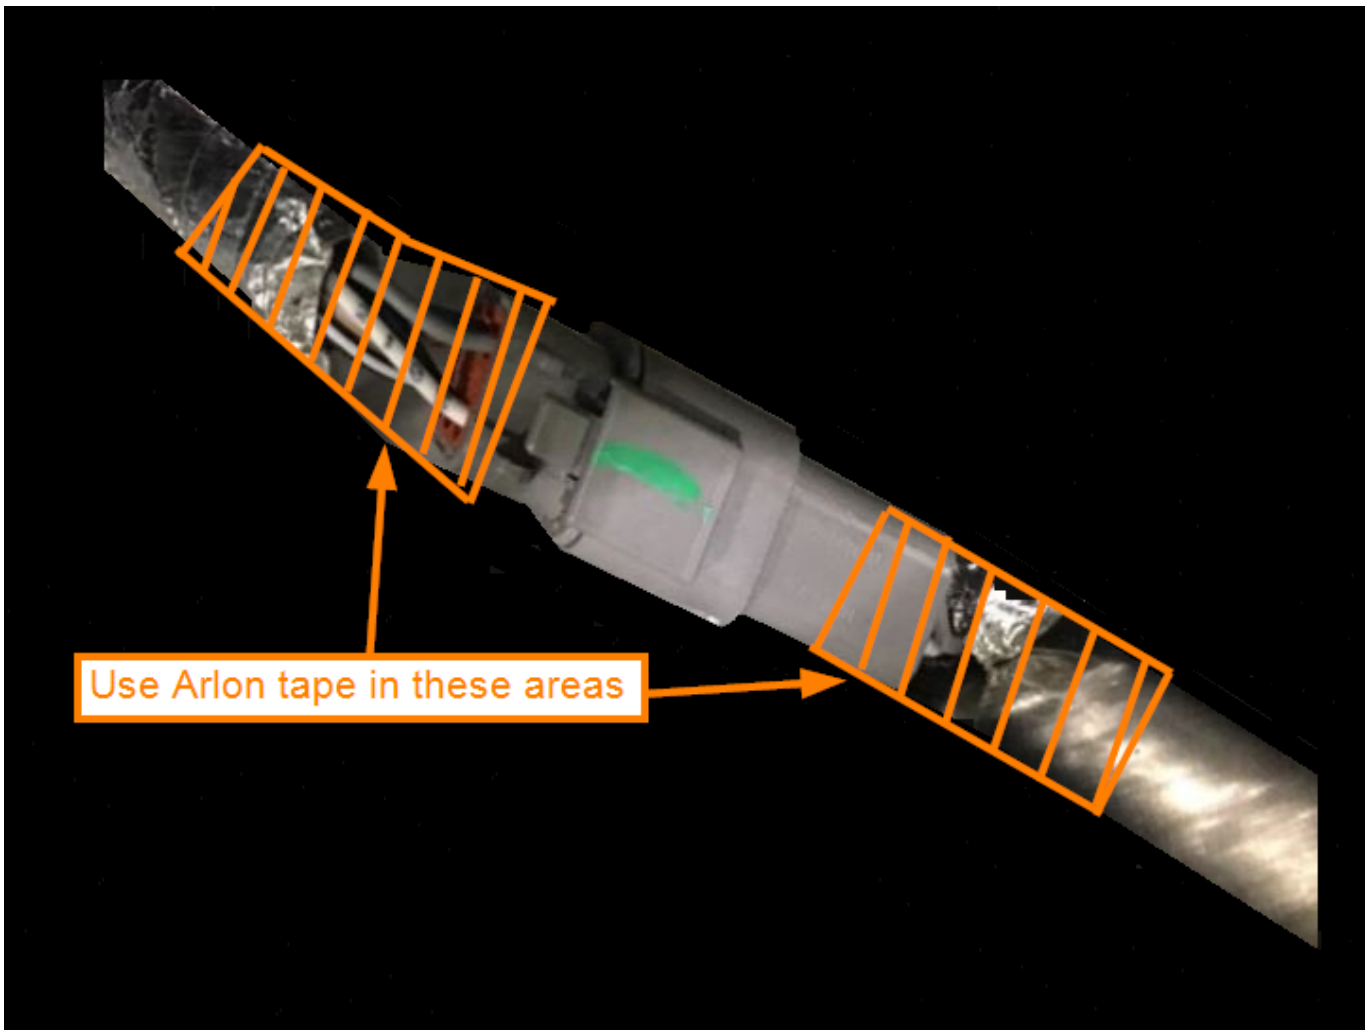
Figure 2 - Area to Apply Arlon Tape

Once the connectors have been repaired, use locally purchased Arlon tape to cover the connector and wires. (See Figure 2).

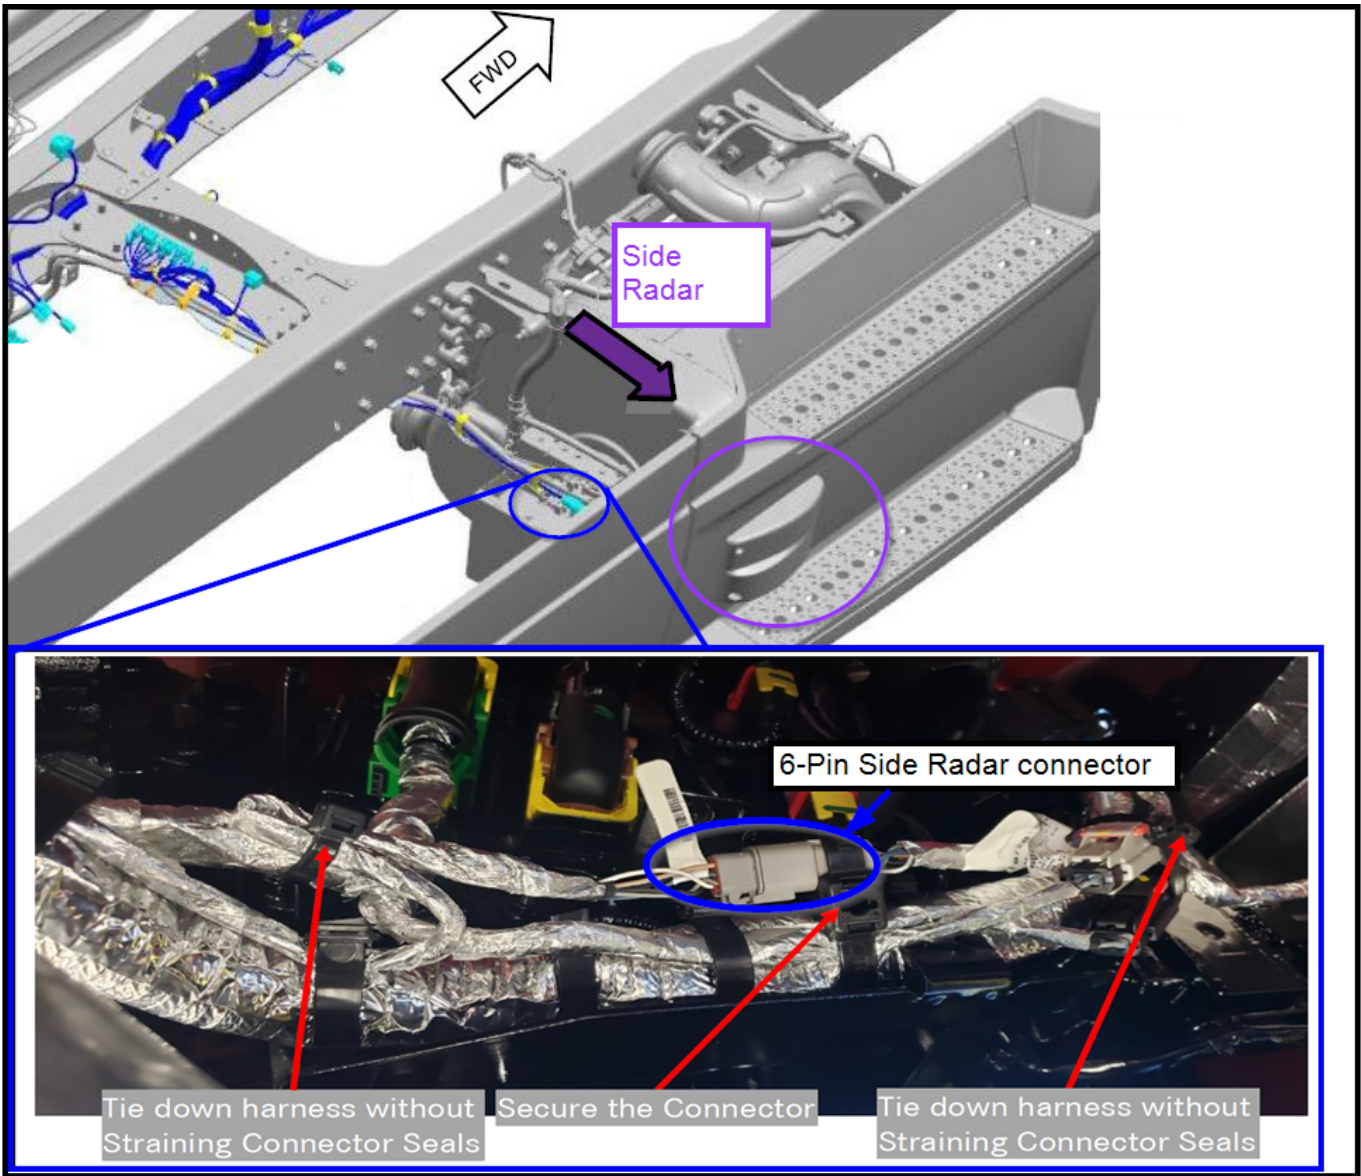
Figure 3 - Side Radar 6-pin Location Showing Wiring Strain Relief

Route the harness so that none of the wires have any strain on them and tie strap them in place. (See Figure 3)

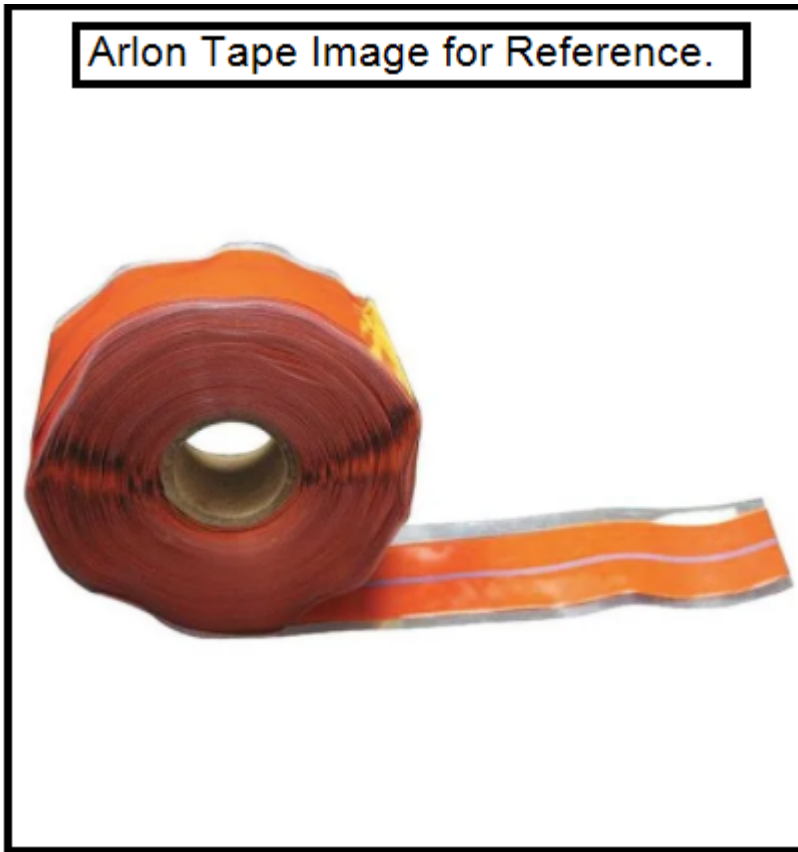
Figure 4 - Arlon self-fusing Tape

Arlon self-fusing tape. (See Figure 4)
