D21M3

Subject: DT12 Gear Grind During Downshift Software Update**Models Affected: DT12 Transmissions****General Information**

Daimler Trucks North America LLC, on behalf of its DETROIT™ Powertrain Division, is initiating Field Service Campaign D21M3 to update TCM software on certain DT12 Transmission models to prevent gear grind during downshift in certain situations.

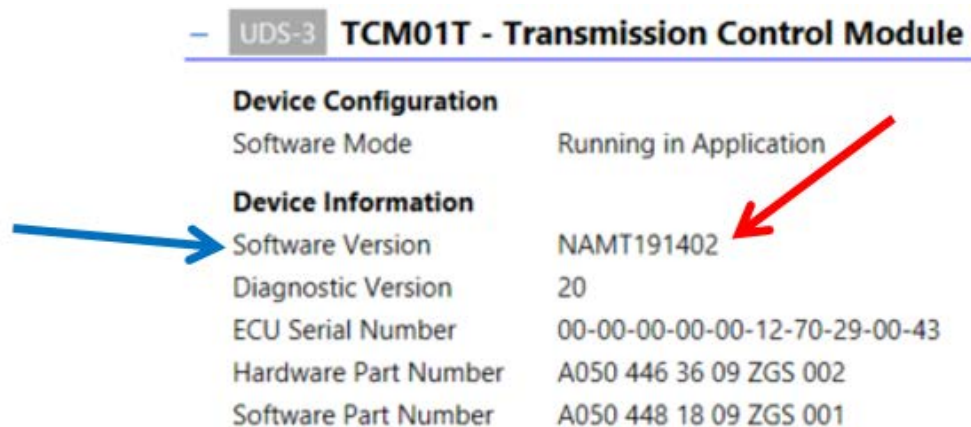
Example: TCM **software NAMT191402** is not at the **MINIMUM** software level required, and needs updating.

5. Is the software and fuel map ZGS version level for the ACM, MCM, CPC, and TCM less than the software and fuel map ZGS revision levels listed in the table on page 4?
NOTE: The ACM, MCM, CPC, and TCM software and fuel map ZGS version level must meet the **MINIMUM** requirements.

- a) Yes, proceed to step 6.
 - b) No; it is equal to, or greater than the minimum software and fuel map ZGS version levels. No programming is necessary. Proceed to the Completion Stickers section.

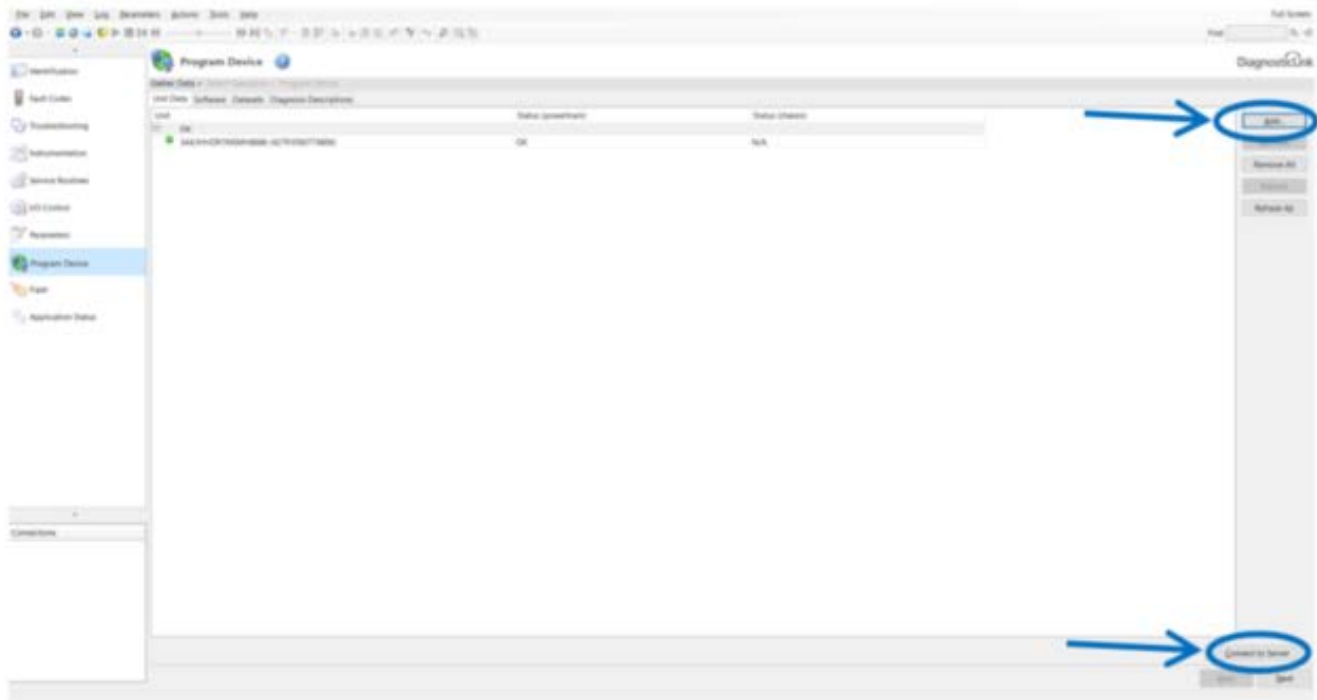
8. Select the "Add" button in the upper right corner of the DiagnosticLink® screen and enter the engine serial number. Then click the "Connect to Server" button in the bottom right corner of the DiagnosticLink® screen. See below figure.

9. Program the ACM, MCM, CPC, and TCM, based on the above inspection results and engine serial number listing included with this recall campaign.
 - **NOTE:** If equipped with CPC501T & ICUC, program the ICUC to the latest software.
