MODEL
2021MY
K5 (DL3a)

NUMBER
210 (Rev 1, 03/23/2021)

TECHNICAL SERVICE BULLETIN

SUBJECT: COMBINATION TSB / SERVICE ACTION: CONSOLE SQUEAK
NOISE INSPECTION AND REPAIR (SA436)

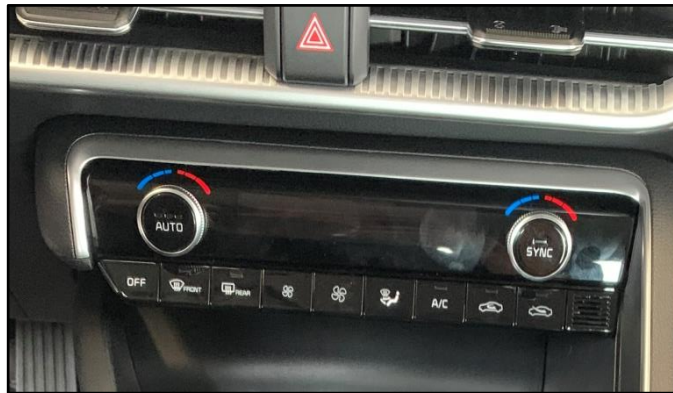
This bulletin provides information regarding a potential squeak noise between the Heating Ventilation Air Condition (HVAC) controller and the floor console upper garnish on some 2021MY K5 (DL3a) produced from March 25, 2020 through to February 23, 2021. Follow the inspection procedure to confirm if the squeak is present. If the squeak is present, technicians are instructed to apply Tesa® Tape to the right corner of the HVAC controller face. Before conducting the procedure, verify the vehicle is included in the list of affected VINs.

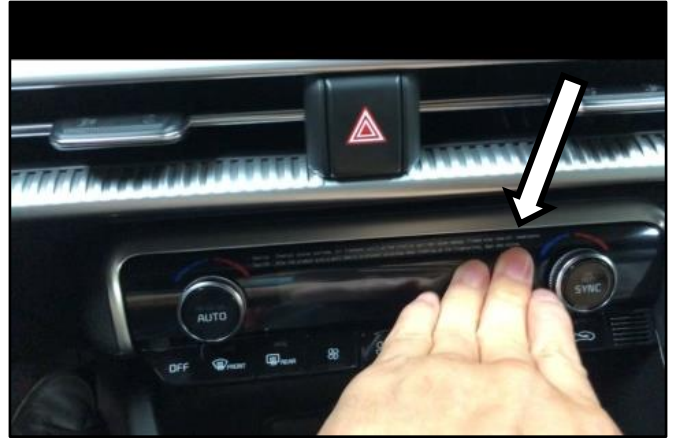
1. Inspect the HVAC controller for squeak by pushing in on the right upper corner of the HVAC controller in the location shown.

If the HVAC controller does not exhibit a squeak noise, no further action is required.

If the HVAC controller squeaks during inspection, follow the Repair Procedure outlined below.

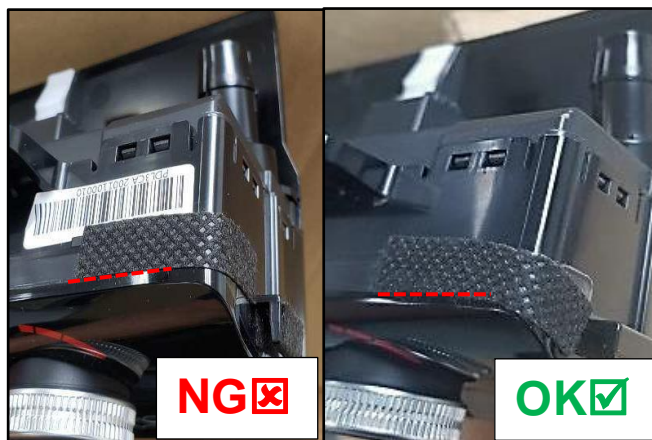
Ensure that the Tesa® Tape is covering over the edge of the HVAC controller face, **OK**. The tape should not be behind the HVAC controller face, **NG**.
