NUMBER  
084 (Rev 7, 3/25/2021)

## TECHNICAL SERVICE BULLETIN

SUBJECT: PARTIAL REPAIR OF C-MDPS MOTOR, ECU, WORM GEAR  
AND/OR STEERING COLUMN HOUSING

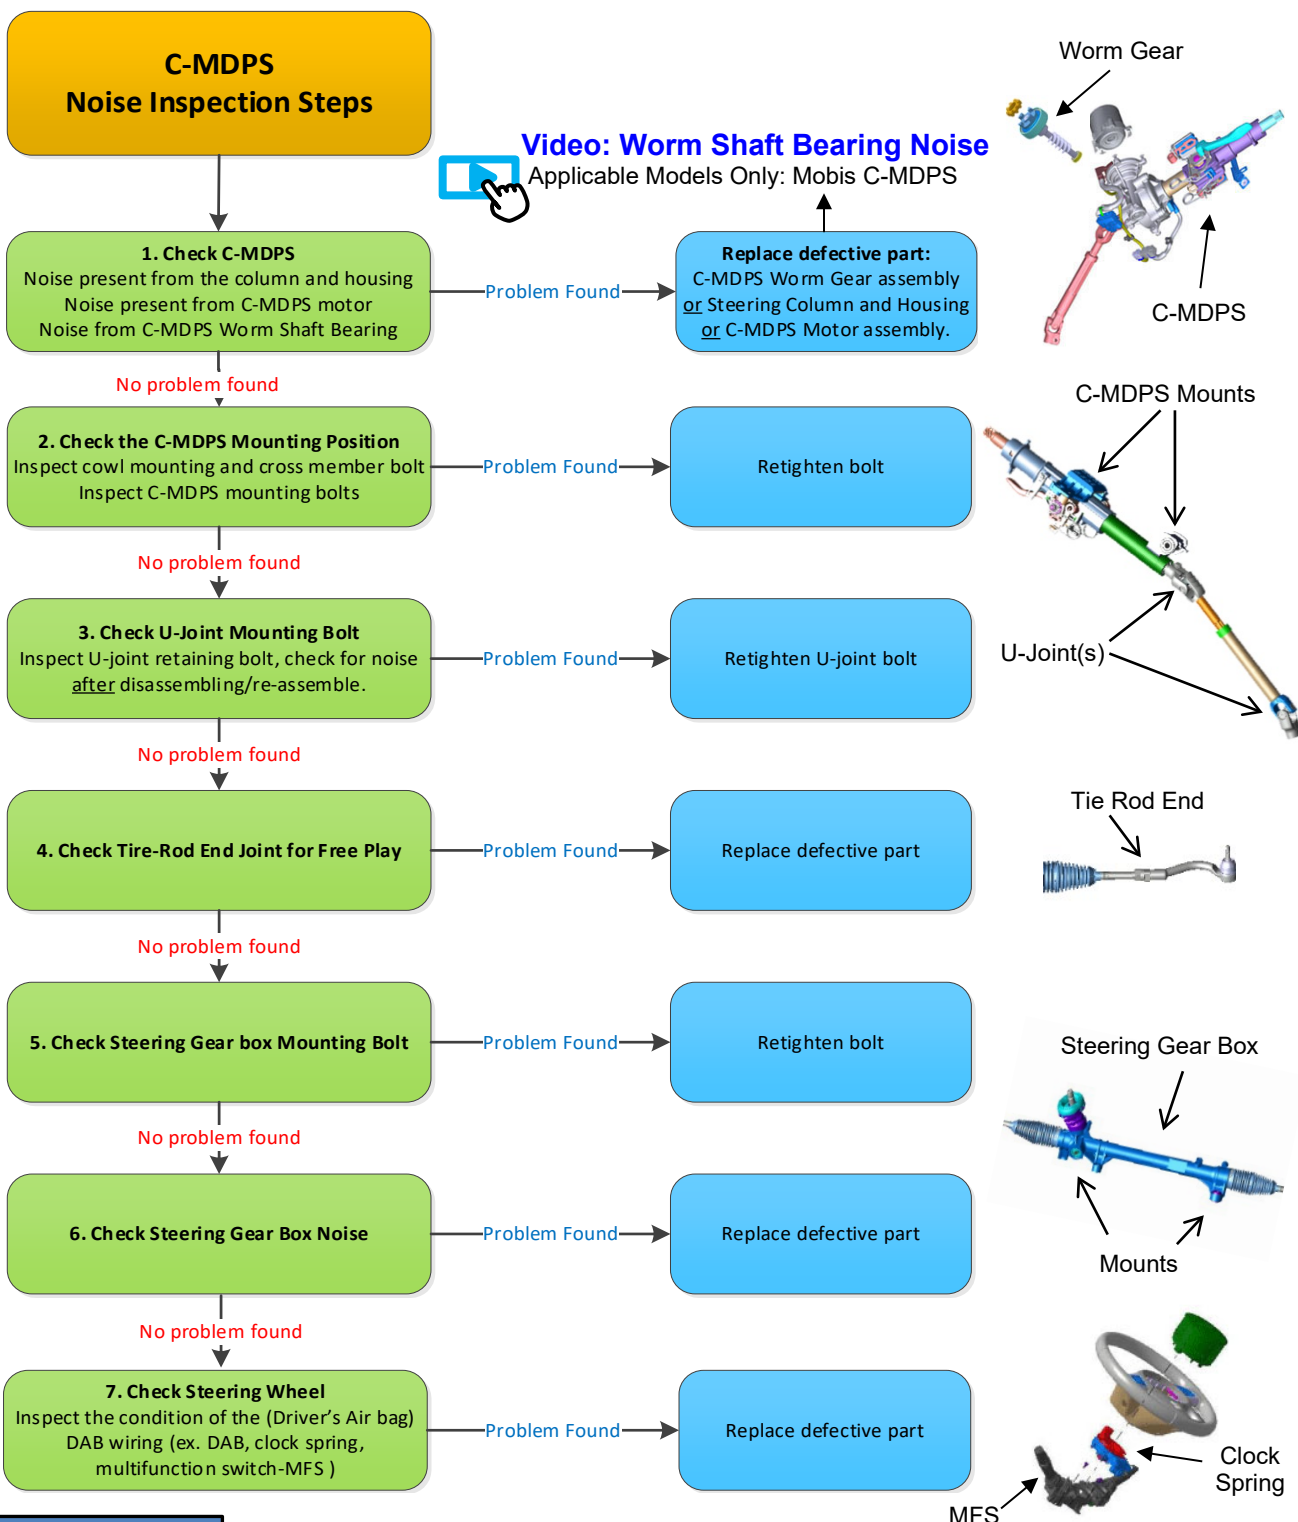
## C-MDPS Common Noise Concerns Flowchart

This bulletin provides information regarding the partial repair of the Motor Driven Power Steering (MDPS) Motor, Electronic Control Unit (ECU), Steering Column Housing, or Worm Gear Assembly. When the steering wheel is rotated a scraping noise can be heard originating from the lower bearing on the Worm Gear Assembly on some 2010MY~ Kia models listed on page 8, equipped with a Column Motor Driven Power Steering (C-MDPS) unit. On vehicles with this condition, the steering effort is not affected. Follow the MDPS Repair Flowchart (page 2) and the C-MDPS Common Concerns Flowchart (page 3), along with the MDPS DTC Table (page 4), and procedure outlined in this bulletin before replacing the C-MDPS Motor, ECU, Worm Gear Assembly, or Steering Column Housing.
