GROUP ELE	MODEL 2022MY Carnival (KA4)
	NUMBER 235	DATE March 2021
<b>TECHNICAL SERVICE BULLETIN</b>		
<b>SUBJECT: SERVICE ACTION: RECONFIGURE TERMINAL LOCATION OF INTEGRATED MEMORY SEAT (IMS) CONNECTOR (SA467)</b>

# SERVICE ACTION: RECONFIGURE TERMINAL LOCATION OF INTEGRATED MEMORY SEAT (IMS) CONNECTOR (SA467)

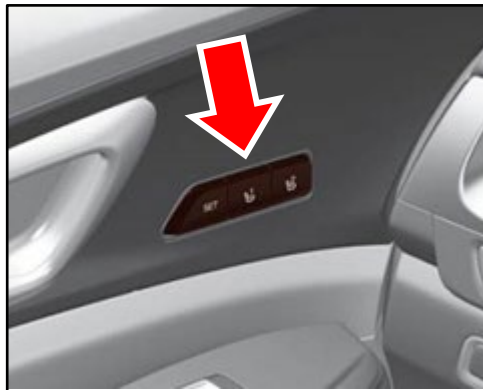
Integrated Memory Seat (IMS) Switch

This bulletin provides the procedure to reconfigure the terminals location of the Integrated Memory Seat (IMS) connector on some 2022MY Carnival (KA4) vehicles produced from January 4, 2021 through February 26, 2021. The IMS seat position memory buttons 1 and 2 may intermittently not operate the power driver's seat when the rear window defroster switch is on. This may be caused by floating voltage on the IMS circuit. To correct this concern, follow the procedure outlined in this bulletin to relocate the ground circuit to eliminate the floating voltage.
