## Installation Check - Rear Bumper Beam Bracket

| <b>Reference number:</b> | SCB 22 A 001 |
| <b>Affected vehicles:</b> | McLaren GT |
| <b>Situation:</b> | The rear bumper beam bracket may not be installed |

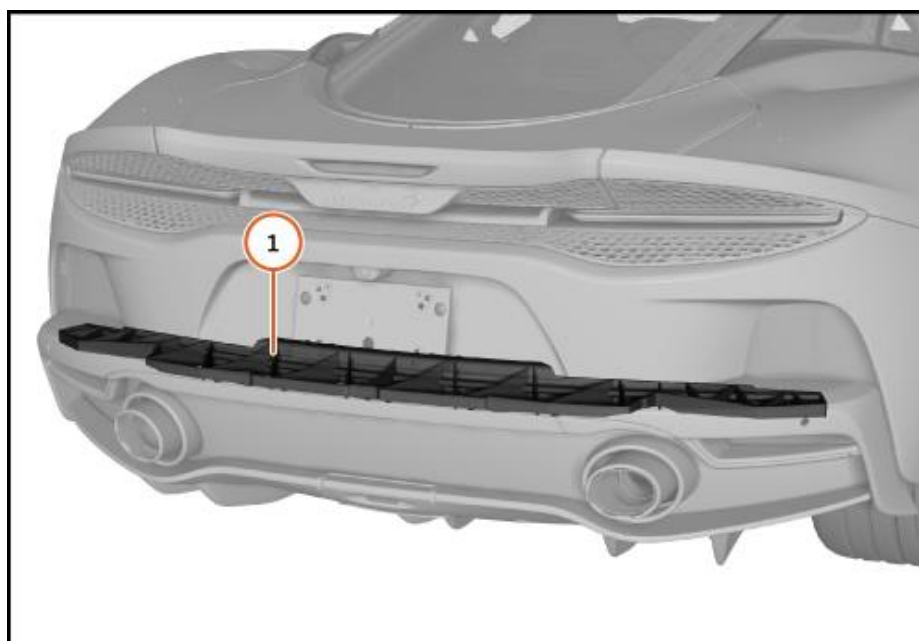
Rear Bumper Beam Bracket (1)

Through continuous product quality monitoring, it has been identified that a number of McLaren GT vehicles may not have the rear bumper beam bracket installed. Therefore, inspection of the part and potential installation is required.

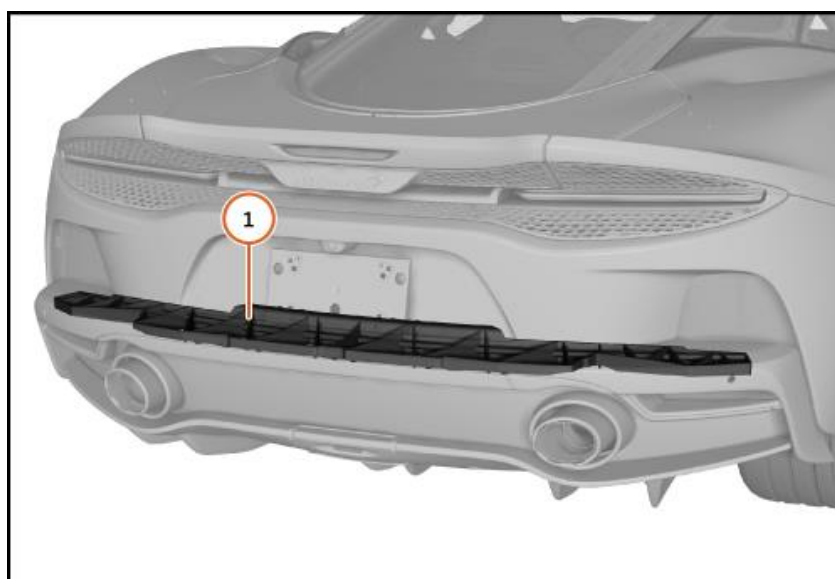
### Step 2

The illustration shows the location of the installed bracket (1)
