# McLaren Speedtail – Replace Auxiliary USB Board

**Bulletin type:** Service Campaign Bulletin  
**Reference number:** SCB 23 M 002  
**Attention:** Retailer Service Managers and Retailer Technicians  
**Affected vehicles:** McLaren Speedtail  
**Situation:** Installed part cannot be used  
**Procedure:** To action affected vehicles during next Retailer visit. Please refer to the information outlined in this document to replace the auxiliary USB board  
**Date:** 11<sup>th</sup> March 2021

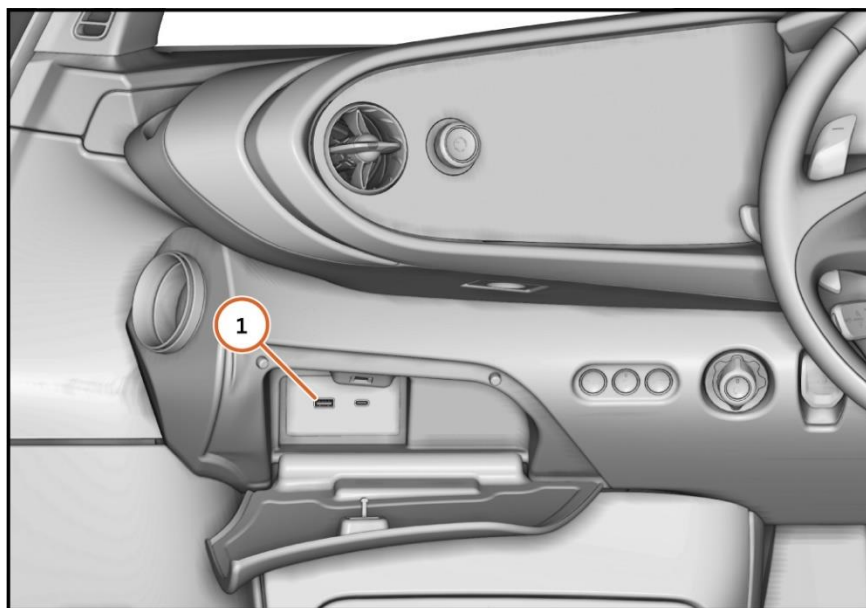
Auxiliary USB board (1)

A known number of McLaren Speedtail vehicles were fitted with auxiliary USB boards with a blanking cover installed over them to prevent usage. A new part has now been released for installation in the affected vehicles, so that the functionality can be utilised.

To perform the required work, follow SIS document: GA-RM-09M021-07-001 - Remove/Install Auxiliary USB board
