39-20-01 - Bevel Box Case Half Leak

Release date: 3/29/2021

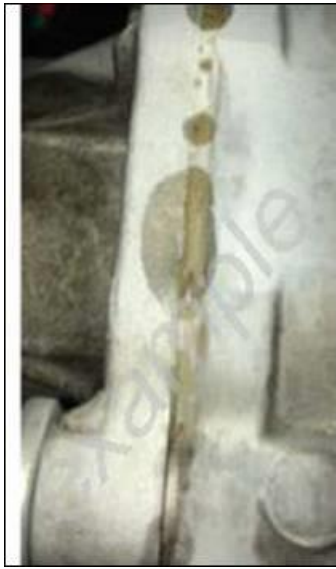
Figure 1.

Gear oil leak from the case halves of the bevel box due to currently used sealant type (Figure 1).
