# Technical Service Bulletin

## 91 Rear parking aid or hands-free tailgate release inop, DTC U115200, B107D31, B107BF0, or B107E31 are stored

91 21 85 2057357/4 March 29, 2021. Supersedes Technical Service Bulletin Group 91 number 20-28 dated November 6, 2020 for reasons listed below.

Model(s)	Year	VIN Range	Vehicle-Specific Equipment
A6, A7, S6, and S7	2019	All	Not Applicable

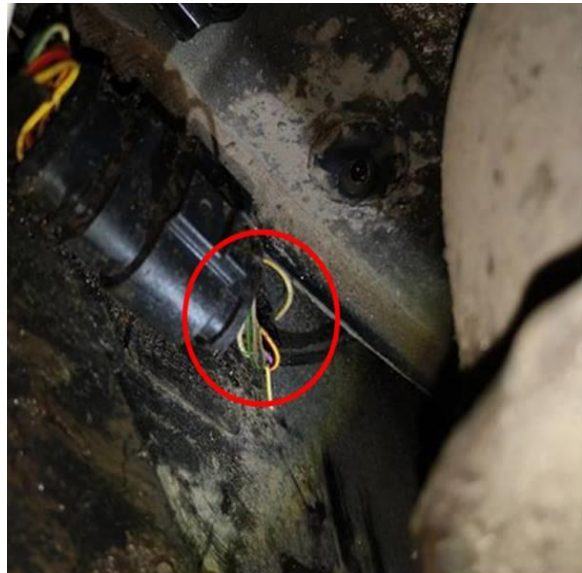
The connector housing or wires leading to connector T14m may become damaged due to road debris.

*Figure 1. Location to inspect T14m for damage.*

1. Inspect connector T14m and its circuitry at the left rear bumper connector station TSFHL (Figures 1 and 2).

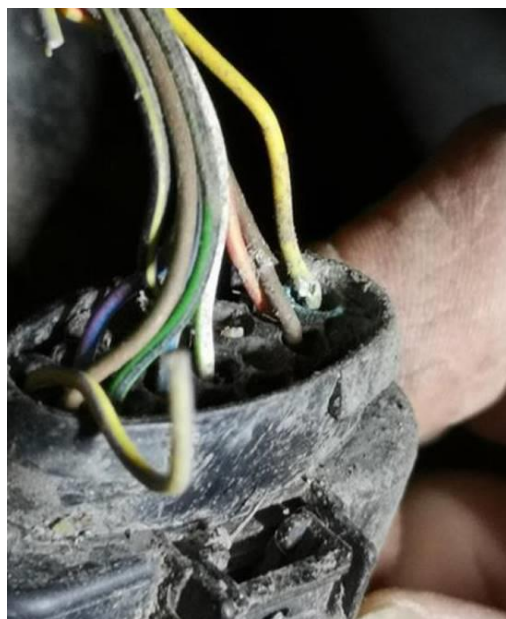
**Figure 2.** Close up of T14m connector showing harness damage.

2. If there is damage found, repair the affected wires and/or connector housing using VAS1978B.
3. Slide the new grommet, part number 6X0 971 921 B onto the harness and then reassemble the connector. Ensure the grommet is fully seated on the connector before refitting the bumper.
4. Once the repair is complete, clear out all DTC's and check the system for functionality.
