Transmission Symptom - Oil Leaks on Transfer Box: Observe Specified Procedure (SY 206/20)

Model Line: **Cayenne (9YA/9YB)**

Model Year: **As of 2018**

Concerns: **Transfer box**

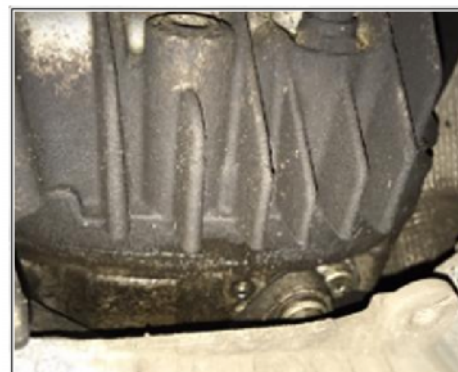
Oil migration in the area of the automatic transmission and transfer box can result in incorrect diagnoses when locating oil leaks. For example, the radial shaft seal on the automatic transmission or transfer box side may leak at the connection point of the automatic transmission and transfer box.

Oil penetration of the connection point on the transfer box housing (housing cover) can result in incorrect interpretations.

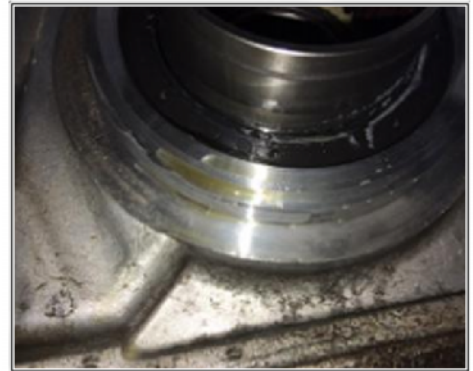
Oil leak on input-shaft radial shaft

Either the radial shaft seal on the automatic transmission or the transfer box may be damaged at the transition from automatic transmission to transfer box.

- 1 Oil leak on transfer box housing with drops forming in the area of the input shaft. The upswinging motion of the input shaft in the axial direction causes the transmission oil ahead of the radial shaft seal to surge with strong pressure fluctuations. This can result in an oil leak complaint.
 - 1.1 In the event of a complain, first check the technical status of the transfer box using the differentiation table:

- If the serial number on the transfer box corresponds to the specified differentiation data from the table, the entire transfer box must be replaced, see ⇒ *Technical Information 'Replacing transfer box'*. Replacing the radial shaft seal alone would not be effective in the long term and the radial shaft seal would leak again.
- However, if the serial number corresponds to a newer version than that in the differentiation list, only the radial shaft seal may then be replaced, see ⇒ *Technical Information 'Replacing sealing ring for transfer box (front transmission side)'*. The hardware version of the transfer box corresponds to the latest technical status.

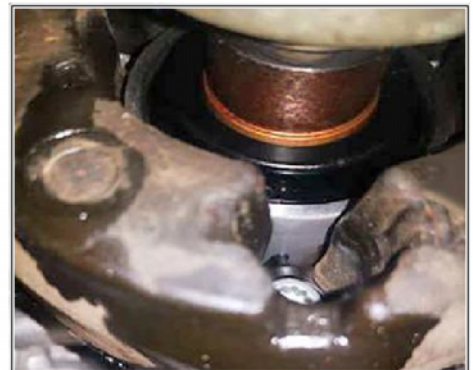
Oil leak on output-shaft radial shaft seal

- 2 Oil leaks in the area of the output shaft to the rear axle ⇒ *Oil leak on output-shaft radial shaft seal.*
If the output-shaft radial shaft seal is damaged, see ⇒ *Technical Information 'Replacing sealing ring for transfer box (rear transmission side)'.*

- Work Procedure: 1 Replace radial shaft seal on output shaft for hang-on transfer box, see ⇒ *Workshop Manual '399255 Replacing sealing ring for transfer box'*.
- 2 Check and top up oil for transfer box, see ⇒ *Workshop Manual '399035 Checking and topping up oil for transfer box'*.
