SERVICE BULLETIN

APPLICABILITY: 2020-21MY Legacy and Outback

NUMBER: 12-317-21

SUBJECT: Console Lid Inner Tray Mat- Design Change

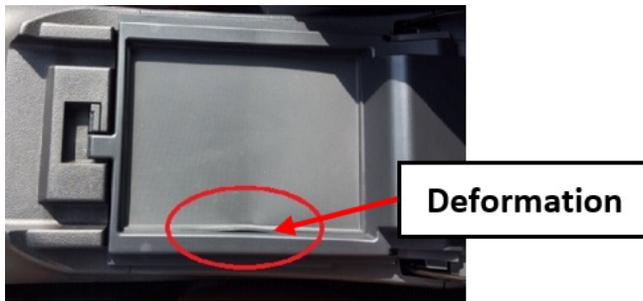
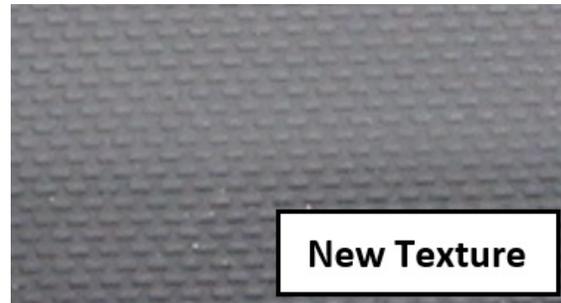
This bulletin announces a change to the mat located in the inside tray of the center console box lid to address concerns of shrinking and deformation. The new mat is made with a revised production process and incorporates an enhanced texture to prevent the condition shown in the photo below.

The new MAT part number is **92177AN021**.

NOTE: The console box lid assembly does NOT have to be replaced to address a condition with the mat as the mat component is serviced separately.
