03/31/2021
CAL FTL 42-003

Subject: Inspection and Correction of the Clearance between the Drive Axle Disc Brake Chamber and the Airliner Leaf Spring

Models Affected: Model year 2021 and 2022 Freightliner New Cascadia vehicles built from January 13, 2020 through February 16, 2021

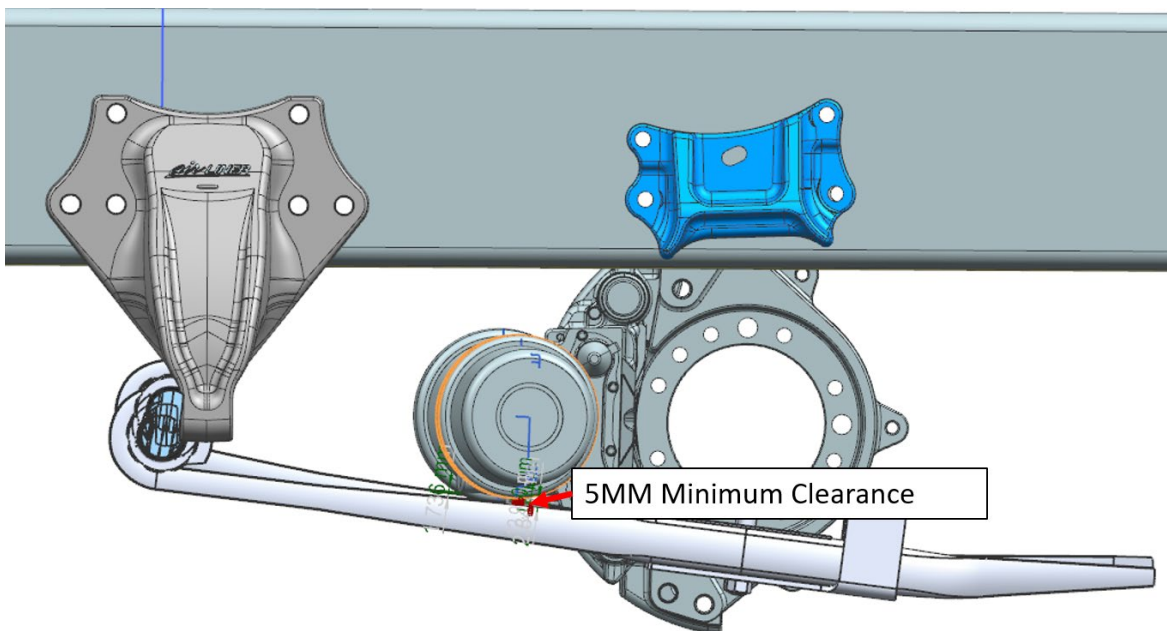
Fig. 1, Clearance between the Bottom of the Disc Brake Air Chamber and the Top of the Airliner Leaf Spring

1. Park the vehicle on a level surface, shut down the engine, and apply the parking brakes. Chock the tires.
2. Measure the clearance between the bottom of the disc brake air chamber and the top of the Airliner leaf spring as shown in Fig. 1. The minimum clearance is .19 inches (5 mm).
If the clearance is equal to or more than 5 mm, no further work is needed.
If the clearance is less than 5 mm, continue to step 3.

3. If the clearance is less than 5 mm, remove the caliper/carrier assembly and hub and rotor assembly to replace the disc brake anchor plate.
