SERVICE BULLETIN

APPLICABILITY: 2019-21MY Forester

NUMBER: 07-191-21

SUBJECT: DTC P257E / Hood Lock Assembly - Design Change

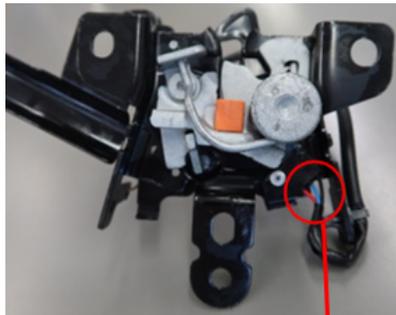
This bulletin announces a design change made to the front hood lock (latch) assembly. The change involves the lock’s micro-switch component which is not serviced separately. The previous micro-switch incorporated a seam which may be compromised by prolonged exposure to highly corrosive conditions (e.g. areas with heavy road salt use). If corrosion penetrates into the internal switch contacts, a DTC P257E: ENGINE HOOD SWITCH CIRCUIT LOW may set causing the Auto Start-Stop system warning lamp to illuminate. In addition, customers may report their remote engine start (RES) will not function. This report may be associated with either the accessory remote version or the STARLINK mobile app version of RES. The new assembly uses a seamless type micro-switch which is impervious to corrosion. OLD and NEW comparison images are supplied below.

“Seam” Type Switch

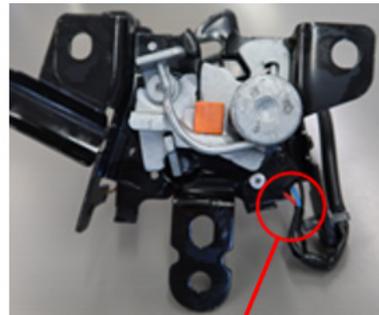
NEW

“Seamless” Type Switch

The new hood lock assembly was incorporated into production starting with VIN **MH473384**.

The new LOCK ASSEMBLY-FRONT HOOD part number is: **57310SJ032**.
