Articles Contained in this Issue

CODE	ARTICLE.....	PAGE
(00)	STIS New Releases	10-11
(01)	QMR of the Month	1-2
(01)	QMR of the Month Award Presentations	2
Tech Tips Greatest Tips		
(01)	Combination Meter and BIU shipments to SOA.....	3
(06)	C1921 – Electronic Parking Brake Inoperative	3-4
(15)	Homelink Mirror, No Operation with Key Off	4
(15)	Failed RES: Reference Error Code SER-4357.....	5
(15)	CP1 software version verification	6

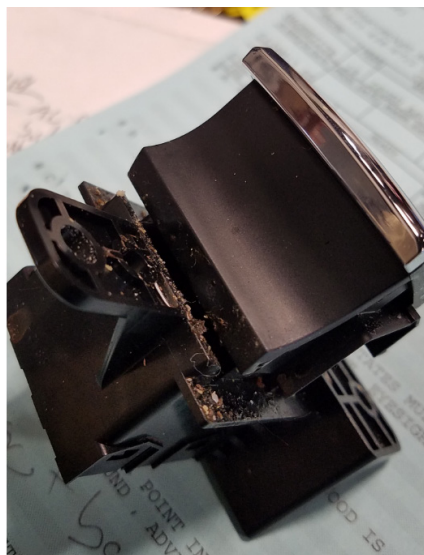
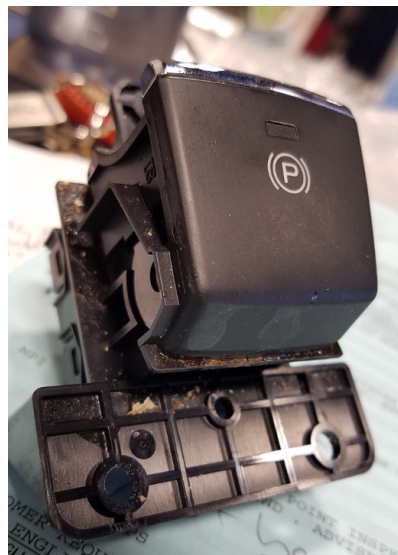
06 C1921 - Electronic Parking Brake Inoperative

DTC detecting condition:

- A fault is detected if the switch was positioned at lock or release continuously for 90 seconds while the vehicle is stopped.
- A fault is detected if an irregular switch condition continues for a predetermined period of time immediately after the switch position is changed. A fault is also detected if the switch condition is not confirmed afterwards.
- A fault is detected if the switch harness is open or shorted.

When diagnosing a C1921 trouble code, be sure to thoroughly inspect the EPB switch. Since the switch is in close proximity to the center console cup holders, there is higher chance for debris and liquids to contaminate the switch assembly. When this happens, the result can be a DTC set or an inoperative EBP/switch. Sticky contaminants, such as spilled soda, can cause the switch to be 'held' also resulting in a DTC. If this is the case, do not attempt to clean the switch, it should be replaced.

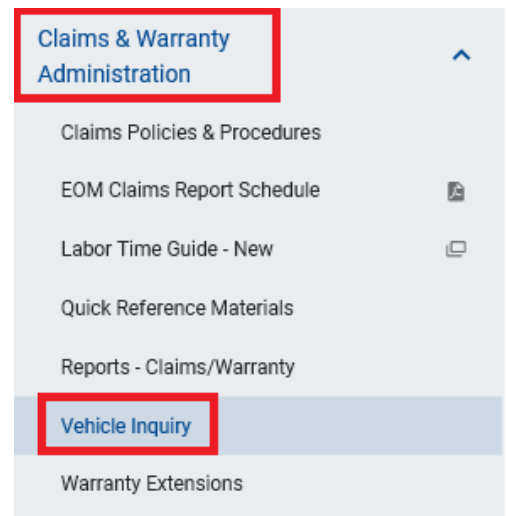
After investigating and discussing further with the supplier, the additional battery power to operate with the key off is not supplied to certain mirror assemblies. This depends on how the mirror was installed.

- **Accessory** installed Homelink mirrors- **Will Not** operate with key in the off position.
- **Factory** installed Homelink mirrors- **Will** operate with key in the off position.

This is considered normal operation. Therefore, if faced with this concern, the Technician should check the vehicle inquiry to see which method the mirror was installed.

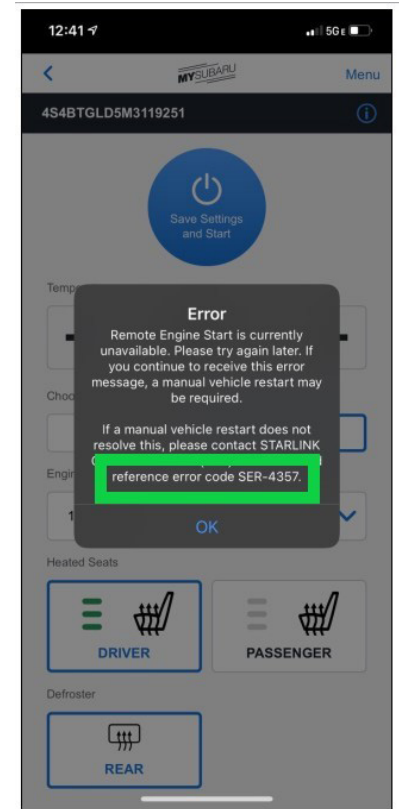
An example of a message displayed following a failed RES request referencing an error code is shown here. **Reference Error code SER-4357** indicates “negative acknowledgment” meaning although the vehicle has successfully received the RES request, there is a vehicle side system preventing engine start. Once the SER-4357 error message has been confirmed the on the customer’s phone, perform the preliminary diagnostic steps below:

1. Confirm the Telematics LED is GREEN.
2. Confirm proper operation of the power door locks.
3. Using the SSM4, verify the BIU indicates all the doors are locked.
4. Confirm proper operation of all door latch switches.
5. Using the SSM4, verify the BIU indicates all the door latches change from closed to open and vice-versa.
6. Verify the vehicle indicates it is in Park when the selector is in the Park position.
7. Using the SSM4, verify Park is indicated across all control modules consistently TCM, ECM, BIU, and KACM.
8. Verify the Push-button Start indicator functions as expected by illuminating GREEN when depressing the brake pedal with the engine OFF.
9. If Steps 1 - 8 are confirmed to be operating properly as indicated, contact Techline for assistance with additional diagnostic steps.

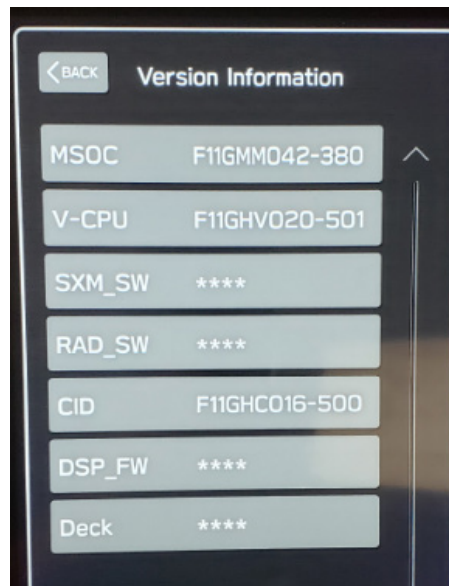
When confirming CP1 system software version information, it is critical to allow the unit to finish the boot-up process before accessing the version information screen. Failure to allow the process to complete could result in missing version information or asterisk symbols (****) as shown below. A good practice would be to wait a minimum of 3 minutes after the boot-up process begins at key on for this information to load properly.

However, this should not be confused with no “RAD_SW” version and “DSP_FW” version displayed or showing asterisk symbols (****) **AFTER** waiting for the system to completely boot-up. That would be a sign of a failed software update. For more details see Subarunet announcement “**Recall WRH-20 / WRI-20 Denso Gen 4 CP1 software update. Critical points to avoiding unnecessary hardware replacement**” posted January 5, 2021.
