Thor Motor Coach Technical Service Bulletin

TSB #	TSB 20-08		
Description/Title:	Overhead Cabinets		
Affected Product Line(s):	<i>Certain model year</i> 2014, 2016-2017 Tuscany XTE 2016-2017 Tuscany 2016 Venetian 2016-2020 ACE, Miramar, Outlaw, Palazzo, 2016-2018 Hurricane, Windsport		
Service Campaign # :	RC000209	Released Date:	1/13/2021
Codes:	Inspect Only: TMCTS80263Y Inspect with Repair: TMCTS80263W	Document Date:	1/13/2021
Time Allowed:	Inspect Only: 0.2 Inspect with Repair: 0.3	Document Revision:	A

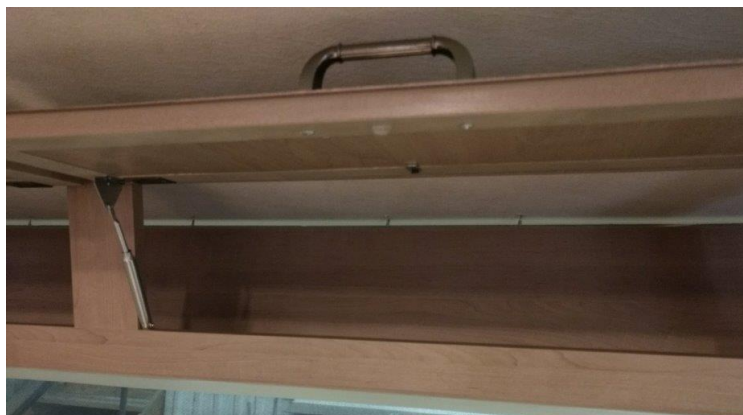
The overhead cabinets located above the driver and front passenger seats may become loose during travel. This Technical Service Bulletin will be gathering information regarding this possible concern and will provide guidance on how to ensure the overhead cabinets are properly secured in the motorhome.
