## Thor Motor Coach Technical Service Bulletin

TSB #	<b>TSB 21-01</b>		
Description/Title:	<b>120VAC load shedding</b>		
Affected Product Line(s):	<b>Certain model year 2021 Four Winds, Quantum, and Chateau motorhomes</b>		
Service Campaign # :	<b>RC000214</b>	Released Date:	<b>3/24/2021</b>
Codes:	<b>TMCTS80265W</b>	Document Date:	<b>3/24/2021</b>
Time Allowed:	<b>0.3</b>	Document Revision:	<b>A</b>

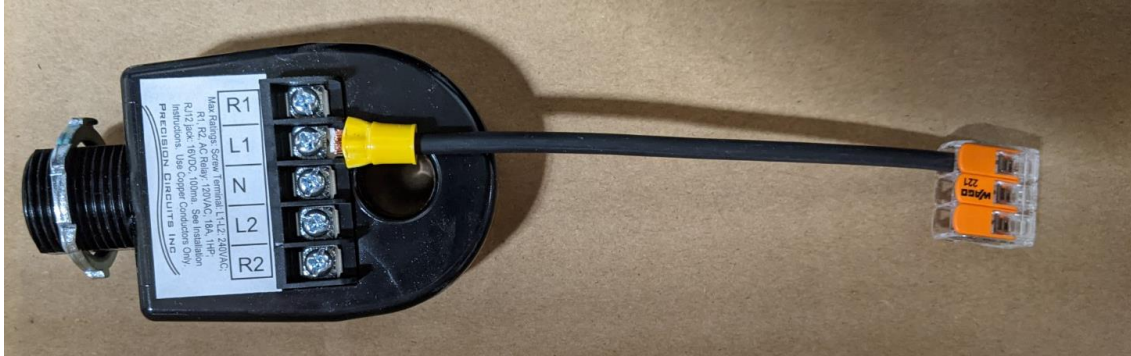
From November 2020 to February 2021, units produced at Plant 250 have a wire missing that would cause the 120VAC load shedding to not work properly. This affects model year 2021 31E, 31EV, 31W, 31WV, SL31, SE31, LF31, and WS31 floor plans with the 2 A/C option.

6. Connect the fork to L1 like is shown in the attached picture.

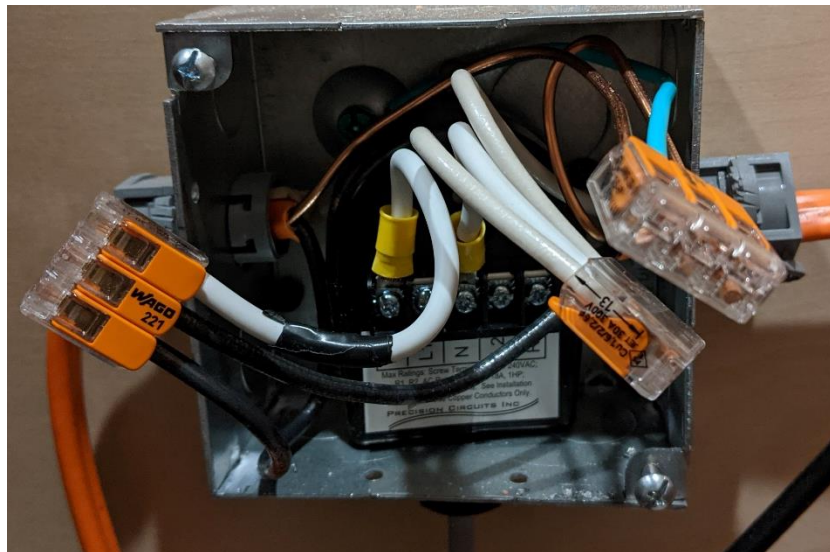
*(Note: White wire with black tape in above photo represents the black wire being added during this TSB.)*

**To test if fix worked, plug into shore power.  
Hit the “Select” button on the Power Control System display panel until you see “Service” on the display. Below Service it should show “30A”.**
