JLRTB02018NAS2

TECHNICAL BULLETIN

'Smart key not found' Message Displayed On Instrument Panel Cluster (IPC) and Intermittent Smart Key Operation

MODEL:	MODEL YEAR:	VIN:	ASSEMBLY PLANT:
E-PACE (X540)	2018-2020	Z00001-Z91414	Graz (Austria)
I-PACE (X590)	2019-2020	F60001-F90426	Graz (Austria)

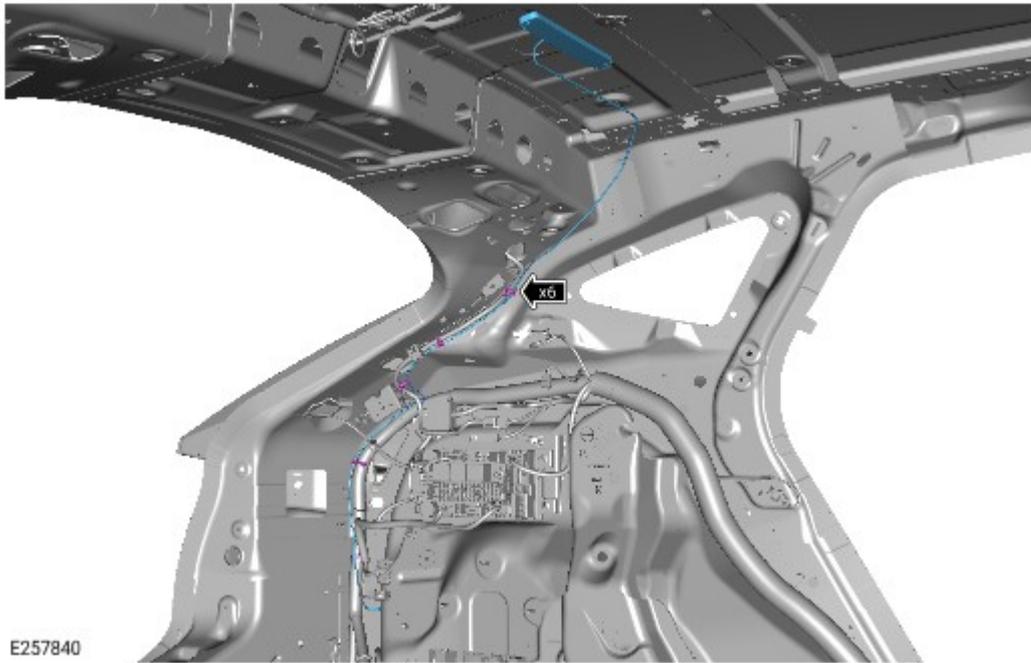
1.

E-PACE - Coaxial cable wiring harness route.

3. Inspect the coaxial cable from the RF receiver to the REA is correctly routed, secured in position and is not trapped. Inspect the condition of the connectors, connector pins between the RF receiver and REA for damage, make sure that connections are secure. Refer to the 'Service Information' section for wiring harness routes and locations.
 - If the coaxial cable is found to be incorrectly routed or trapped, but no damage has occurred, **continue to step 4.**
 - If the coaxial cable and/or connectors and connector pins are found to be damaged, **continue to step 5.**
 - If the coaxial cable is not found to be damaged, incorrectly routed or trapped, **continue with diagnosis (see TOPIx Workshop Manual section 419-01: Anti-Theft - Passive - Diagnosis and Testing - Anti-Theft - Passive).**
 4. Refer to the 'Service Information' section to correctly re-route the coaxial cable.
-

- Refer to the 'Service Information' section to make sure the coaxial cable is correctly routed.

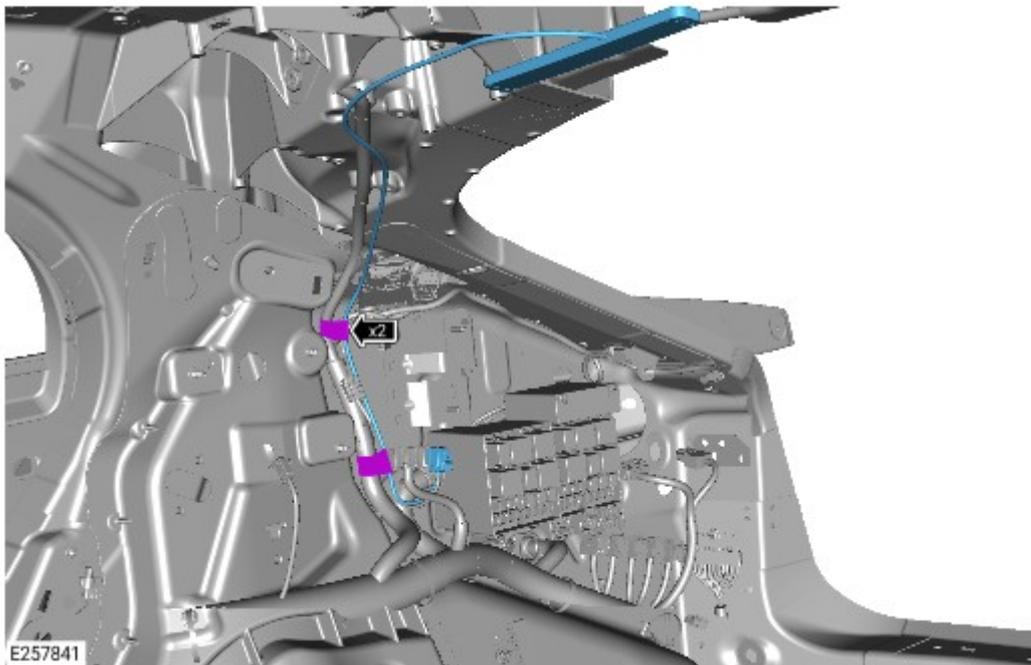
2.

I-PACE - Coaxial cable wiring harness route.

10. Inspect the coaxial cable from the **RF** receiver to the **REA** is correctly routed, secured in position and is not trapped. Inspect the condition of the connectors, connector pins between the **RF** receiver and **REA** for damage, make sure that connections are secure. Refer to the 'Service Information' section for wiring harness routes and locations.
- If the coaxial cable is found to be incorrectly routed or trapped, but no damage has occurred, **continue to step 11.**
 - If the coaxial cable and/or connectors and connector pins are found to be damaged, **continue to step 12.**
 - If the coaxial cable is not found to be damaged, incorrectly routed or trapped, **continue with diagnosis (see TOPIx Workshop Manual section 419-01: Anti-Theft - Passive - Diagnosis and Testing - Anti-Theft - Passive).**

-
11. Refer to the 'Service Information' section to correctly re-route the coaxial cable.

- Refer to the 'Service Information' section to make sure the coaxial cable is correctly routed.
-
13. Install the headliner (see TOPIx Workshop Manual section 501-05: Interior Trim and Ornamentation - Removal and Installation - Headliner).
-
14. Install the right loadspace trim panel (see TOPIx Workshop Manual section 501-05: Interior Trim and Ornamentation - Removal and Installation - Loadspace Trim Panel).
