JLRTB02059NAS2

TECHNICAL BULLETIN

25 MAR 2021

Incorrect Operation of Climate Control Air Distribution

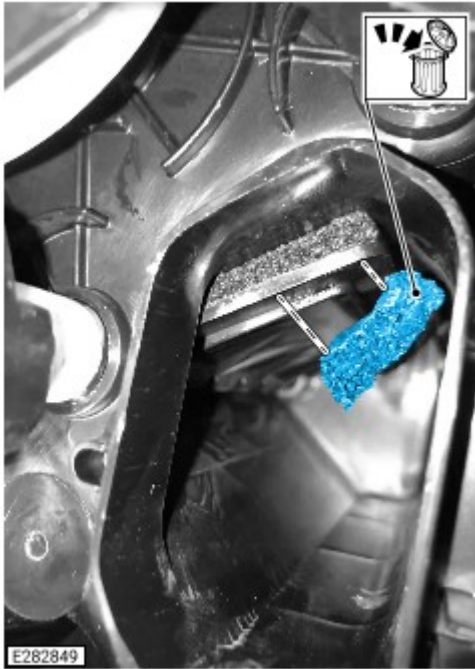
8.

The airflow distribution doors have become locked. In some cases, the foam seals on the back of the distribution doors have become detached and trapped the doors.

Remove and discard any adhesive foam pads that have detached from the left and right distribution doors.
