Countries: CANADA, UNITED STATES **Document ID:** IK1900263
Availability: ISIS, Bus ISIS, FleetISIS, Body Builder, IsSIR **Revision:** 0
Major System: ACCESSORIES **Created:** 2/26/2021
Current Language: English **Last Modified:** 3/15/2021
Other Languages: NONE **Author:** William Knoth
Viewed: 93

Title: Bus B6.7 Aftermarket Dual A/C Cylinder Head Failures

Applies To: Bus w/ B6.7 with Aftermarket Dual Air Conditioning Systems

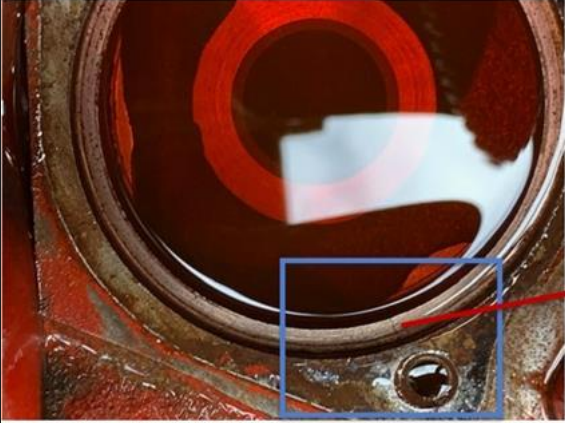
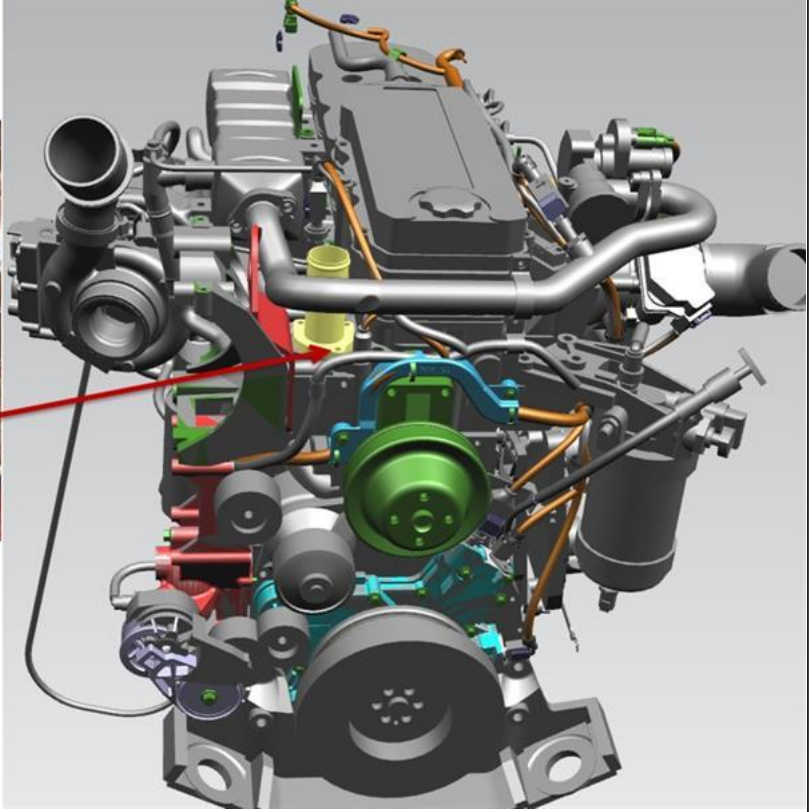
Some configurations of aftermarket A/C systems can produce excessive loads on the cylinder head resulting in cracks around the thermostat housing area. This will be seen by the customer as an external coolant leak.

Step	Action	Dec
1	<p>DIAGNOSTIC:</p> <p>Does the vehicle have an aftermarket dual A/C system installed with a coolant leak in this area?</p>

<p>Yes. Quic instr instr cylin cont</p> <p>No. diag artic</p>

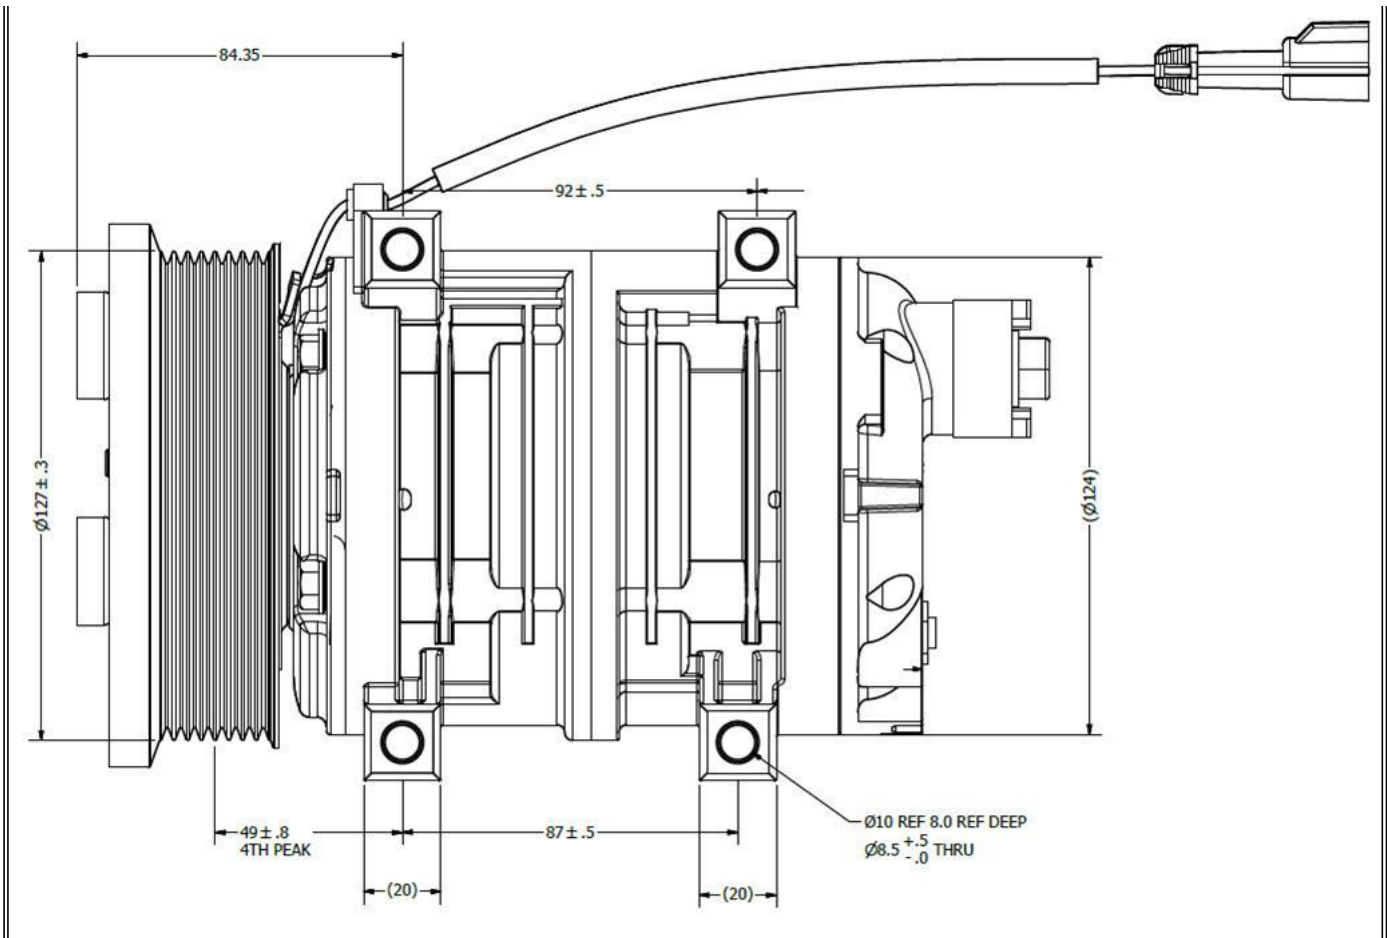
Figure 3: Compressor Dimensional Requirements

Step	Action	Decision
2	<p>DIAGNOSTIC:</p> <p>Does the aftermarket A/C system use compressors that meet the dimensional requirements in figure #3?</p>	<p>Yes. Continue to Repair Instructions</p> <p>No. This article will not apply, please consult the A/C manufacturer</p>

The repair can only be performed on A/Cs systems that meet the compressor dimensional requirements outlined in the image above.
