SUBJECT: NEW VEHICLE DEMONSTRATION / DELIVERY HOLD

Customer Satisfaction Program 21B03

Certain 2020 Model Year Super Duty F250-F600 Vehicles Equipped with a 10R140

Transmission - Number One Planetary and Ring Gear Assembly

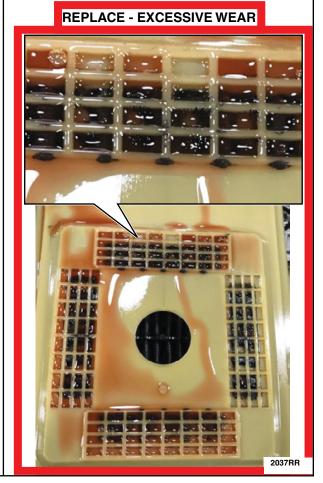
FIGURE 1

- For all **UNSOLD**/in-stock vehicles: reinstall and reuse the transmission fluid filter from the vehicle.
- For all **SOLD** vehicles use the following table and See Figure 1.

Vehicle Mileage	Normal Wear	Excessive Wear	
Less than 20,000 miles	Reuse Trans. Filter	Replace Trans. Filter	
Greater than 20,000 miles	Replace Trans. Filter	Replace Trans. Filter

REUSE - NORMAL WEAR

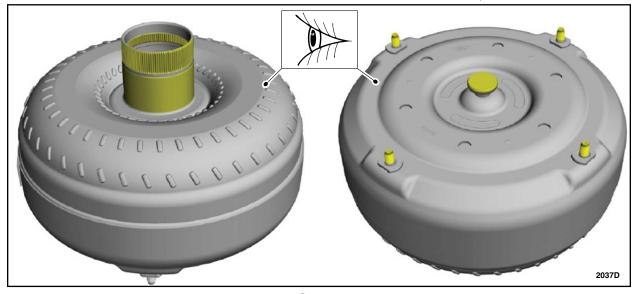
FIGURE 5

- 5. Inspect the torque converter. If you answer yes to any of the following questions a new or re-manufactured torque converter must be installed. See Figure 5.
 - Does the sealing surface have a groove worn from the seal?
 - Has a torque converter malfunction been determined based on complete diagnostic procedures?
 - Is the torque converter stud or studs, threaded pads, impeller hub or bushing damaged?
 - Is there evidence of water or antifreeze contamination?
 - Does the torque converter exhibit external discoloration (due to overheating)?
 - Overheat discoloration would be a darker color with possible bluing.
 - Discoloration would be a different color than the rest of the torque converter.

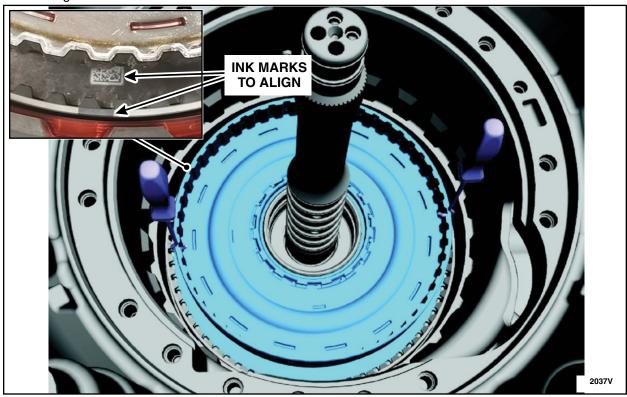
FIGURE 15

NOTE: The ink marks must be aligned or a transmission vibration can occur.

17. Using two pick hooks, install the new number one planetary carrier with the ink markings aligned. See Figure 15.

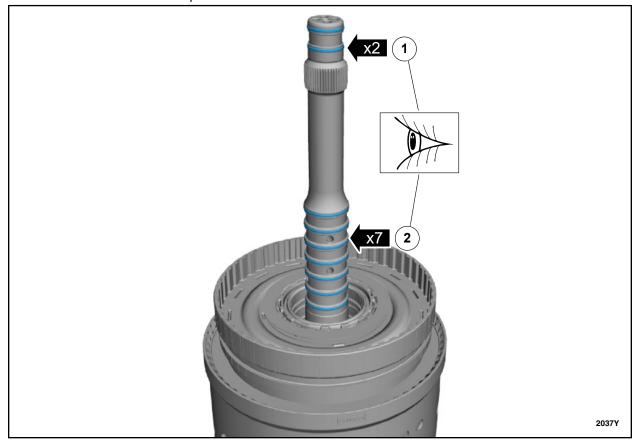
FIGURE 18

- 20. Inspect the input shaft seals for damage. See Figure 18. Do any of the input shaft seals show signs of damage?
 - 1. Torque converter seals.
 - 2. Front support assembly seals.
 - If $\boldsymbol{YES}\,$ Remove the damaged seals, then proceed to Step 21.
 - If NO Proceed to Step 27.
