TECHNICAL SERVICE BULLETIN

Electronic Shift On-The-Fly (ESOF) 4WD - Intermittent Grinding Noise While Driving

21-2076

Ford 2013-2018 F-150

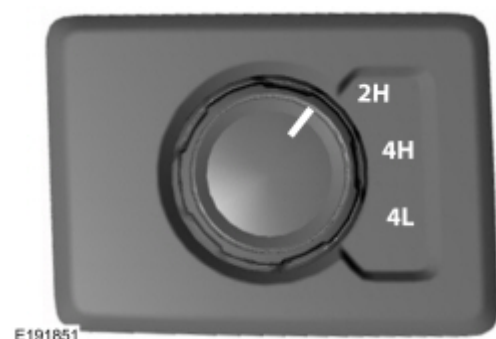
Figure 1 - Example of MSS without 4A selection

1. Does the vehicle have a MSS that only includes 2H, 4H and 4L positions (does not include 4A)? (Figure 1)

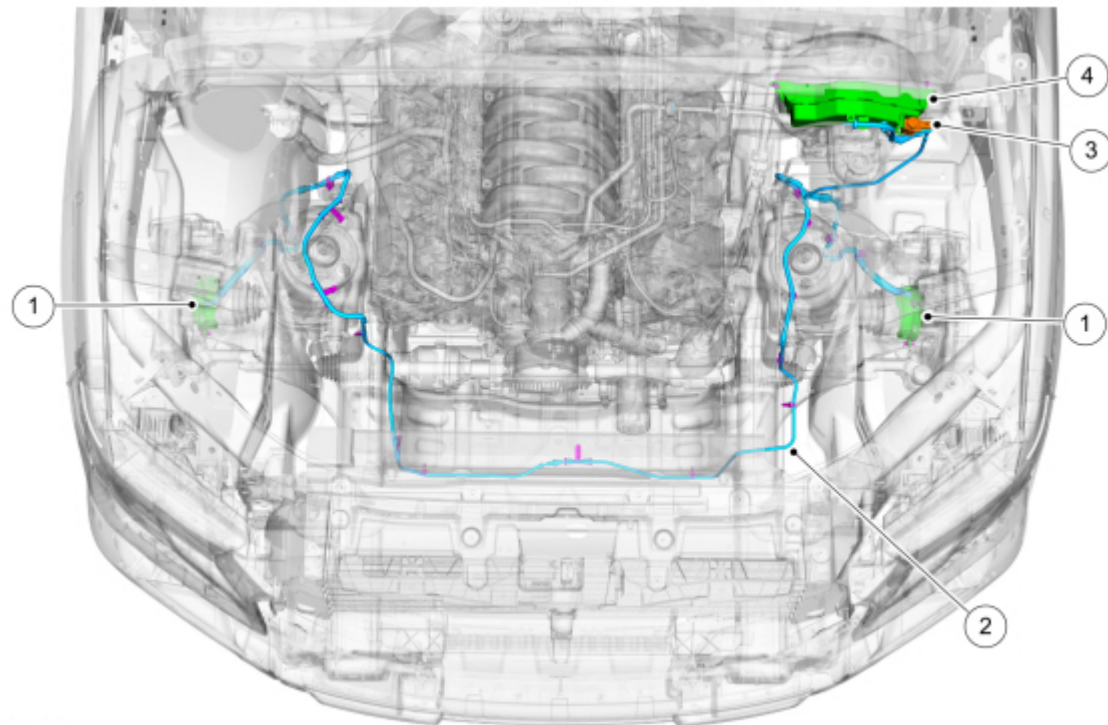
Figure 2

3. Inspect the IWE vacuum hoses. Refer to Workshop Manual (WSM), Section 308-07A. Are there any disconnected or damaged vacuum hoses? (Figure 2)

(1). Yes - reconnect or replace the vacuum hose as required. Refer to WSM, Section 308-07A.

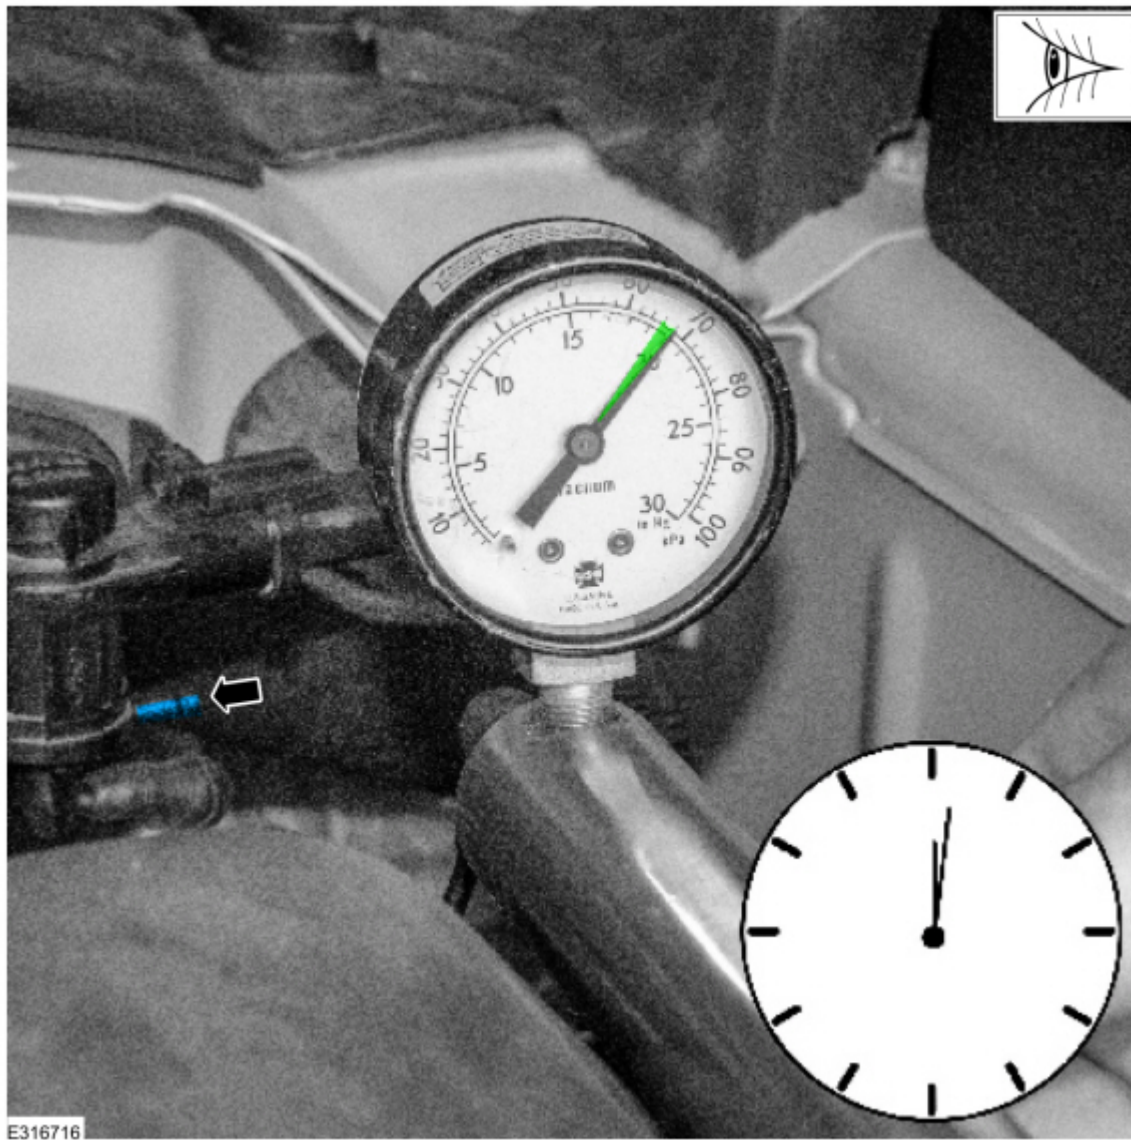
Figure 3

4. Replace the vacuum check valve located near the vacuum reservoir. Refer to WSM, Section 308-07A.
5. Disconnect the vacuum line to the IWEs at the vacuum solenoid.
6. Connect a hand vacuum pump to the IWE vacuum supply line and apply 508 mm (20 in) Hg of vacuum. Does the vacuum drop more than 12.5 mm (0.5 in) Hg per minute? (Figure 3)
 - (1). Yes - proceed to Step 7.
 - (2). No - connect the IWE vacuum supply line to the solenoid and proceed to Step 11.

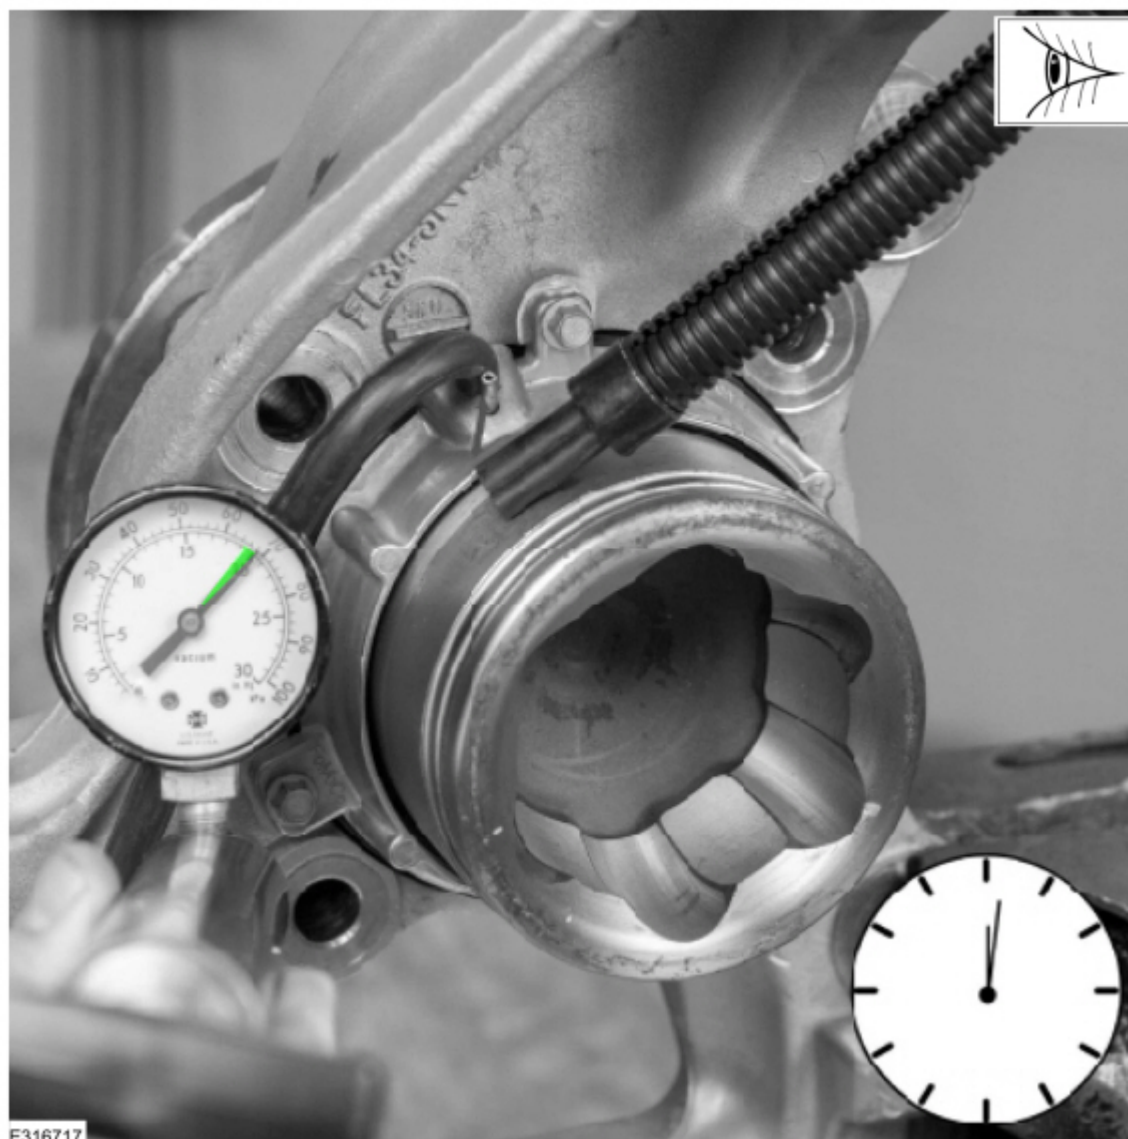
Figure 4

7. Using a hand vacuum pump, apply 508 mm (20 in) Hg of vacuum to each IWE, one at a time, and monitor the vacuum gauge. Does the vacuum drop more than 12 mm (0.5 in) Hg per minute? (Figure 4)

- (1). Yes - proceed to Step 9.
- (2). No - proceed to Step 8.

8. Replace the vacuum lines between the solenoid and IWEs. Refer to the WSM, Section 308-07A. Proceed to Step 13.
9. Remove the IWE assembly from the affected wheel. Refer to WSM, Section 308-07A.

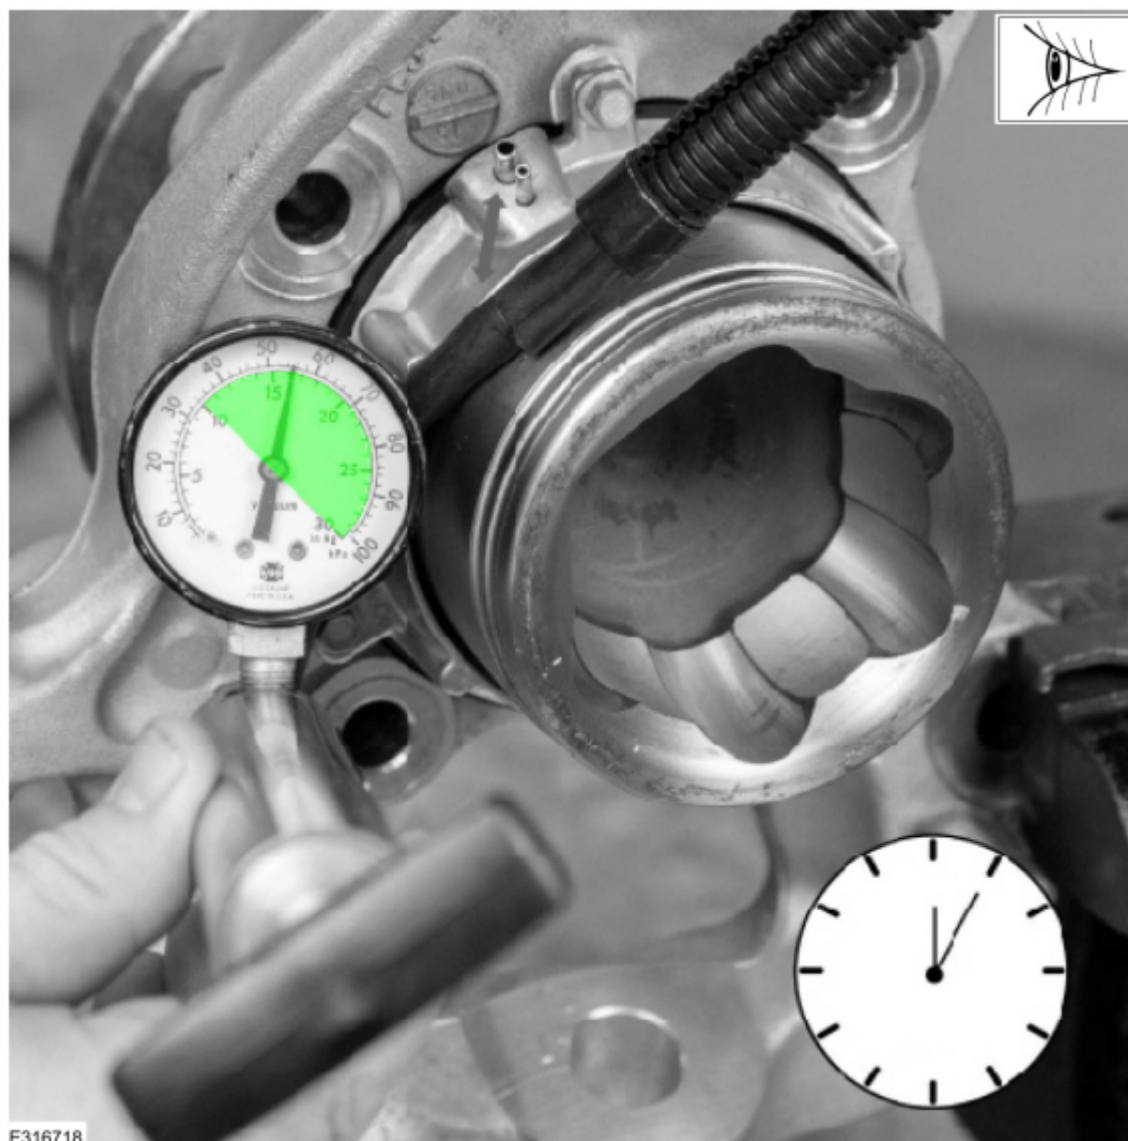
Figure 5

- (2). No - replace the IWE assembly. Refer to WSM, Section 308-07A. Proceed to Step 13.
11. Test the IWE vacuum supply lines.
 - (1). Disconnect the vacuum supply line at the left or right IWE and connect a vacuum gauge to the supply line as shown in Figure 5.

- (2). Start the engine and allow it to idle for 5 minutes to build vacuum.
 - (3). Connect the appropriate Ford diagnostic scan tool and enter TCCM data logger.

- (4). Active command the vacuum solenoid.
 - Command IWE_OS # to No.

(5). Repeat this test on the opposite IWE vacuum supply line.

12. Is the vacuum at both left and right supply lines greater than 254 mm (10 in) Hg?

(2). No - replace the vacuum lines between the solenoid and IWEs. Refer to the WSM, Section 308-07A. Proceed to Step 13.
