Subject: ELECTRICAL CONCERN AND/OR MULTIPLE DTC'S DUE TO AFTERMARKET DEVICE	M-Tips No.: MT-001/21
	Last Issued: 03/15/2021

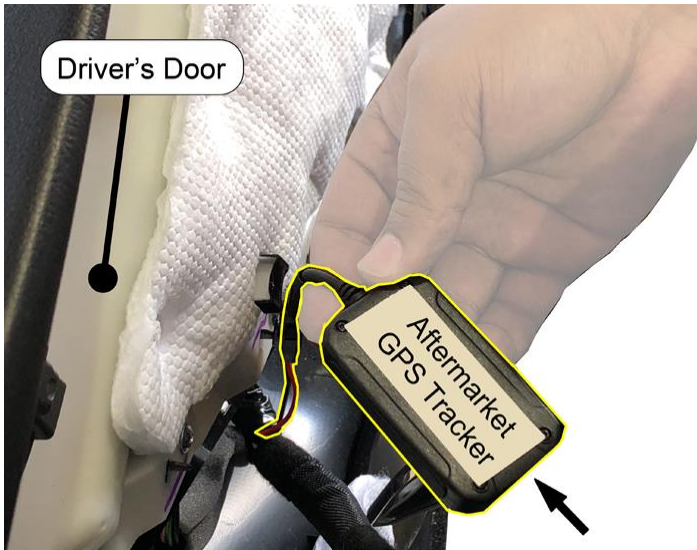
Example 3

Some aftermarket devices that are wired to the vehicles’s wiring harness may create unusual electrical symptoms and/or store DTCs.

Below are examples of concerns due to an aftermarket GPS tracking device wired to the power window main switch:

- Engine no start
- Battery discharge
- Main relay buzzing
