**HYUNDAI**
Technical Service Bulletin

GROUP Body Electrical	NUMBER 21-BE-005H
DATE March, 2021	MODEL(S) Santa Fe (TMa) Palisade (LX2)

SUBJECT: SURROUND VIEW CAMERA DISPLAY TROUBLESHOOTING GUIDE

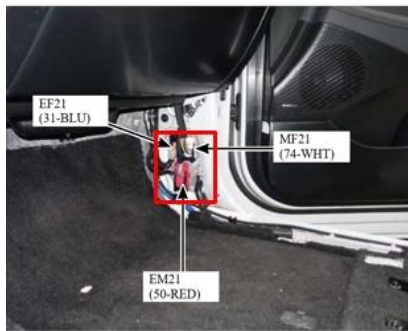
Front passenger side lower kick panel

Location of possible improper coaxial cable connection:

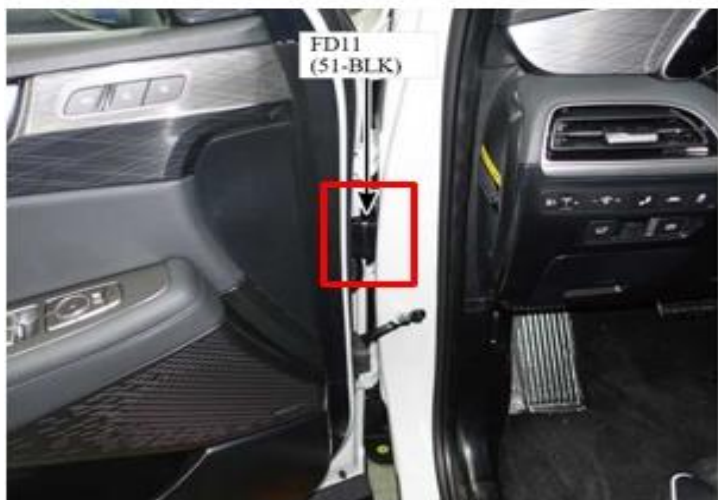
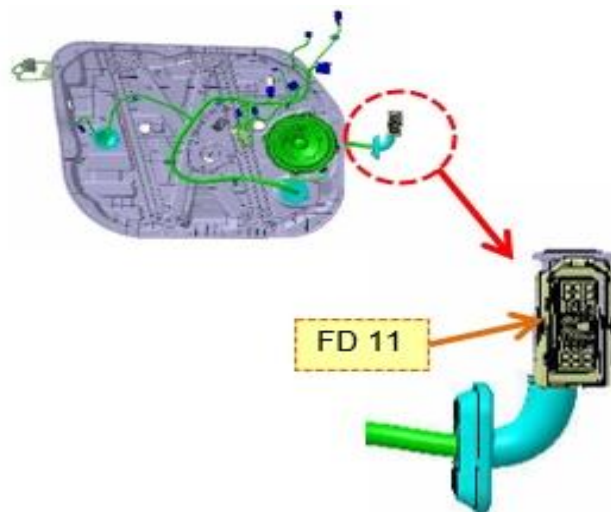
Driver door harness

Location of possible improper coaxial cable connection:

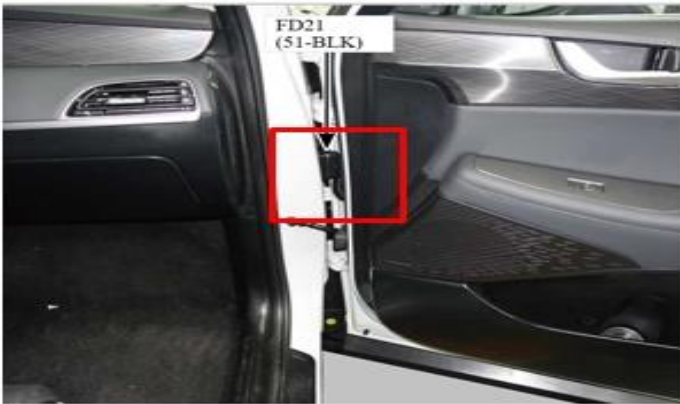
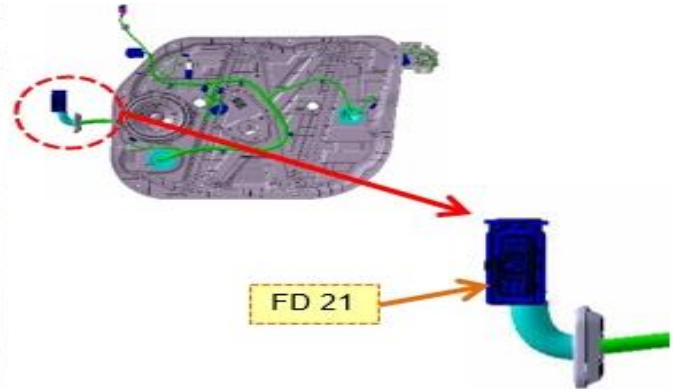
Front passenger door

Location of possible improper coaxial cable connection:

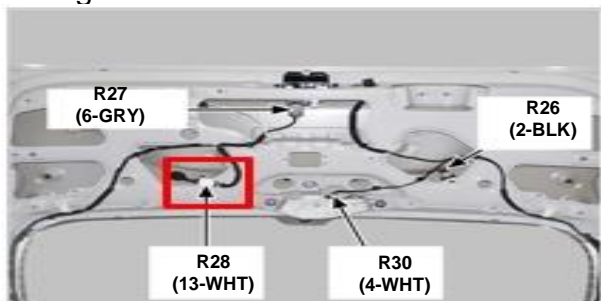
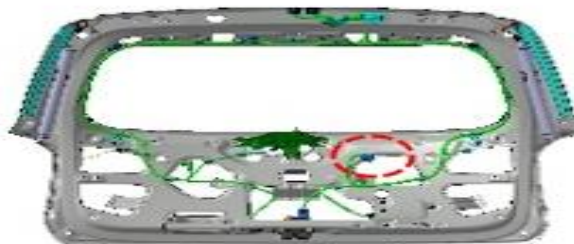
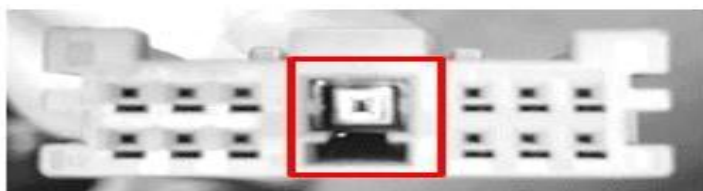
Tail gate harness

Location of possible improper coaxial cable connection:

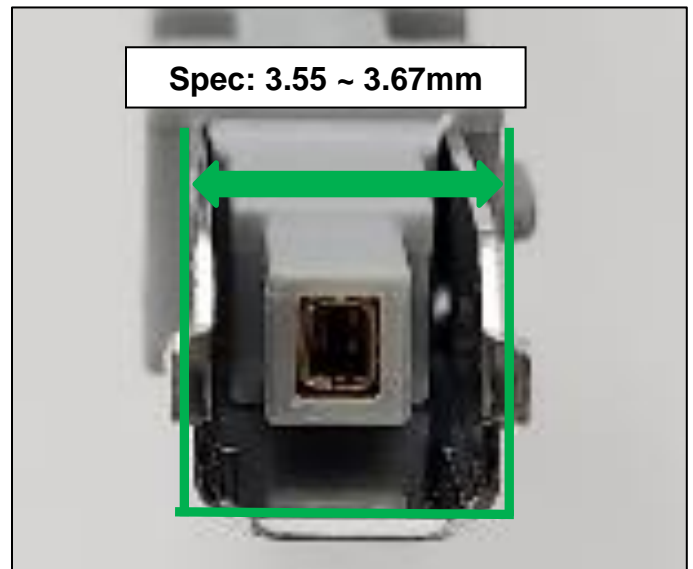
- 5a. Inspect the female pins for deformation. Measure the distance between vertical sides to ensure they are within specification.

Spec: 3.55 ~ 3.67mm

The pins are U-shaped, and should form 90 degree angles (square corners).

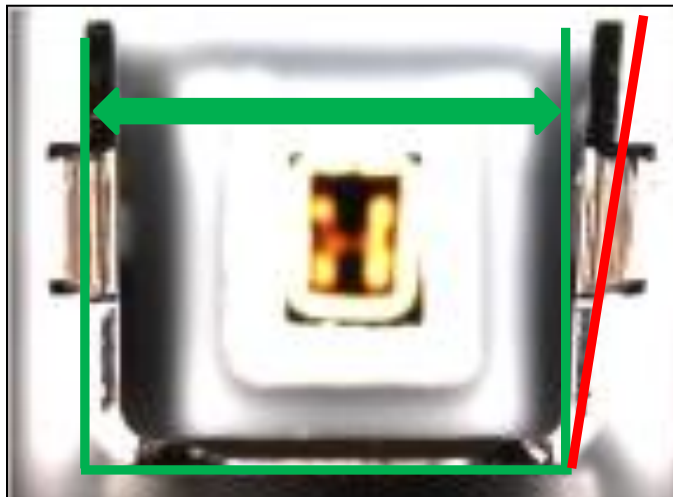
- 5b. This is an example of a U-shaped pin that is deformed and splaying outwards (not square at 90 degree angle).

6. If necessary, reshape the pin to specification using a pair of long-nose pliers.

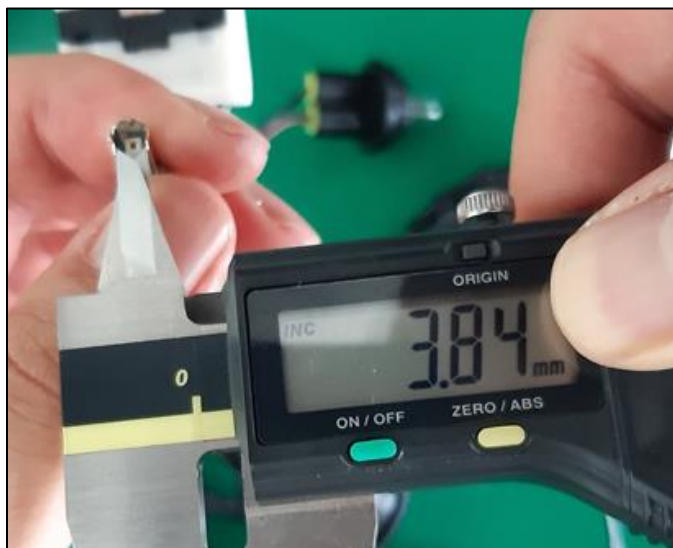
It is also out of specification when measured using a digital micrometer.
