Technical Service Bulletin

GROUP	NUMBER
Body Electrical	21-BE-006H
DATE	MODEL(S)
March, 2021	Elantra (ADa) Santa Fe (TMa)

FRONT VIEW CAMERA REPLACEMENT

This TSB supersedes TSB# 20-BE-006H-1 to expand the affected vehicles date range.

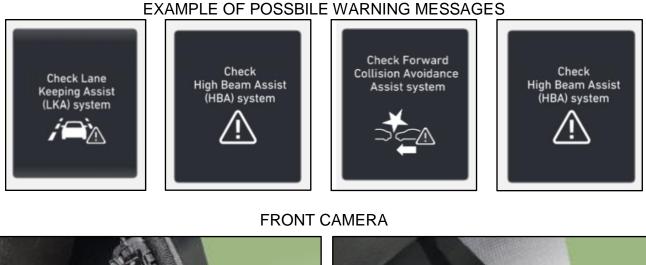
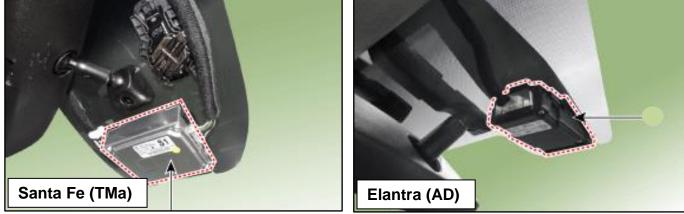
Description: Certain 2019-2020MY Santa Fe and 2018-2020MY Elantra equipped with the front multifunction camera may exhibit one or more of the following warnings on the instrument cluster; Lane Keep Assist System (LKAS), Front Collision Avoidance Assist (FCA), High Beam Assist (HBA), Smart Cruise Control (SCC), and Autonomous Emergency Braking (AEB). This bulletin describes the procedure to replace the front camera/ multi-function camera.

NOTE: When the Warning Indicator Message turns ON, the diagnostic code C1604 (ECU Hardware Error) or C1606 (CAN Time out - BCM & ADM or ECU Software – Error) will be triggered.
