Technical Service Bulletin

Mazda North American Operations
Irvine, CA 92618-2922

Subject: MAZDA SERVICE PROGRAM (MSP49) - CREAKING / SQUEAKING NOISE FROM RIGHT REAR SUSPENSION	Bulletin No.: 02-005/21
	Last Issued : 03/25/2021

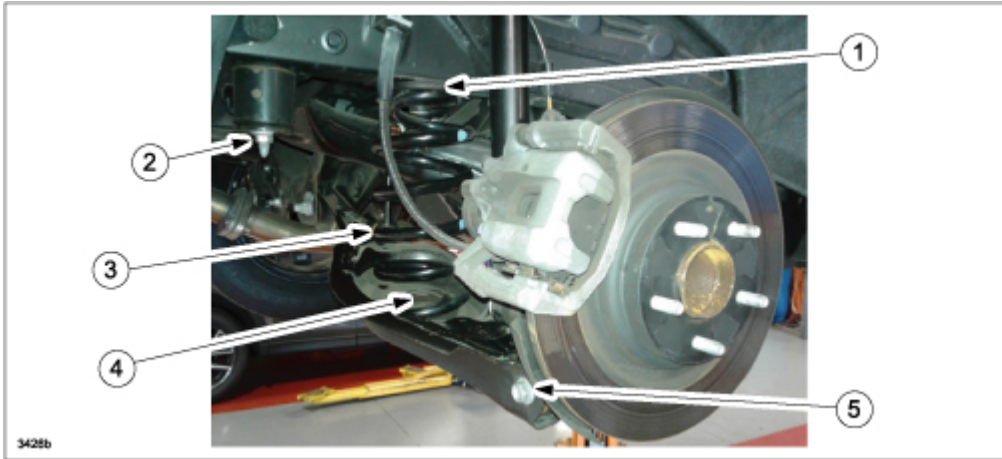
REPAIR PROCEDURE**RIGHT REAR COIL SPRING REMOVAL/INSTALLATION**

1	Upper spring seat rubber
2	Rear stabilizer control link lower side nut - 45-55 {4.6-5.6, 34-40}**
3	Rear coil spring
4	Lower spring seat rubber
5	Rear lower arm outer bolt - 127-154 {13-15, 94-113}**
