# Technical Service Bulletin

FLOCK FINISHING ON DOOR SASH MOLDING PEELS OFF WHEN OPENING FROZEN DOOR

Bulletin No.: 09-008/21

2017-2019 CX-5 2018-2019 CX-5 (Mexico spec.)

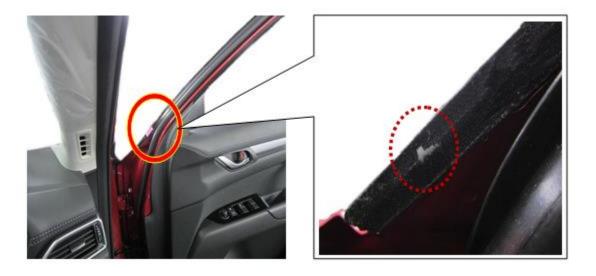
Some customers may notice the flock finishing on the door sash molding is peeled off (as shown below) when opening the frozen door. This concern may be caused by insufficient durability due to an improper production process of the door sash moldings. To eliminate this concern, the production process of the door sash moldings has been changed.

- 1. Verify the customer concern.
- 2. Replace the affected door sash molding(s) with modified part(s) according to the instructions on MGSS online:
  - FRONT SASH MOLDING REMOVAL
  - FRONT SASH MOLDING INSTALLATION
  - REAR SASH MOLDING REMOVAL
  - REAR SASH MOLDING INSTALLATION
- 3. Verify the repair.
