Technical Service Bulletin

RUSTY PANEL AT BOTTOM (INNER SIDE) OF DOORS

Bulletin No.: 09-009/21

APPLICABLE MODEL(S)/VINS 2017-2021 CX-5

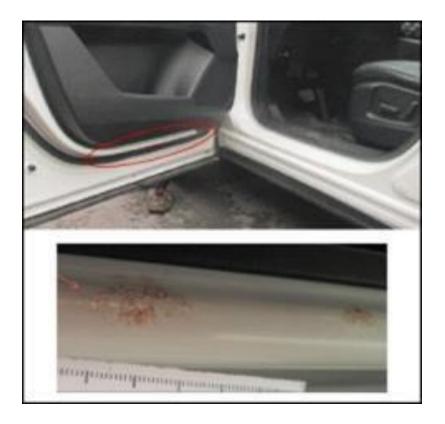
Some customers may complain about rust at the bottom (inner side) of the doors where the seaming welt is located. It is caused by mud/sand adhering to the side sill, which scratches the paint surface when the door is opened/closed. The mud/sand is most likely brought in by the driver and/or passenger when stepping in and out of the vehicle.

- 1. Verify the customer concern.
- 2. Repair the paint rust/blister damage on the affected door panel(s) according to normal bodyshop repair procedures.
- 3. After the paint repair has been completed, attach the protection film to the door panels according to steps a ~ f below.

NOTE: Attach the protective film to all (4) four door panels, even those without any paint rust/blister damage.
