Draft Mack Chassis - Model GR/GU - Hood Warpage

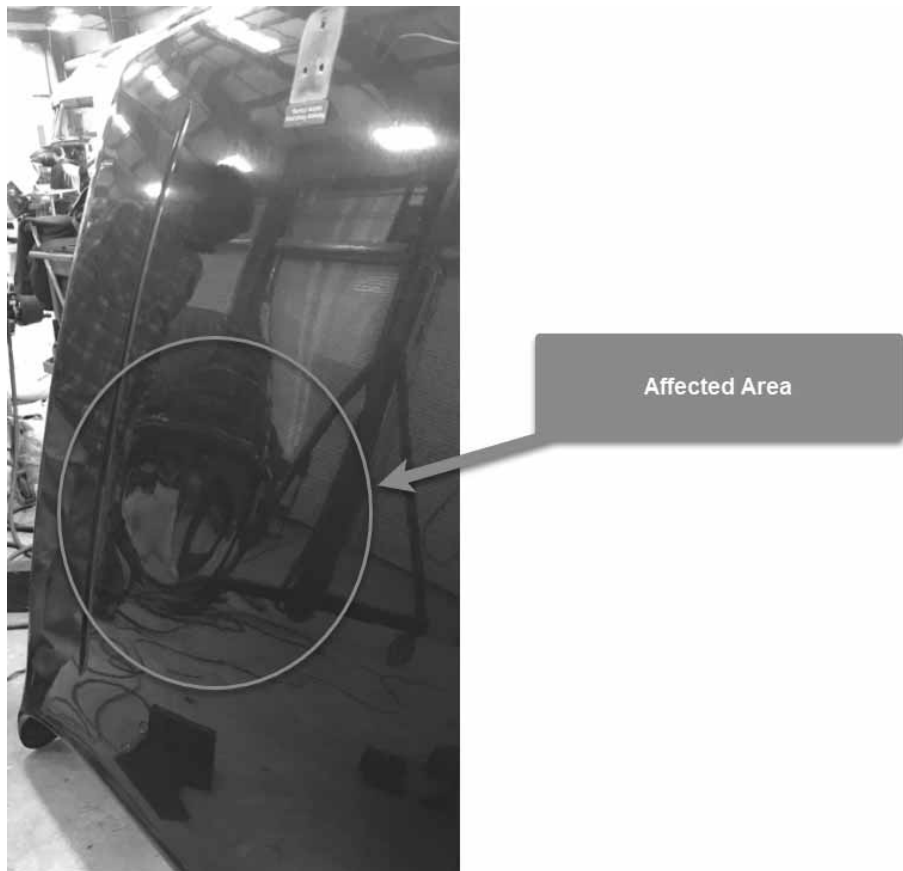
Affected models will have an appearance similar to the one shown in the circled area in the example below.

It has been determined that an increase of lateral structural hood support is required to correct this issue.
