Service Alert

"LOW BATTERY RISK. START VEHICLE TO CHARGE 12V BATTERY"
WARNING MESSAGE

Service Alert No.: SA-005/21

2021 Mazda3 2021 CX-30

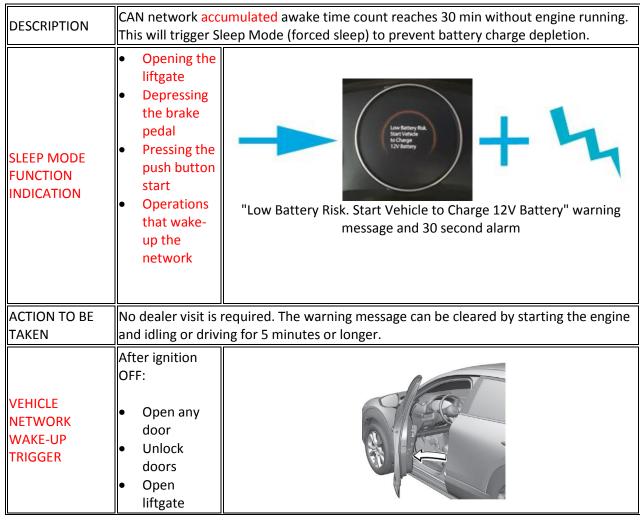
The vehicle network starts to wake-up at the moment any side door is opened in order to increase the startup speed of electrical components and the network awake cumulative time count begins by the customer doing any one of the following wake-up triggers:

- Open any door(s)
- Unlock doors
- Open liftgate
- Depress brake pedal
- Push start/stop button
- Other operations that wake-up the network

No dealer visit is required. The warning message can be cleared by starting the engine and idling or driving for 5 minutes or longer.
