982 – 4.0 liter Manual Transmission Cable Unclamps at Transmission Housing Bracket

Models	Model Year	Model Type	VIN Range	Vehicle-Specific Equipment
718	As of 2020 up to 2021	982510, 982810, 982160, 982360	N/A	480 – 6-speed manual transmission

Revision	Release Date	Changes
0	March 18, 2021	Original document

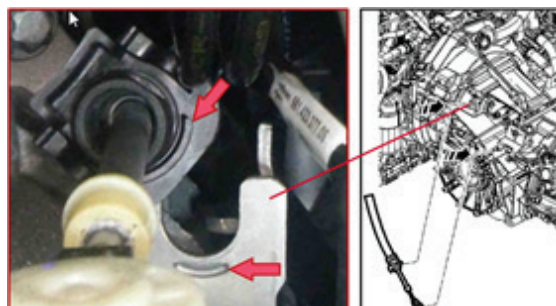
The workshop determines the shift cable's integrated clamp comes loose from its mounting bracket on the transmission's driver side. When this occurs, the cable is loose and shifting is not possible.

Suspected is, that the mating surfaces of the clamp to the bracket do not fully engage at assembly. (See arrows in Fig. 1.) This condition occurs during vehicle operation. Many possible modes leading to the loosening could exist to explain this detachment. This matter is under investigation. In the meantime, please perform the instruction highlighted below, if the cable detaches.

Figure 1 -
Assembly Location of Shift Cable
Clamp and Bracket on Transmission
Housing

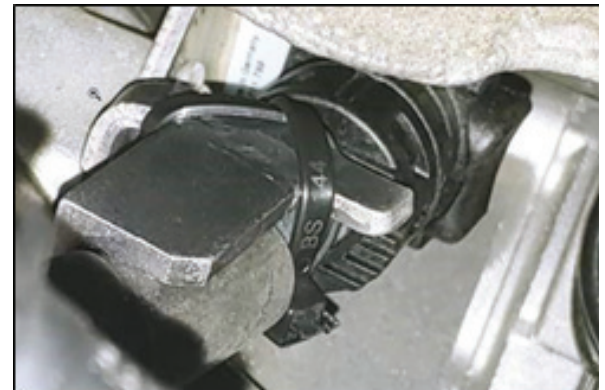
**Figure 2 -
Cable Tie Orientation**

- 1) Reattach the shift cable to the bracket.
- 2) Wrap two (2) cable ties in a cross pattern around both the shift cable and the mounting bracket (see Fig. 2).
- 3) Fully tighten the cable ties.
- 4) Trim any excess material from the cable tie.
